AC Inspection as Found

Tokai Carbon
3931 Carbon Plant Road
Ozark, AR 72949

AC Inspection - Rev. 2

Location: MOTOR SHOP LR
Serial Number: 8004
Description: 40/10HP WESTINGHOUSE
1800/900RPM 326T

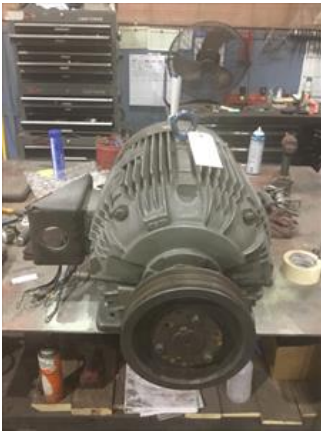
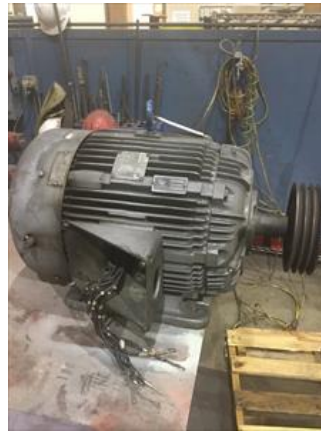
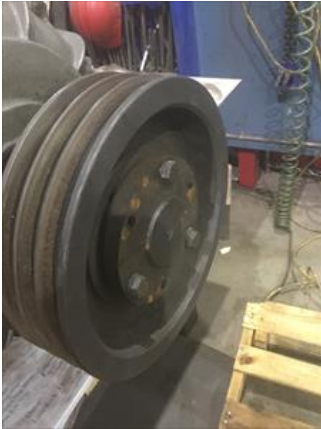
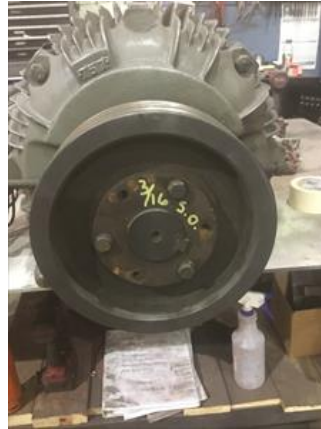
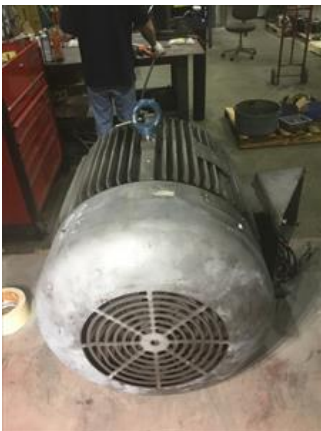
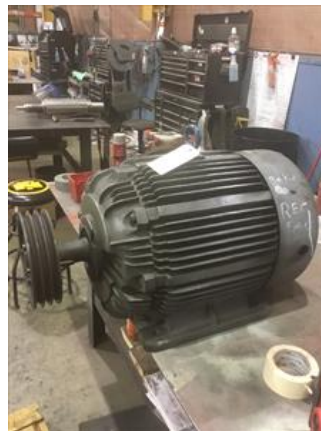
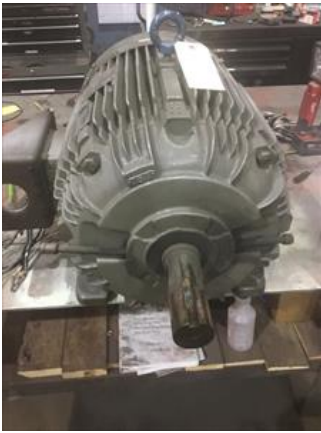
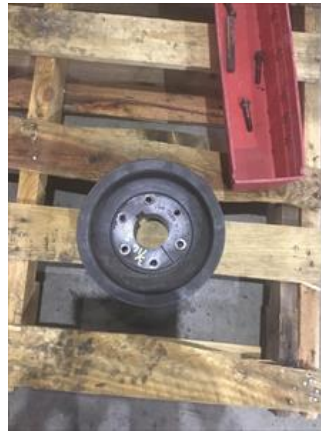
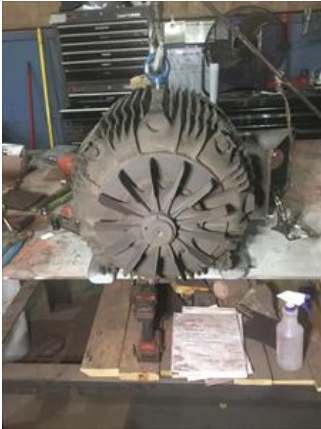
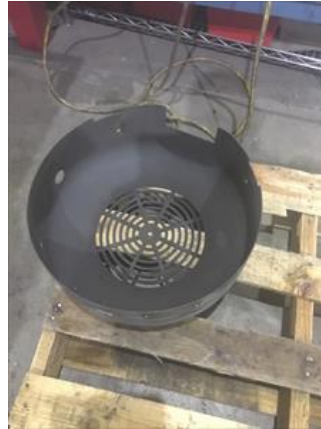
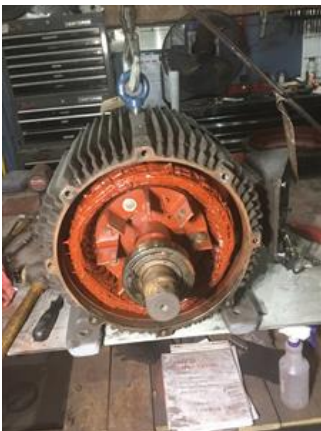
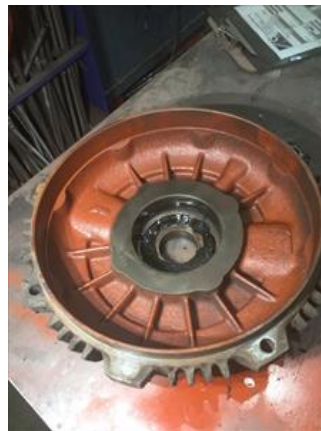
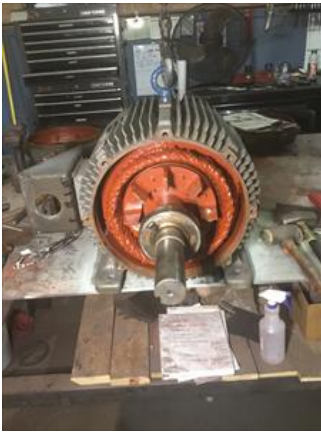
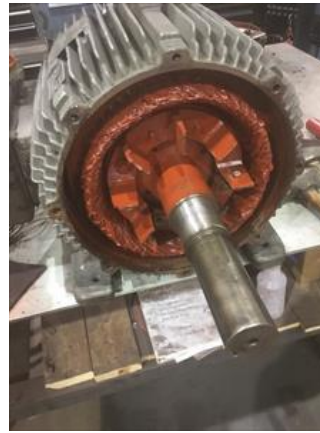
3. Photos of all six sides of the machine.

4. Describe the Overall Condition of the Equipment as Received
Serviceable.

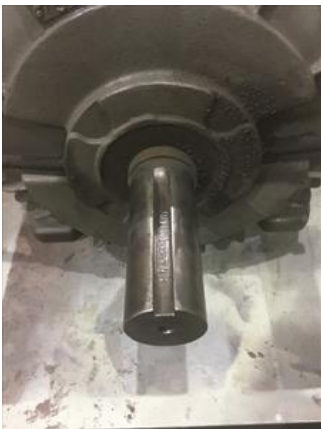
6. Does Shaft Turn Freely?

(Yes) Yes

7. Does Shaft Have Visible Damage?

(No) No

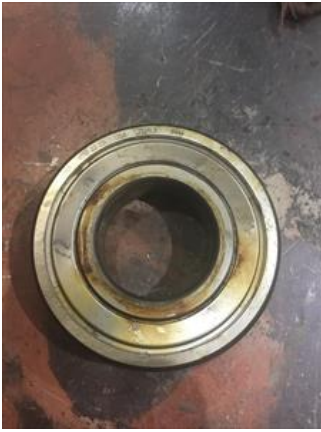
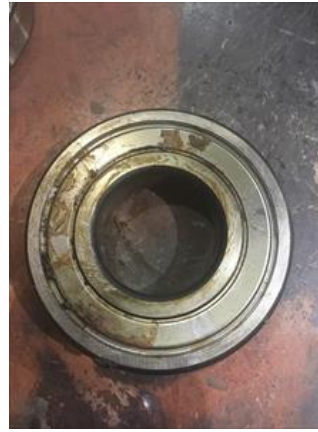
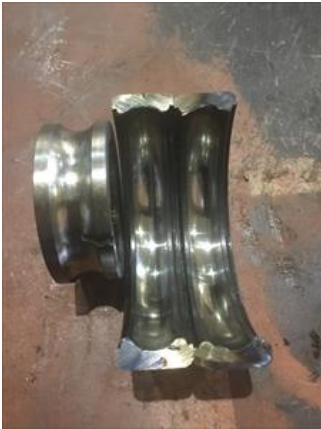
30. Drive End Bearing Condition

replace

73.	Post Rewind Surge Test		
74.	Post Rewind Hi-Pot		
75.	Technician		
Root Cause of Failure			
76.	Failure locations		
77.	Root cause of failure <i>Contaminated grease.</i>		
Mechanical Fits- Rotor - Post Repair

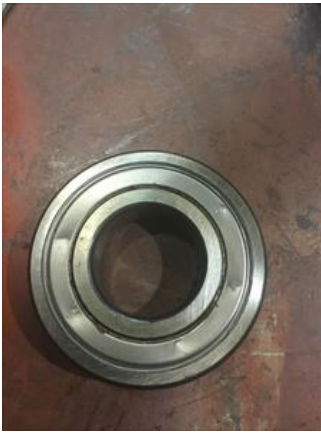
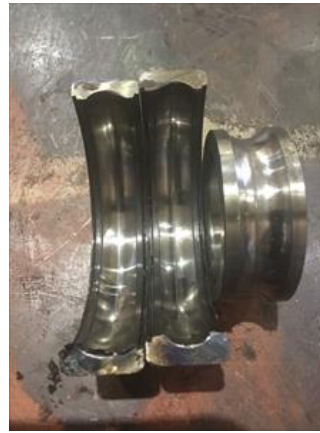
35. Opposite Drive End Lubrication Type	(Grease) Grease Lubricated
36. Opposite Drive End Bearing Insulation or Grounding Device?	none
37. Opposite Drive End Wavy Washer/Snap-Ring Other Retention Device?	none
38. Opposite Drive End Bearing Condition	replace
39. Drive End Seal	none
40. Opposite Drive End Seal	none
