## AC Inspection as Found

Dassault Falcon Jet (11751)

### AC Inspection - Rev. 2

Description: 30HP BALDOR 3600RPM 286TS

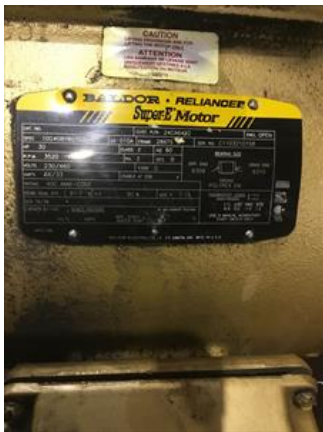
1. Report Date
2. Nameplate Picture

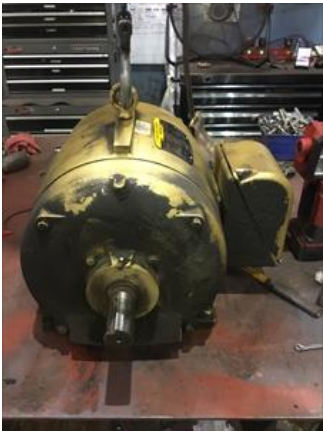
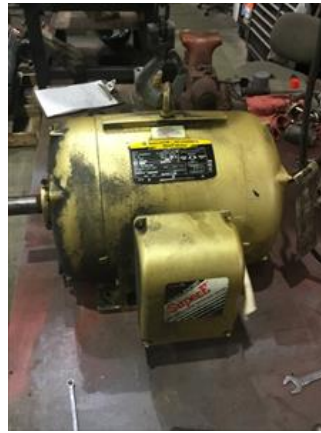
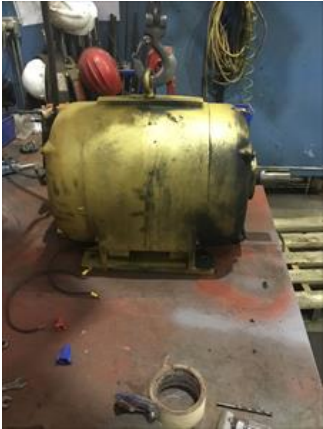
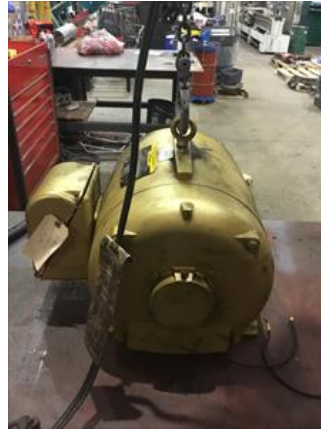
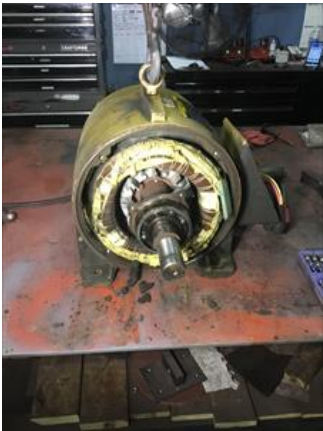
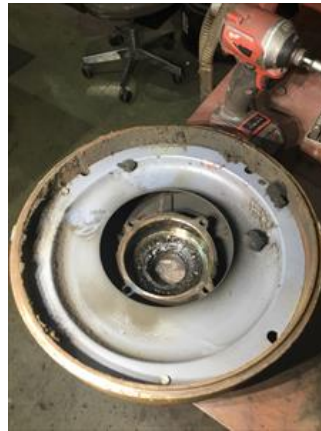
3. Photos of all six sides of the machine.

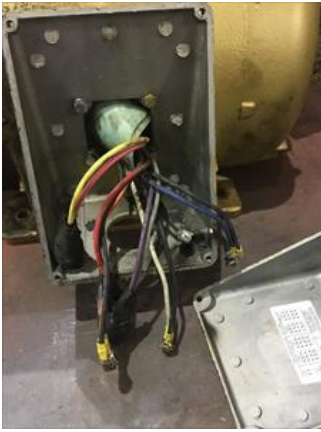
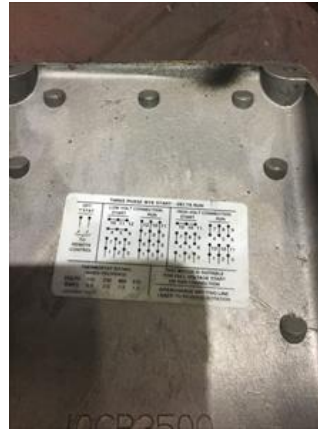
11. Lead Length	9.5 Inches
12. Frame Condition	pass
13. Fan Condition	(N) NA
14. Broken or Missing Components	missing eyebolt.

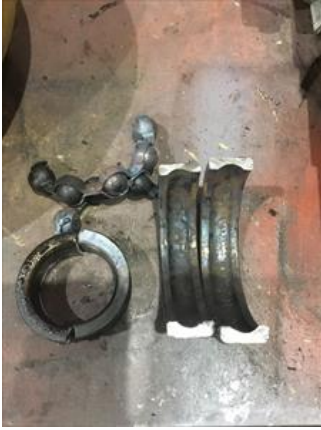
22. Drive End Bearing Brand

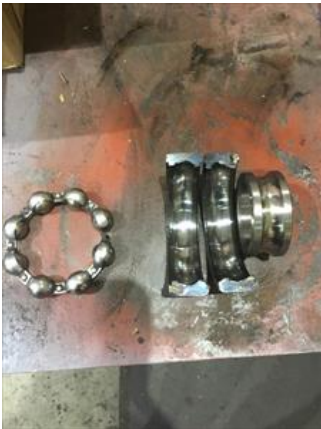
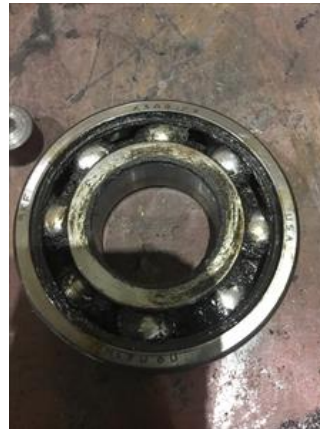
24. Drive End Bearing Qty.	1
25. Drive End Bearing Type	<b>(Ball) Ball Bearing</b>
26. Drive End Lubrication Type	<b>(Grease) Grease Lubricated</b>
27. Drive End Bearing Insulation or Grounding Device?	<b>none</b>
28. Drive End Wavy Washer/Snap-Ring Other Retention Device?	<b>none</b>
29. Drive End Bearing Condition	<b>welded on to shaft.</b>
30. Opposite Drive End Bearing Brand	
31. Opposite Drive End Bearing Number-	6309

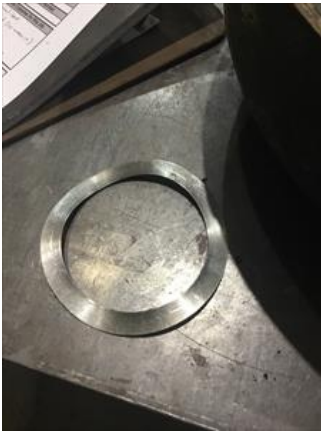
37. Opposite Drive End Bearing Condition

replace

72.	Post Rewind Surge Test		
73.	Post Rewind Hi-Pot		
74.	Technician		
Root Cause of Failure			
75.	Failure locations <i>D.E. Bearing journal bad &amp; ODE housing fit has lip worn in.</i>

76.	Root cause of failure <i>Contaminated grease caused premature bearing failure.</i>		
Mechanical Fits- Rotor - Post Repair			
77.	Shaft Runout Post Repair
