AC Inspection as Found

Twin Rivers

AC Inspection - Rev. 2

Description: 350HP GE 900RPM 8266/8288S

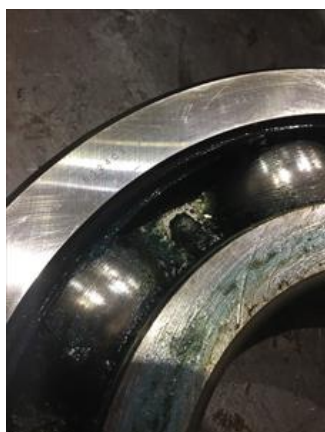
P33

33. Drive End Bearing Condition

replace

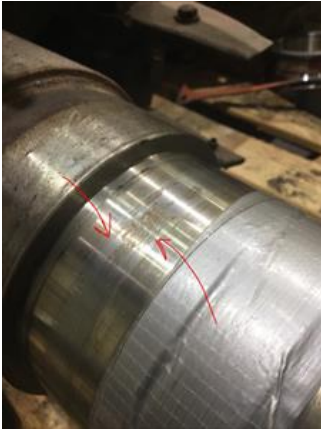
P77

Lip worn in

55. Drive End Bearing Shaft Fit Condition

(F) Fail

64.	End Bell Air Seal Fits		
	Drive End Air Seal	Opposite Drive End Air Seal	
65.	List Machine Work Needed Below <i>D.E. Shaft fit bad. Has lip worn in. D.E housing fit has excessive pitting.</i>
