AC Inspection as Found

Sage V Foods

Description: 50HP BALDOR

Hi-Speed Job Number: 101627

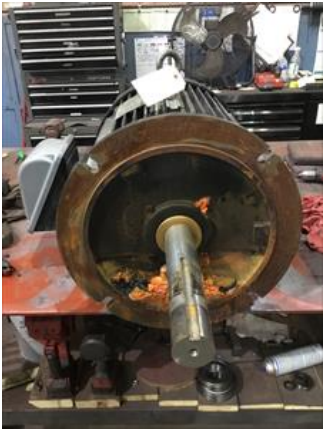
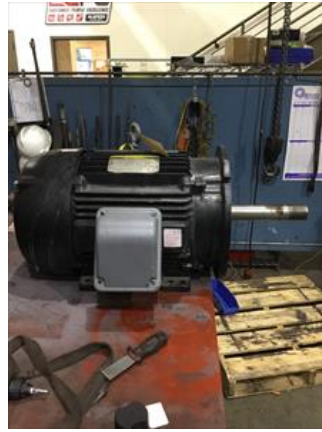
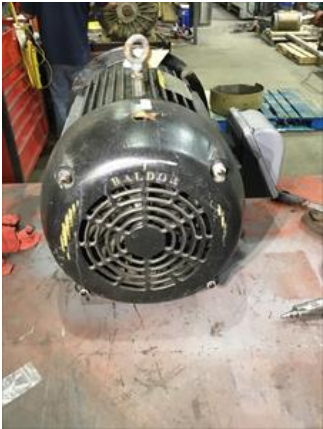
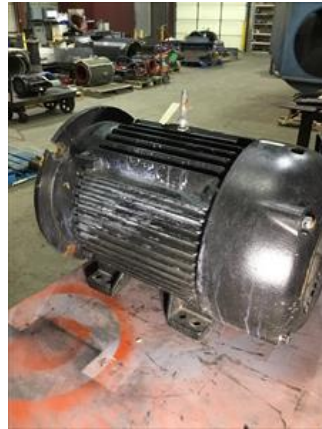
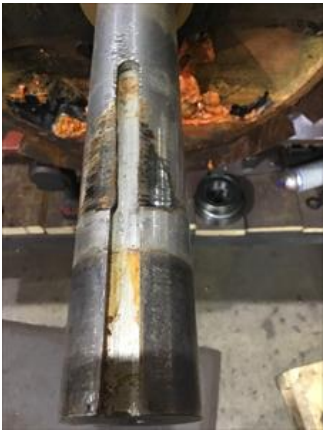
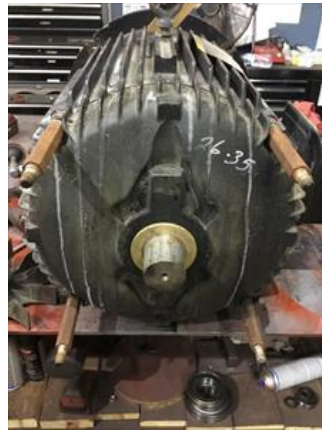
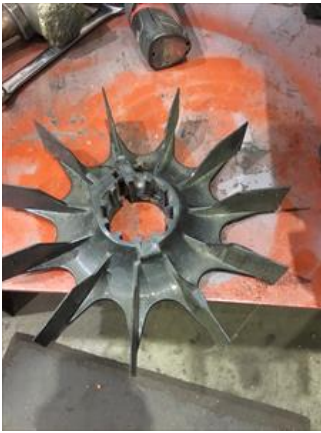
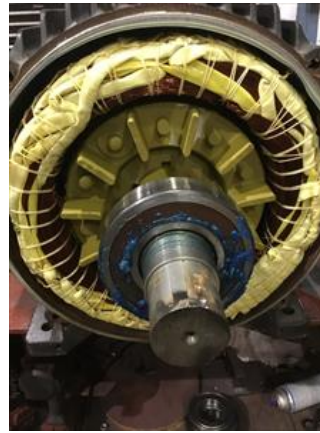
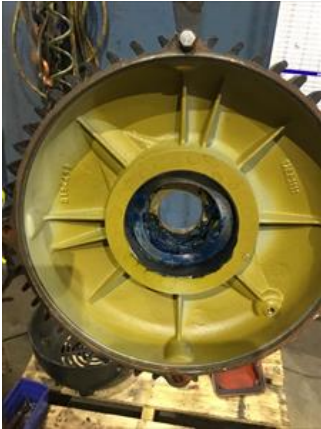
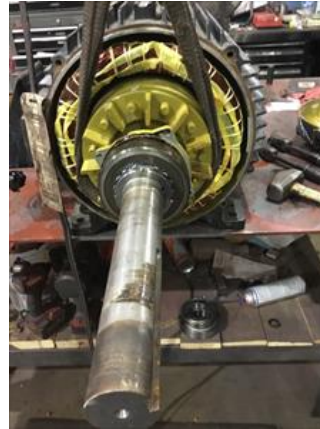
| ● | 6. Does Shaft Have Visible Damage? | (Yes) Yes | P17 |
| ■ | <i>Key way wallowed.</i> | | |

45. List the Parts needed for the Repair Below
New shaft, and new bearings.

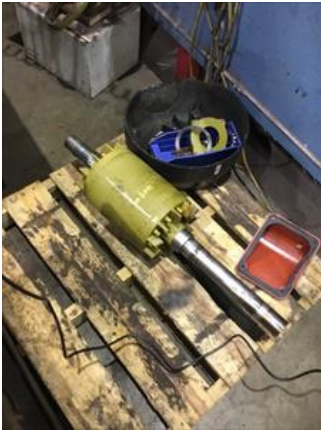
Rotor Inspection

42. Growler Test (Pass) Pass

44. Rotor Condition shaft replacement needed.
