**AC Inspection as Found**  
**AMERICAN COMPOSTING**  
11911 FAULKNER LAKE ROAD  
NORTH LITTLE ROCK, AR 72217

**AC Inspection - Rev. 2**

**Location:** MOTOR SHOP LR  
**Serial Number:** ES 2016 018914 ZP  
**Description:** 17.3KW ELMOT-SCHAFFER  
1800RPM 160L

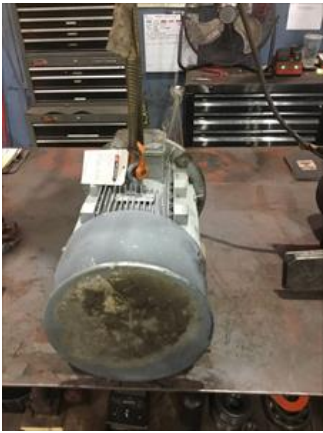
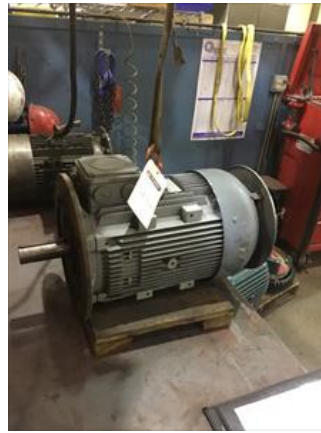
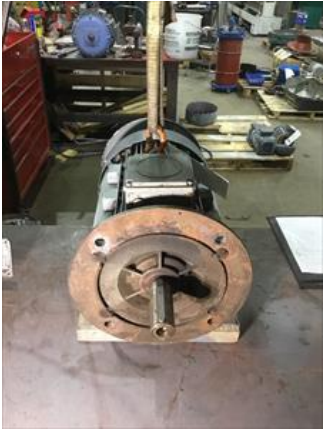
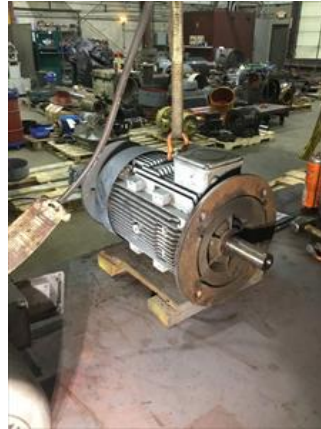
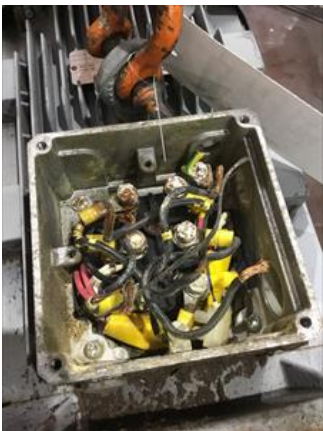
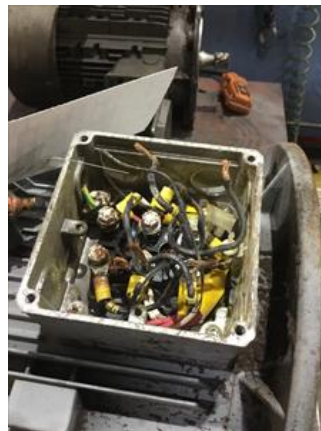
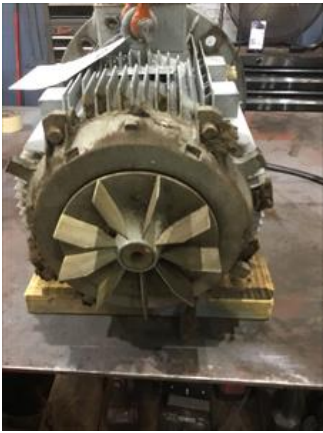
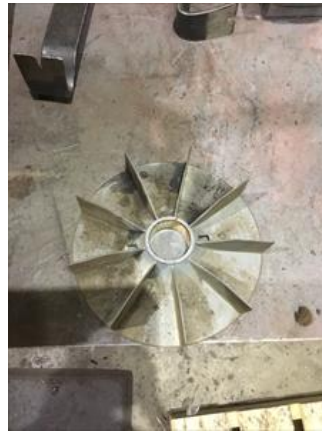
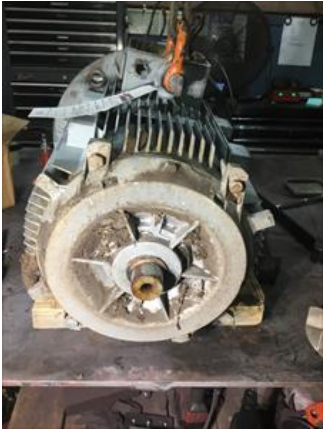
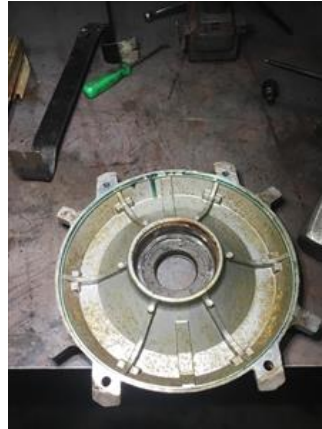
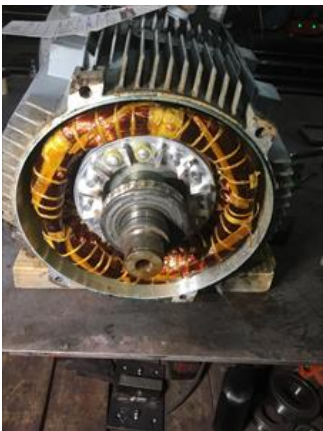
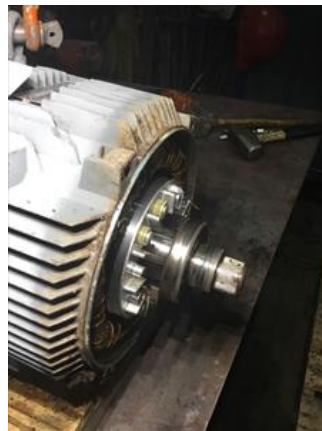
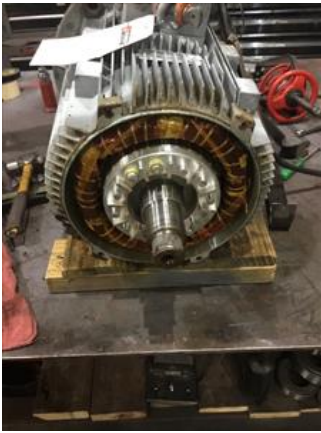
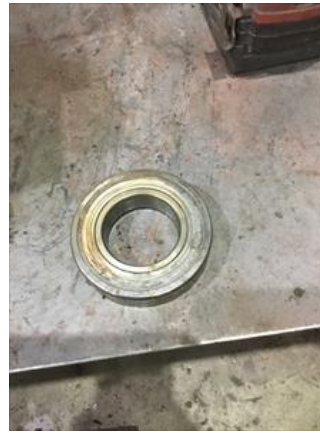
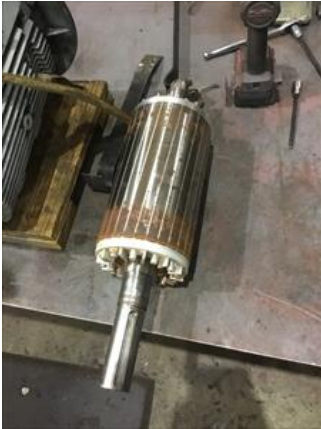
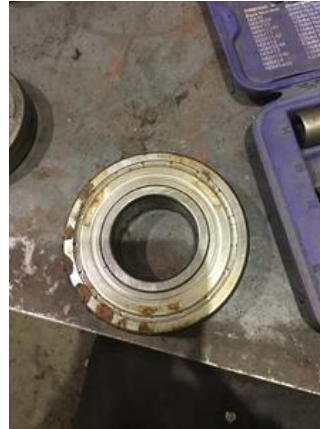
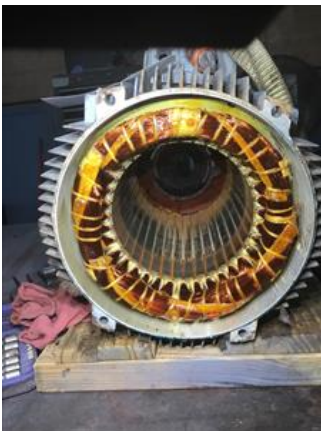
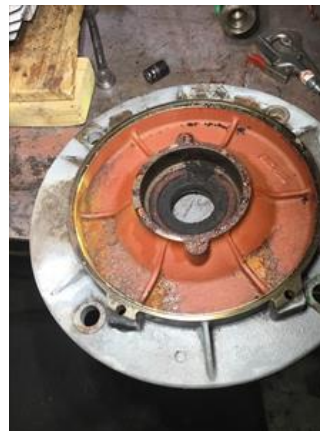
3. Photos of all six sides of the machine.

4. Describe the Overall Condition of the Equipment as Received  
Serviceable

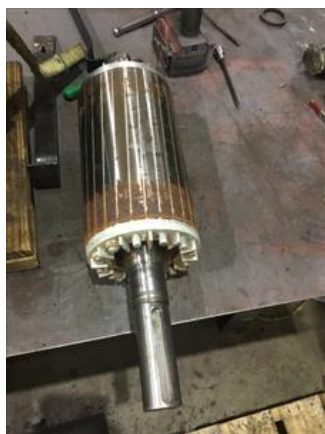
## Rotor Inspection

| 42. Growler Test | (Pass) Pass |
| 44. Rotor Condition | rusted |

| 45. List the Parts needed for the Repair Below<br><i>Replace 4 ea end bell mount bolts. Re-sleeve both housing fits. Replace 6309 &amp; 6209 2Z bearings. Replace both housing lip seals, 45*72*10</i> | |
