AC Inspection as Found
North Little Rock Wastewater (10219)
7400 Baucum Pike
N. Little Rock, AR 72117

AC Inspection - Rev. 2

Location: MOTOR SHOP LR
Serial Number: Y 07 17700602-0001 M 0002
Description: 25HP US MOTORS AERATOR
1200RPM 324LPZH

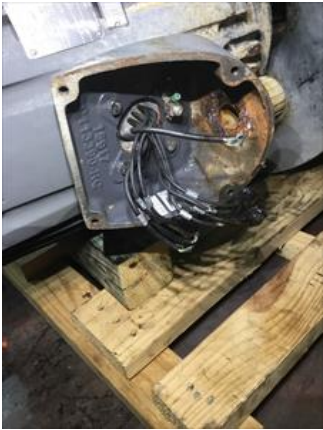
12. Lead Length	7 Inches
13. Lead Numbers	1-9
14. Frame Condition	pass
15. Fan Condition	(P) Pass

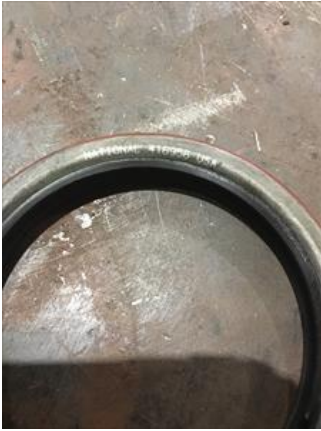
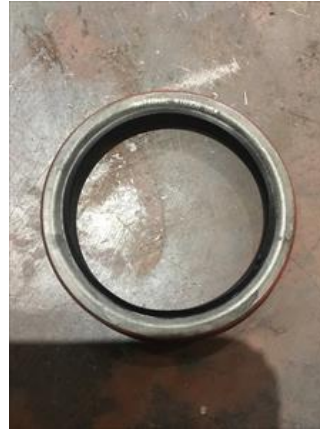
36. Opposite Drive End Lubrication Type	(Grease) Grease Lubricated	
37. Opposite Drive End Bearing Insulation or Grounding Device?	none	
38. Opposite Drive End Wavy Washer/Snap-Ring Other Retention Device?	none	
39. Opposite Drive End Bearing Condition	replace	
40. Drive End Seal	National 416956	P102
