AC Inspection as Found

Custom Craft Poultry

AC Inspection - Rev. 2

Location: Shop
Serial Number: 870183882.06.06.001
Description: SEW GEARMOTOR 1800RPM
160M

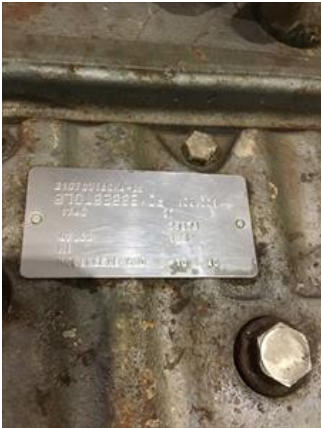
P37

1. Report Date
2. Nameplate Picture

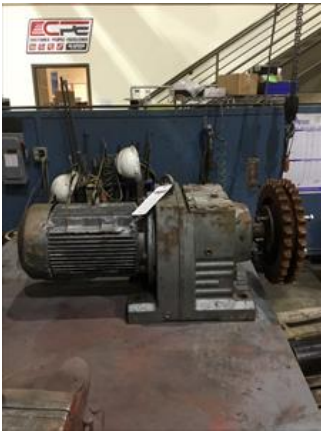
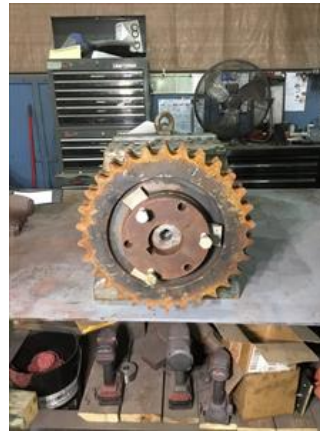
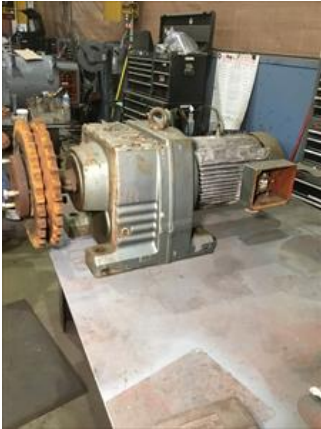
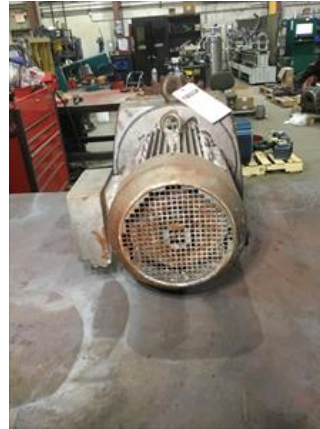
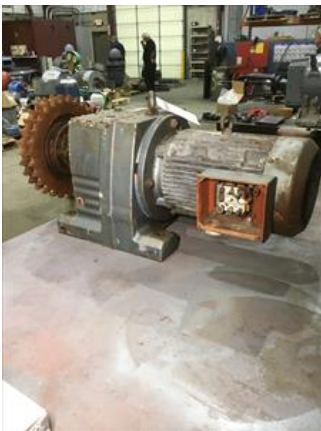
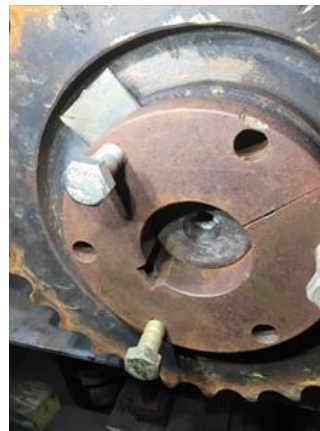
P45

3. Photos of all six sides of the machine.

4. Describe the Overall Condition of the Equipment as Received
Rusted and dirty.

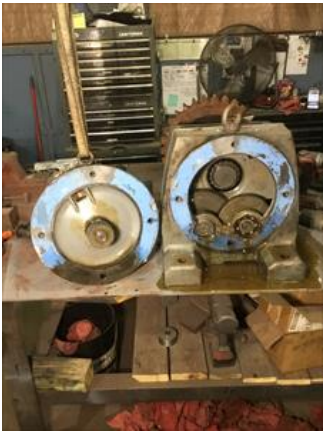
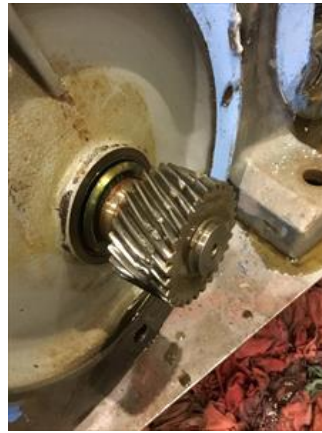
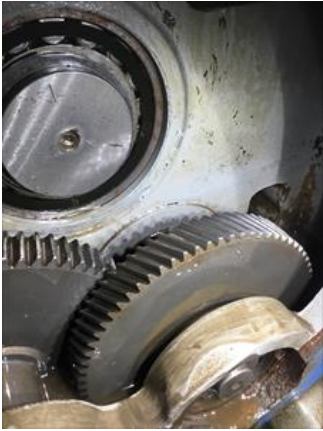
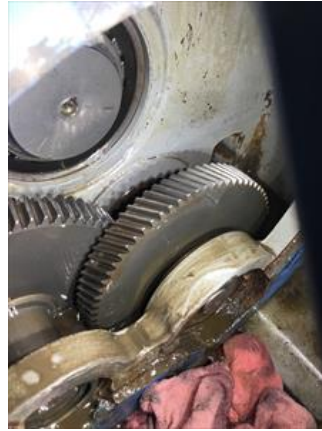
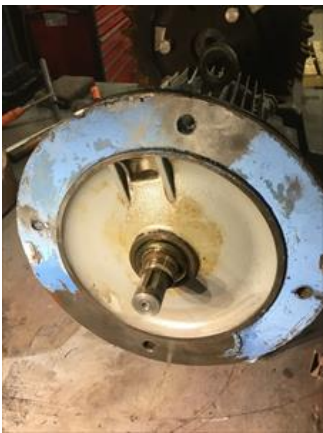
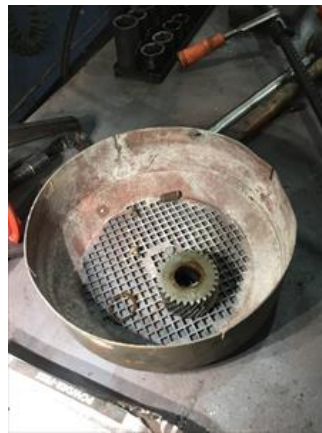
P100

16. Broken or Missing Components

- Connection block terminals broken, fan assembly missing, and ode housing broken and multiple gears stripped from wear.

74.	Post Rewind Surge Test		
75.	Post Rewind Hi-Pot		
76.	Technician		
Root Cause of Failure			
77.	Failure locations <i>Multiple Gearbox gears worn. Motor shaft output gear worn. Connection box mount block needs replacing. Ode housing broken and needs re-sleeved. Fan assembly missing.</i>

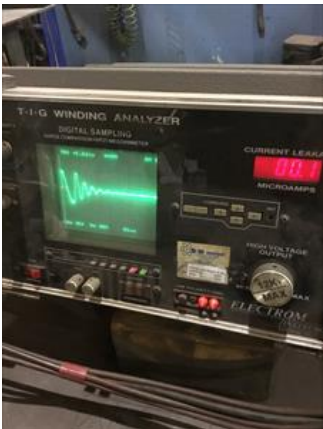
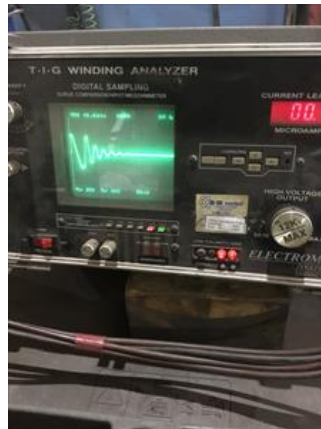
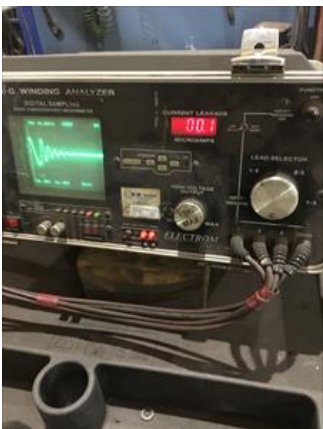
P57

19. Perform Surge Test

(P) Pass

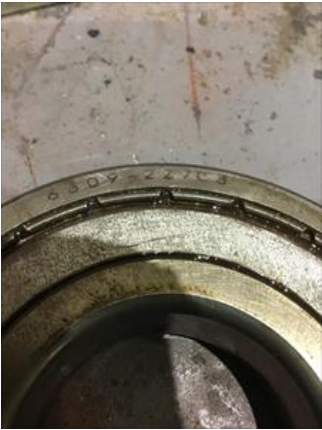
</div>			
25.	Drive End Bearing Number-	6309 2Z/C3	P30

31.	Drive End Bearing Condition	replace	
32.	Opposite Drive End Bearing Brand	skf

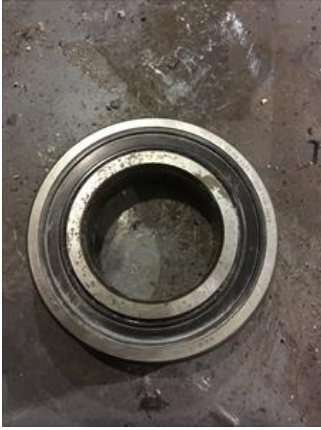
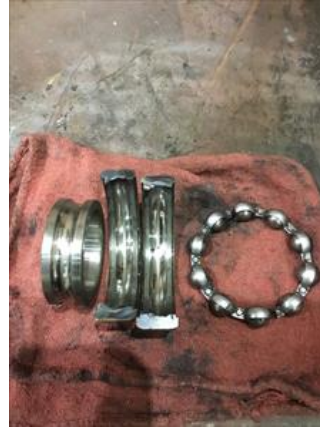
P90

33. Opposite Drive End Bearing Number-

6209 2rs

replace

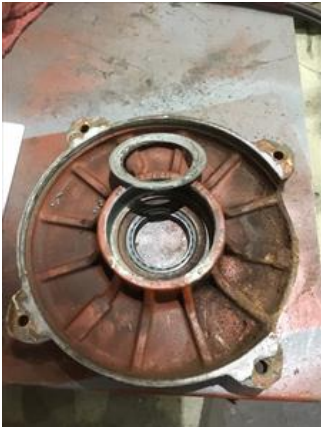
P99

38. Opposite Drive End Wavy Washer/Snap-Ring Other Retention Device?

wavy washer

60.	Opposite Drive End - Endbell Bearing Fit Condition (F) Fail		
61.	Bearing Cap Condition		
	Drive End Bearing Cap	Opposite Drive End Bearing Cap	
	N/A

62.	End Bell Air Seal Fits		
	Drive End Air Seal	Opposite Drive End Air Seal	
63.	List Machine Work Needed Below <i>ODE housing fit worn beyond limits.</i>

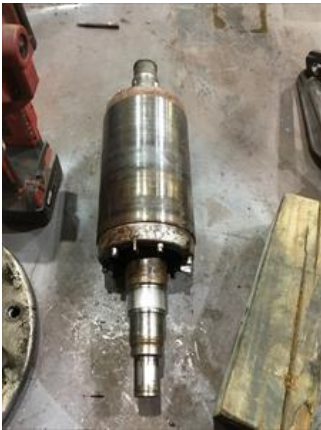
P3

(Squirrel Aluminum) Squirrel
Cage Aluminum Die Cast

43. Growler Test

(Pass) Pass
