AC Inspection as Found

Reynolds Metals company

AC Inspection - Rev. 2

Description: 100 hp

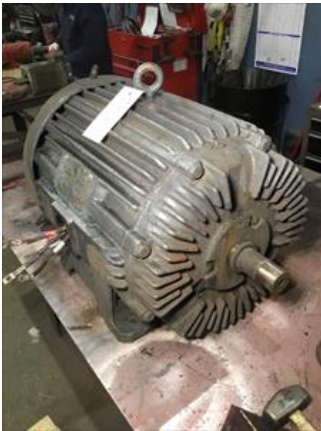
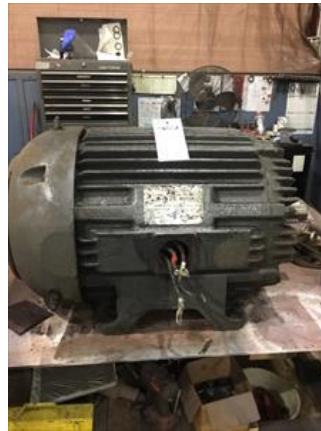
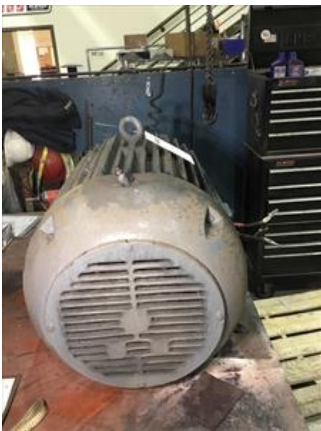
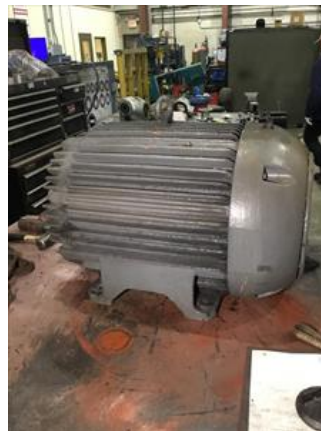
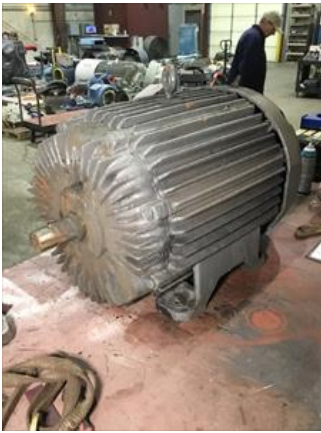
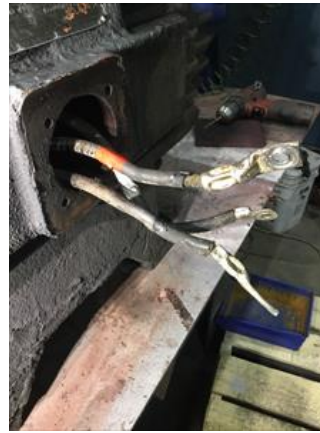
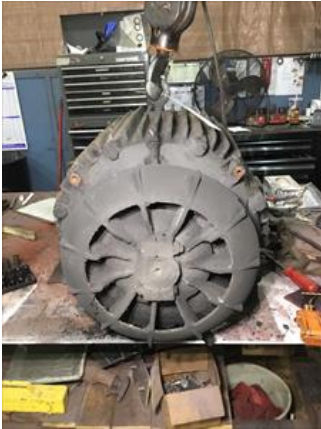
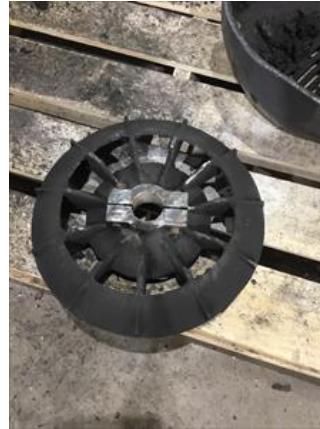
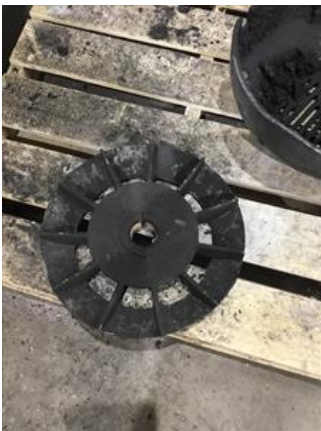
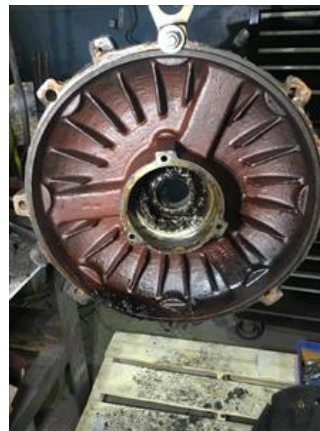
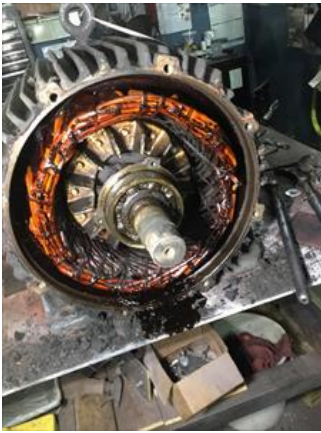
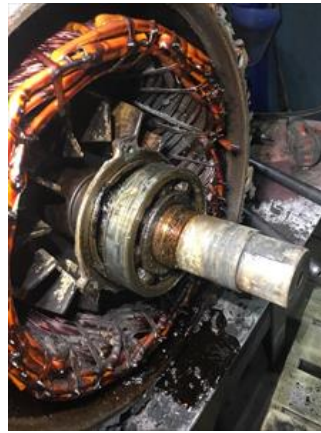
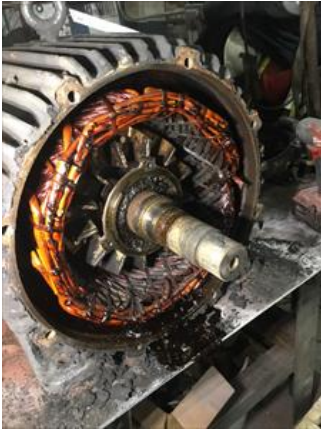
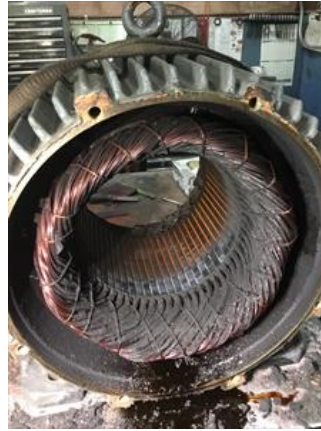
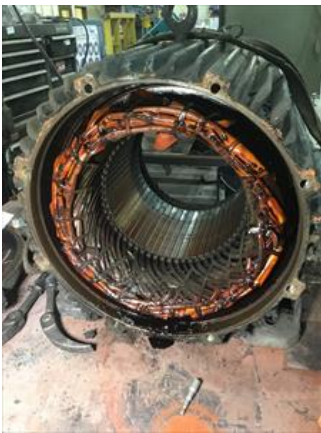
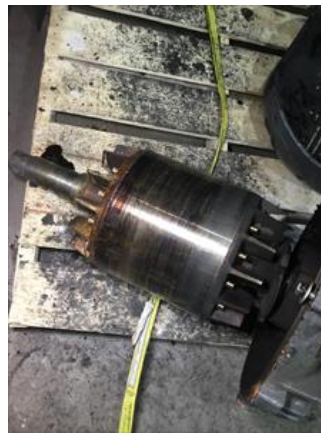
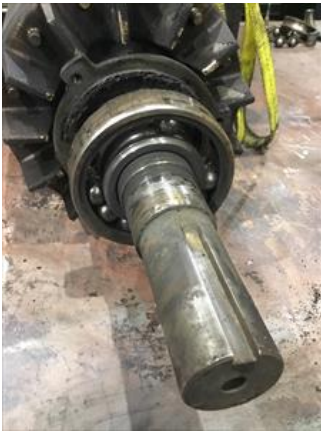
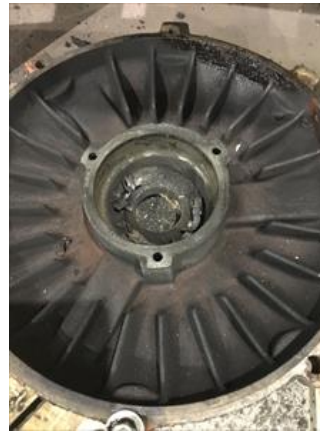
P45

3. Photos of all six sides of the machine.

4. Describe the Overall Condition of the Equipment as Received
Serviceable

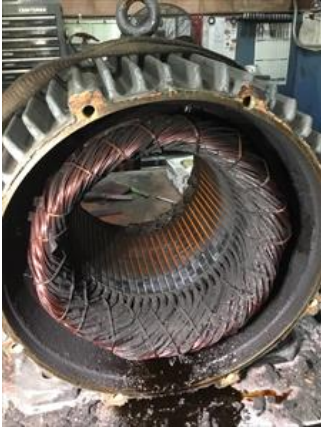
16. Insulation Resistance/Megger	Megohms	
17. Winding Resistance		
1-2	1-3	2-3

19. Number of Stator Slots	60
20. Stator Condition	rewind
21. Stator Thermistors/Ohms	
22. Stator Overloads/Ohms

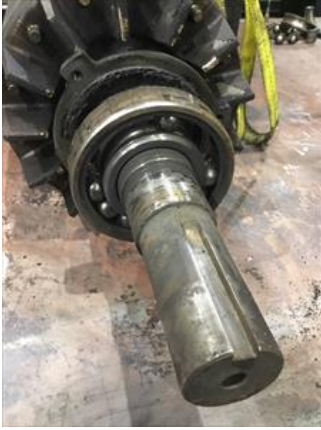
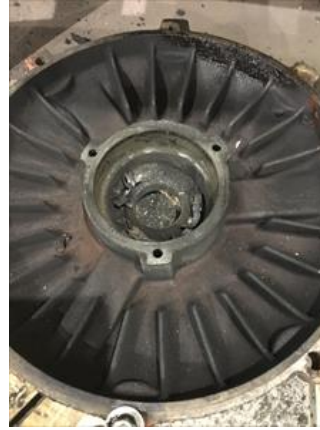
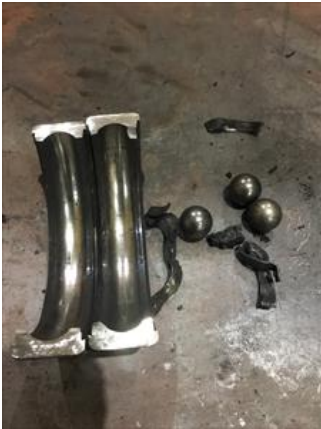
23. Drive End Bearing Brand	unreadable
24. Drive End Bearing Number-	6313
25. Drive End Bearing Qty.	1
26. Drive End Bearing Type	(Ball) Ball Bearing
27. Drive End Lubrication Type	(Grease) Grease Lubricated
28. Drive End Bearing Insulation or Grounding Device?	none
29. Drive End Wavy Washer/Snap-Ring Other Retention Device?	none

73.	Post Rewind Surge Test		
74.	Post Rewind Hi-Pot		
75.	Technician		
Root Cause of Failure			
76.	Failure locations		
	D.E bearing cage failed, due to excessive grease contamination on both bearings.

Sleeve both end bell housing fits. Repair O.D.E shaft bearing journal. Polish rough shaft seal area on DE.
