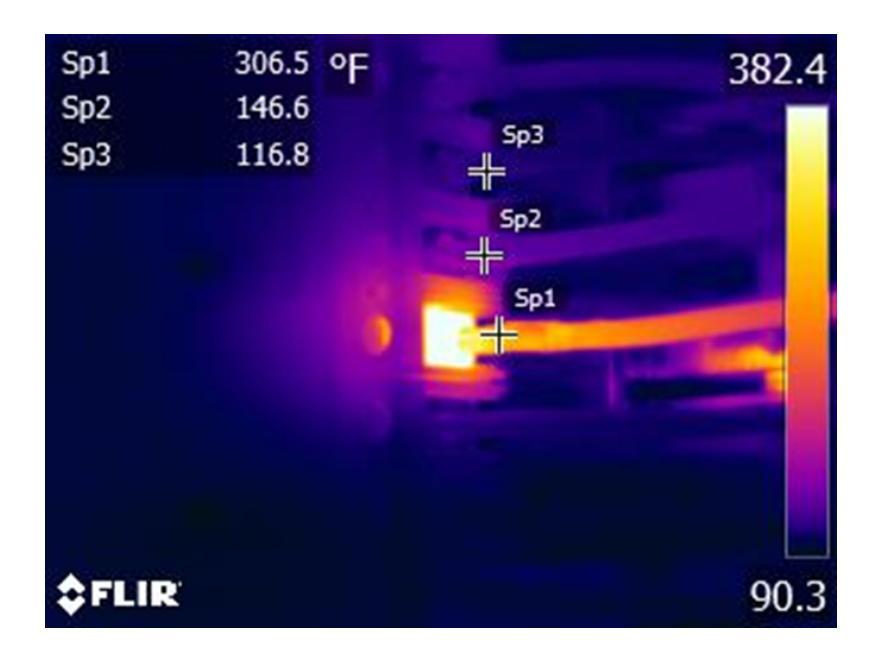
QSI-200 Disconnect

Knife switch

Measurements		
Li1		
Max	182.0 °F	
Avg	116.8 °F	
Min	84.8 °F	
Sp1	175.8 °F

Fault Worn/faulty knife components

> Defect Rating CLASS II

IR image shows heat on B phase. This is likely due to worn knife components. Inspect, repair, and replace components as needed.
