All electrical panels were scanned using a **FLIR T865** infrared camera. The following report only contains defects that were found during the survey. Below is our classification system for each defect included in this report. If there are any questions or comments, please feel free to contact us at any time.

HI-SPEED

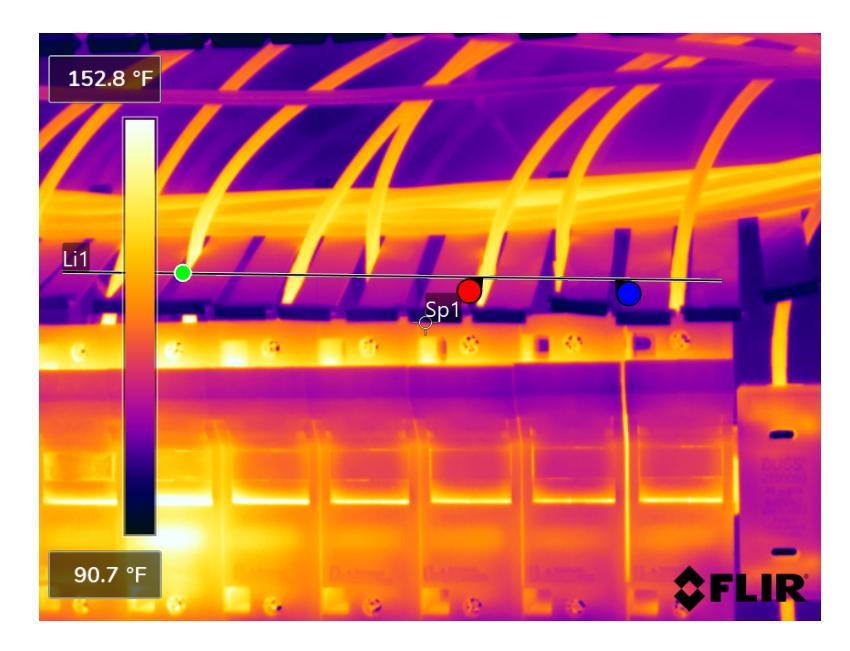
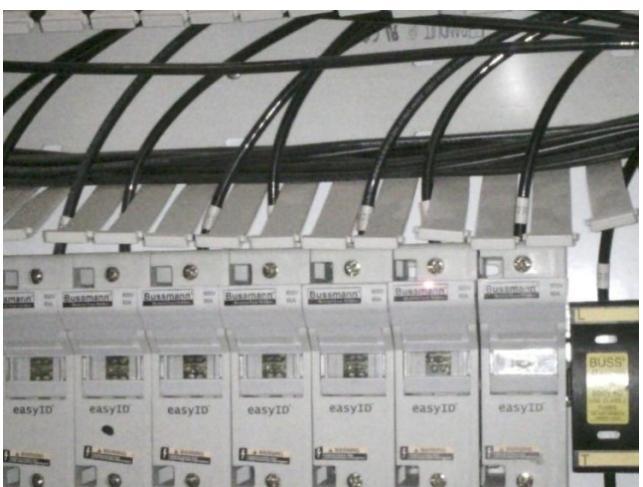
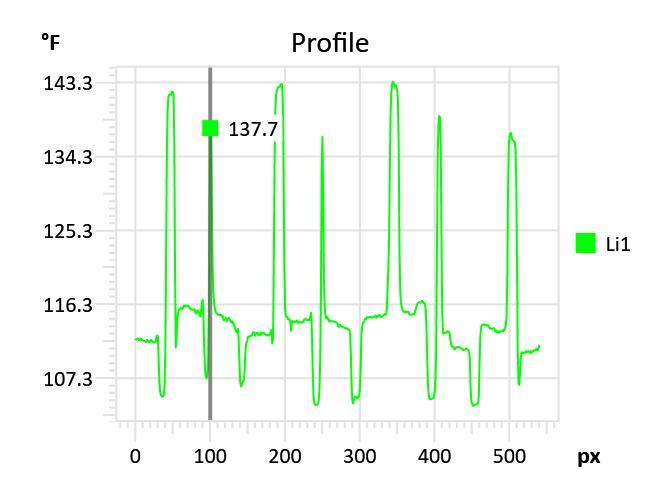
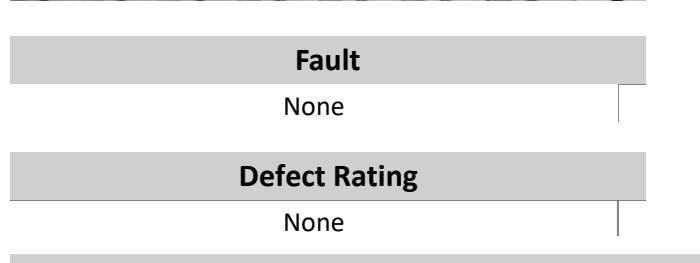
(RECHECK) FB3018

FB3018 VFD26XX Fiberglass

Measurements		
Li1		
Max	143.4 °F	
Avg	115.6 °F	
Min	104.0 °F	
Sp1	110.6 °F
