Agitator 741 Motion Amplification Study, West Lake Chemical Aberdeen, MS

1: Executive Summary

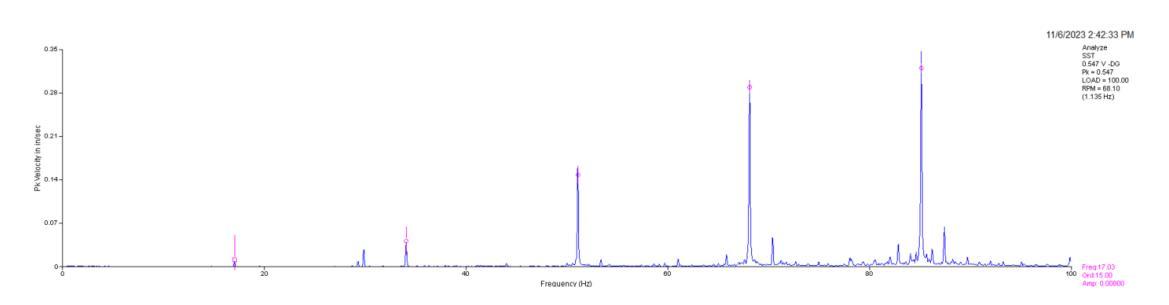
Figure 7: Gearbox Output End Horizontal (GOH)

Some issues were definitely noticed while acquiring video and vibration data of the motor and gearbox. While using a strobe light to confirm input and output rpms, we noticed some backlash at the input side of the gearbox. It is unclear if the gearbox or the fluid coupling is causing this backlash. There is also some slip between the motor and input side of the gearbox. This may be normal for this type of fluid coupling but can generate excessive heat over time. The main issues we found were excessive motor/base movement according to MA video. We also noticed quite a bit of gear mesh vibrations throughout the gearbox and motor. We don't have technical info of the gearbox such as number of shafts, gears, number of teeth on gears, but our data does help us determine some of this info, as we know the input and output rpm. Gearbox data shows the most dominant vibrations at harmonics of 15 x output rpm. This leads us to believe that the gearbox has internal wear that is likely related to an intermediate and or the output section of the gearbox. There is quite a bit of gear mesh related vibrations in the motor which also creates concern for this gearbox.
