AC Inspection as Found
Almatis Inc/RCP Bauxite (10014)
4701 Alcoa Road
Bauxite, AR 72011

AC Inspection - Rev. 2

Location: LR Motor Shop

Description: 1.5HP RELIANCE 1800RPM
182TDZ SHAKER

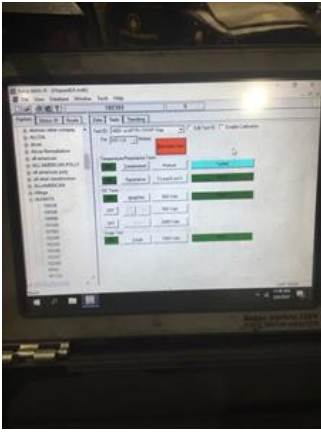
■ *Oil saturation on windings but passed surge test.*

Root Cause of Failure		
66. Failure locations		
	<i>O ring Seals allowed oil to leak into the stator.</i>	
67. Root cause of failure		
	<i>O ring Seals allowed oil to leak into the stator.</i>	
Dynamic Balance Report

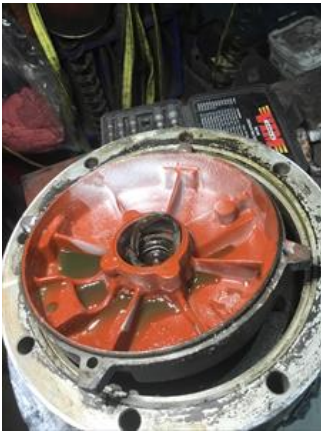
| 40. Opposite Drive End Bearing Condition | replace |
