## AC Inspection as Found

Remington (10243)

### AC Inspection - Rev. 2

Description: 15HP BALDOR 3520RPM

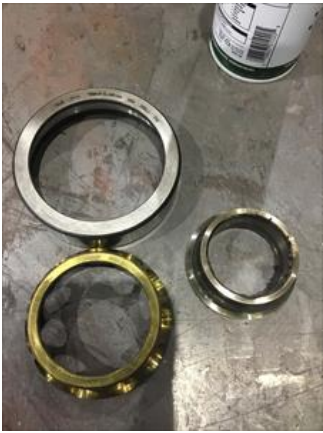
P12

25. Drive End Bearing Brand

26. Drive End Bearing Number-	7309
27. Drive End Bearing Qty.	1
28. Drive End Bearing Type	(Thrust) Thrust
29. Drive End Lubrication Type	(Grease) Grease Lubricated
30. Drive End Bearing Insulation or Grounding Device?	none
31. Drive End Wavy Washer/Snap-Ring Other Retention Device?	none

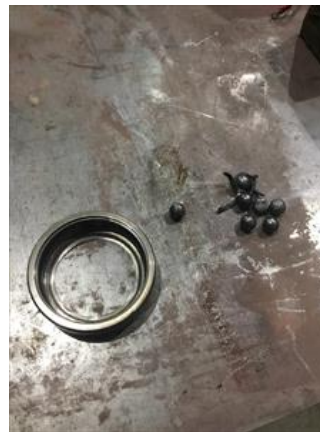
P99

33. Opposite Drive End Bearing Brand

Skf

6208

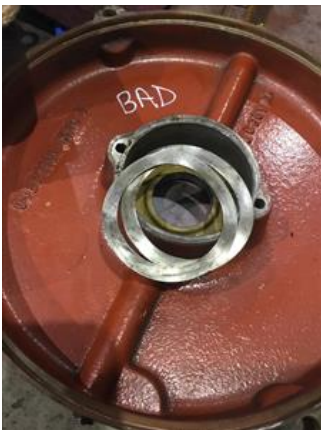
P114

40. Opposite Drive End Bearing Condition

cage failure

*Contaminated grease in both housings caused premature catastrophic bearing cage failure on the opposite drive end.*

52.	Growler Test		(Pass) Pass
53.	Number of Rotor Bars		28
54.	Rotor Condition		pass
55.	List the Parts needed for the Repair Below <i>Sleeve ODE housing fit. Replace bearings and DE housing seal.</i>
