AC Inspection as Found

Sage V Foods

AC Inspection - Rev. 2

Description: 10HP PUMP NO N/P

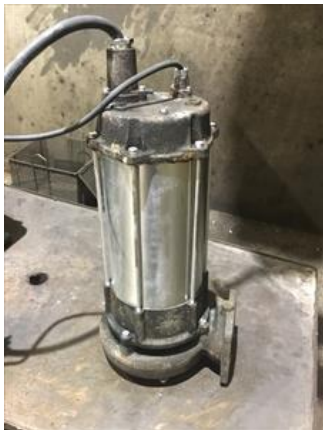
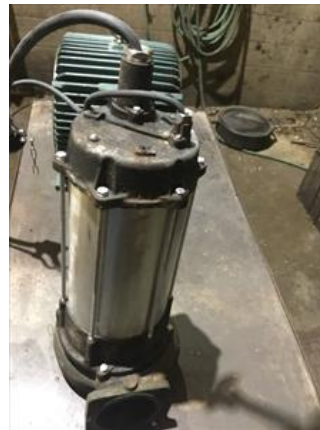
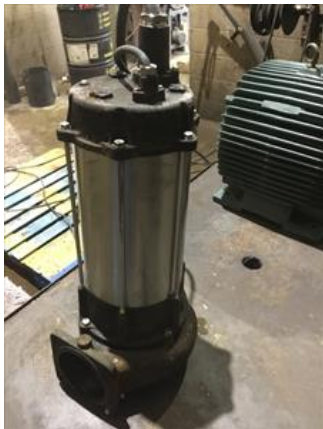
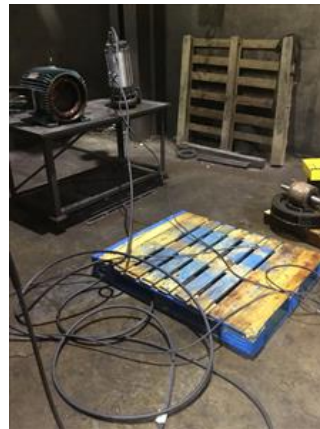
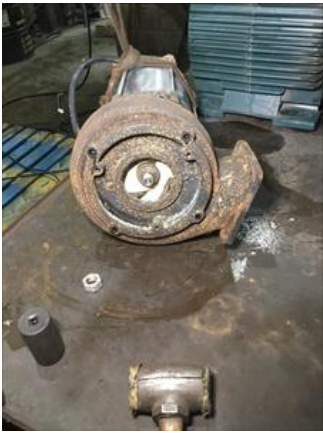
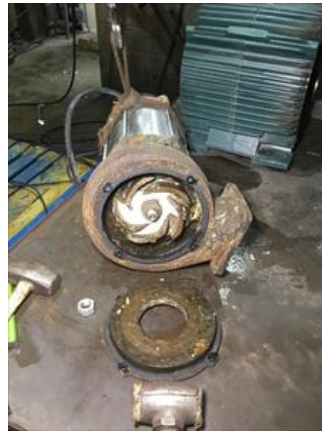
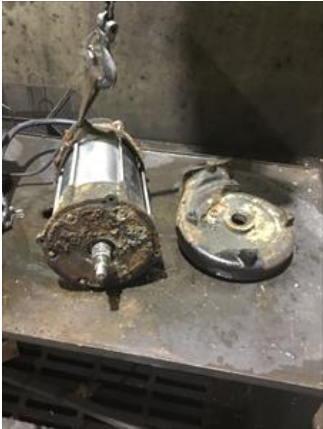
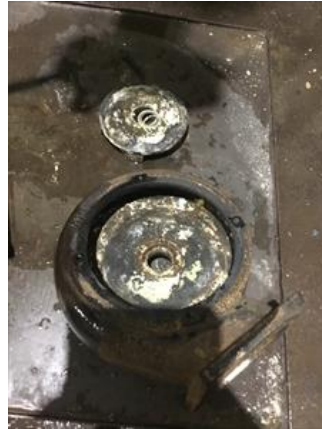
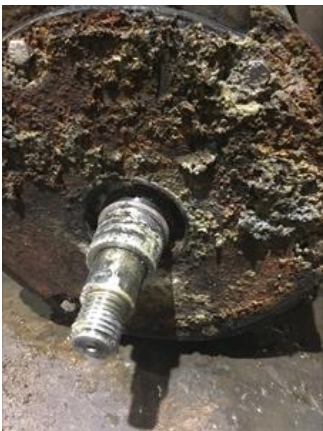
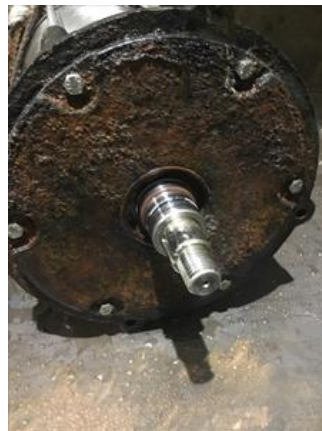
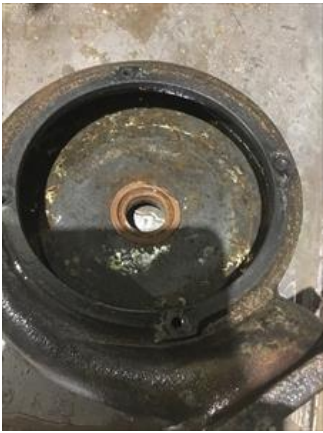
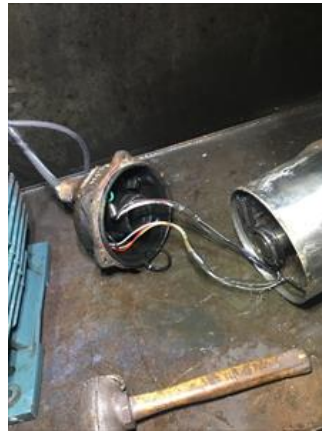
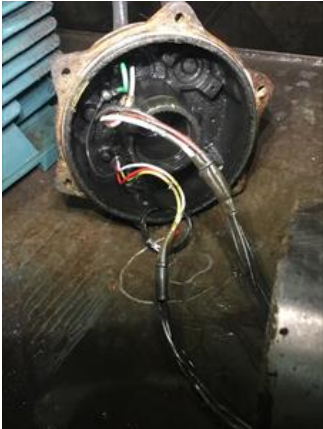
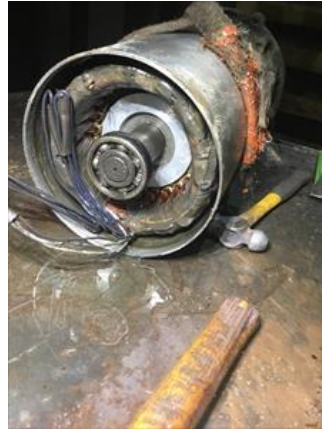
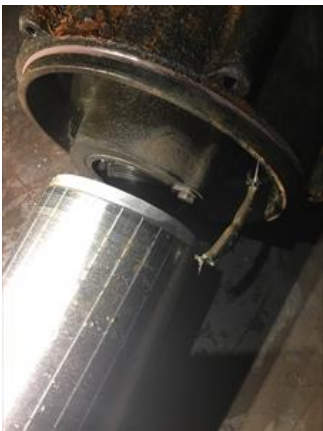
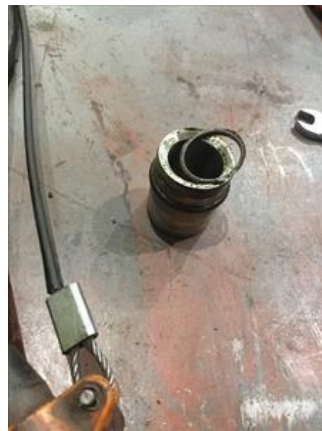
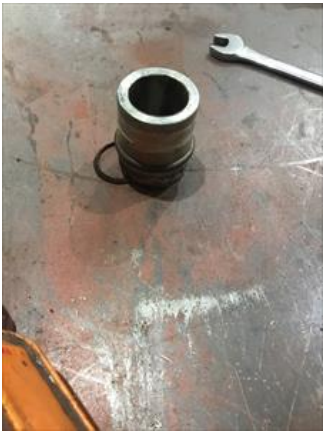
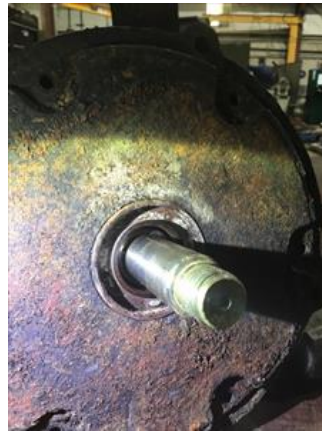
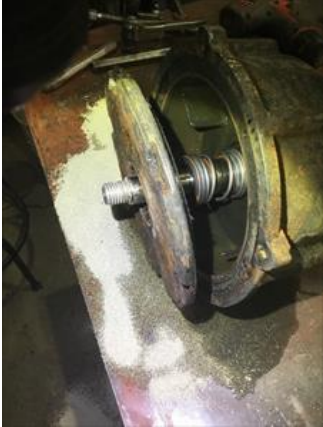
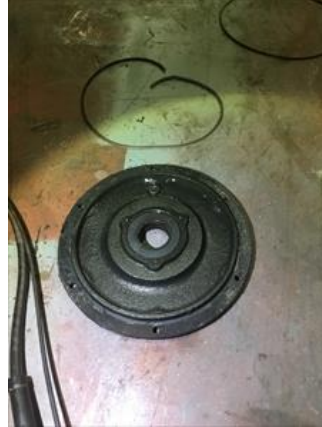
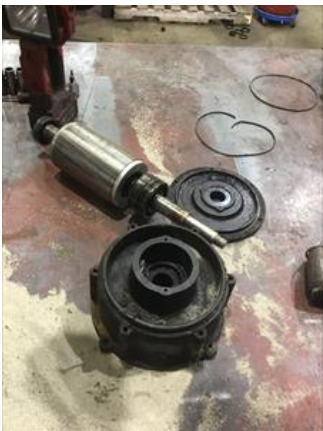
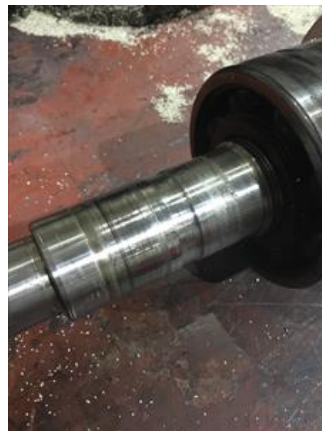
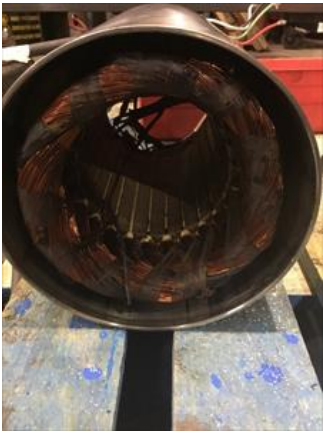
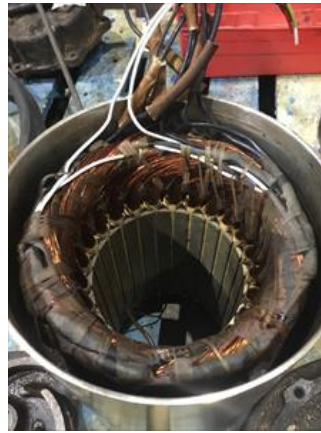
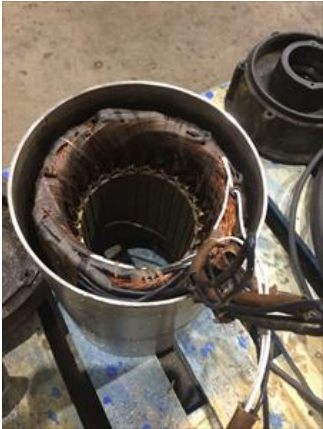
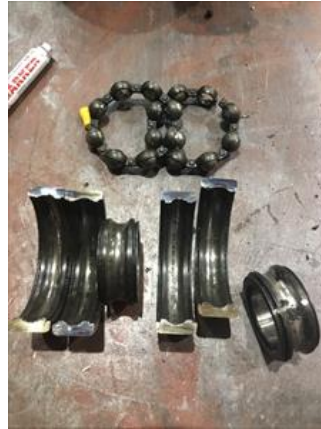
3. Photos of all six sides of the machine.

4. Describe the Overall Condition of the Equipment as Received
Serviceable

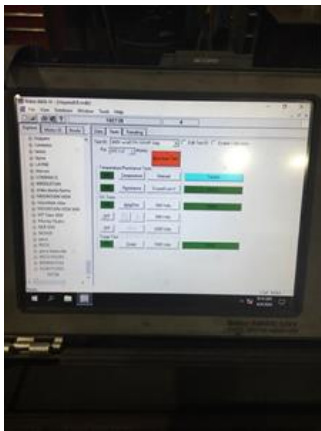
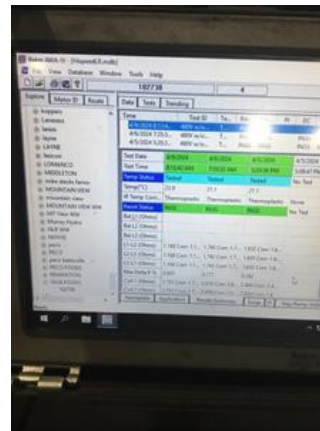
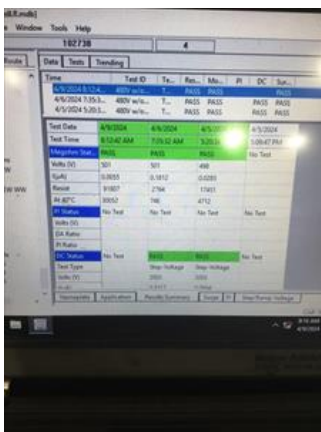
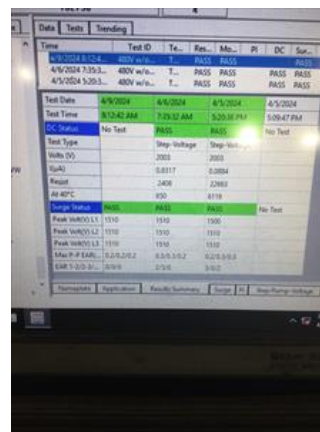
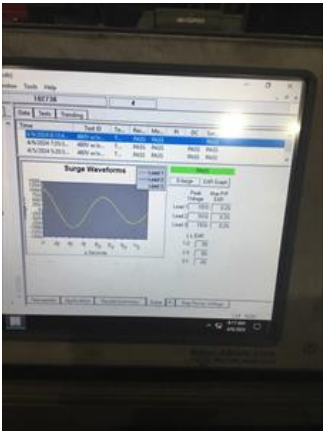
26. Stator Condition P84

Possible rewind due to winding strings being brittle and cracked in multiple places.

57.	Number of Rotor Bars	27
58.	Rotor Condition	pass
59.	List the Parts needed for the Repair Below <i>Seal and o-ring kit. Repair D.E. Seal surfaces. Re-sleeve D.E and ODE housing fits. Repair ODE shaft bearing journal. Possible rewind due to brittle winding strings in stator housing.</i>

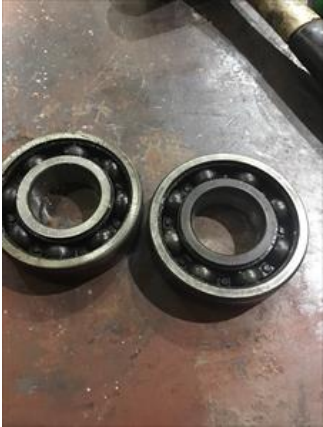
32. Drive End Bearing Type	(Ball) Ball Bearing	P51

33. Drive End Lubrication Type	(Oil) Oil Lubricated	
34. Drive End Bearing Insulation or Grounding Device?	None	
35. Drive End Wavy Washer/Snap-Ring Other Retention Device?	None	
36. Drive End Bearing Condition	replace	P82

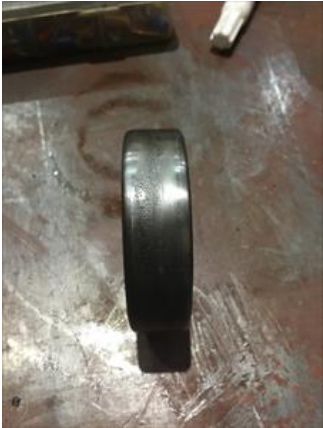
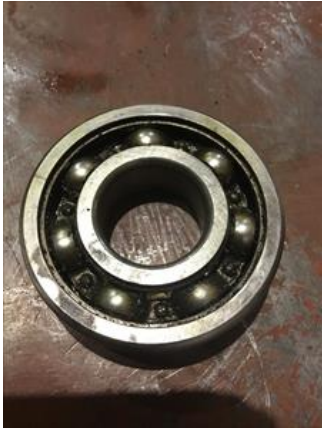
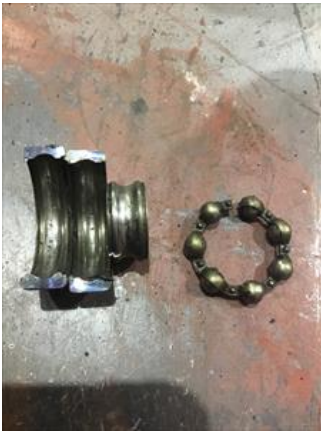
37. Opposite Drive End Bearing Brand	unknown	
38. Opposite Drive End Bearing Number-	6305 C3	
39. Opposite Drive End Bearing Qty.	1	
40. Opposite Drive End Bearing Type	(Ball) Ball Bearing	P106

44. Opposite Drive End Bearing Condition	replace	
45. Drive End Seal	replace	
<div>
