AC Inspection as Found

Sage V Foods
5901 SLOAN DRIVE
LITTLE ROCK, AR 72206

AC Inspection - Rev. 2

Description: 10HP PUMP NO N/P

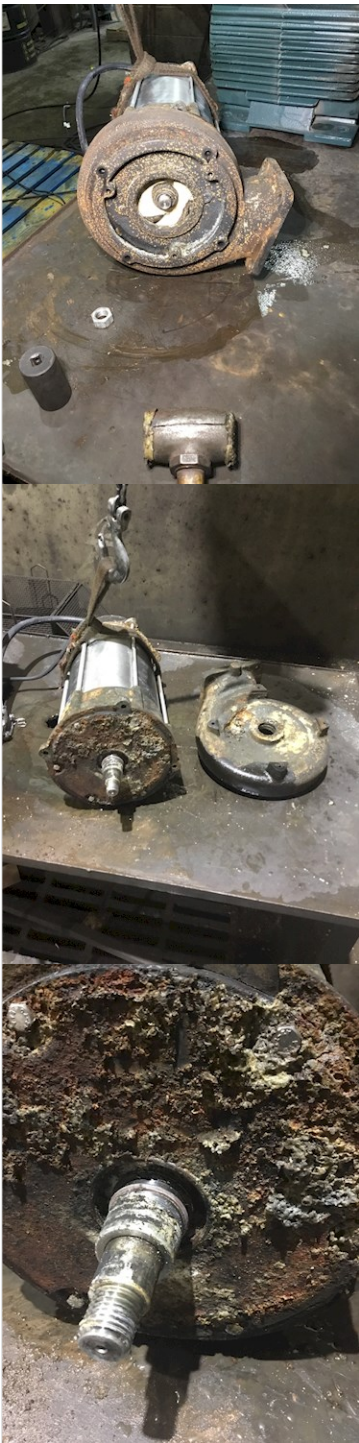
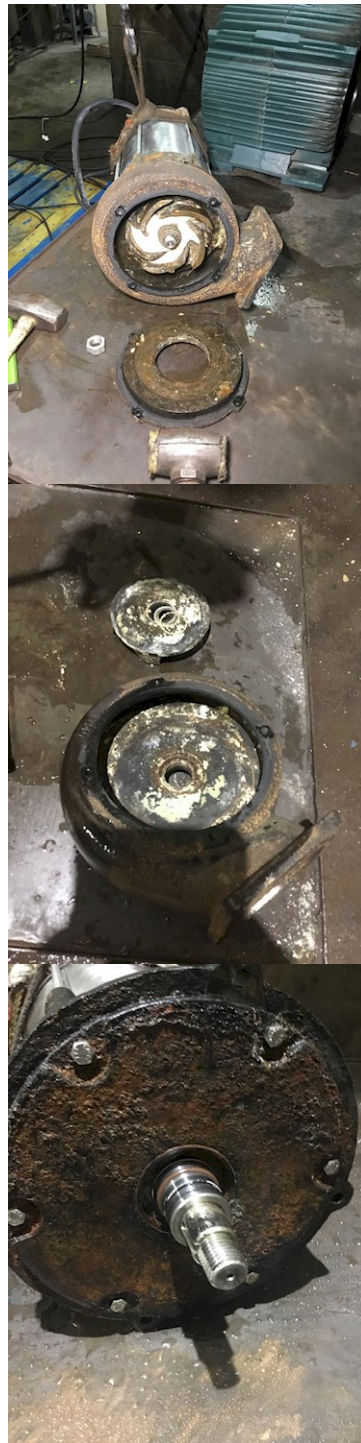
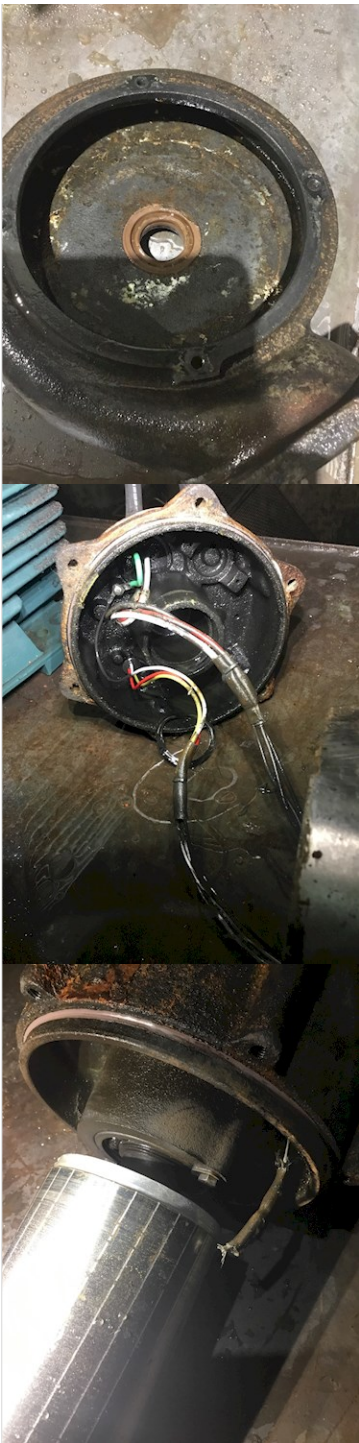
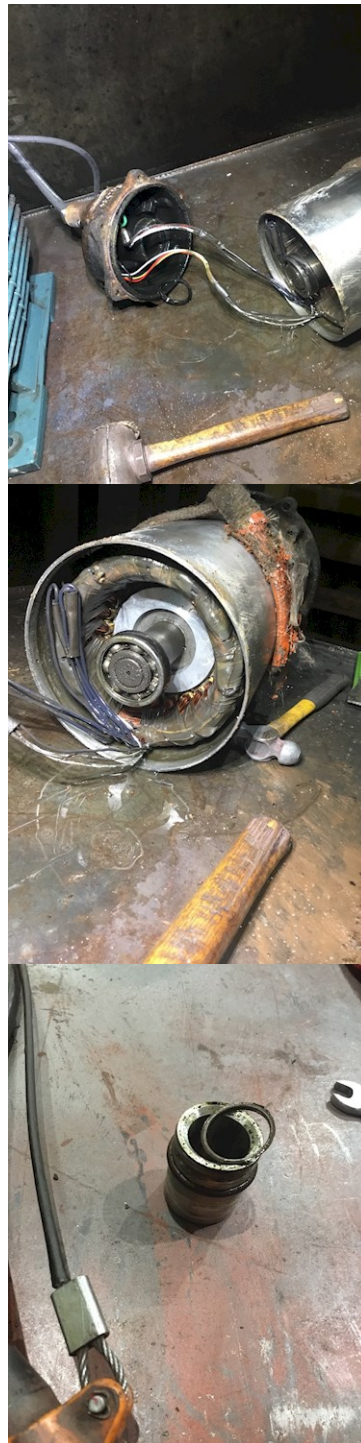
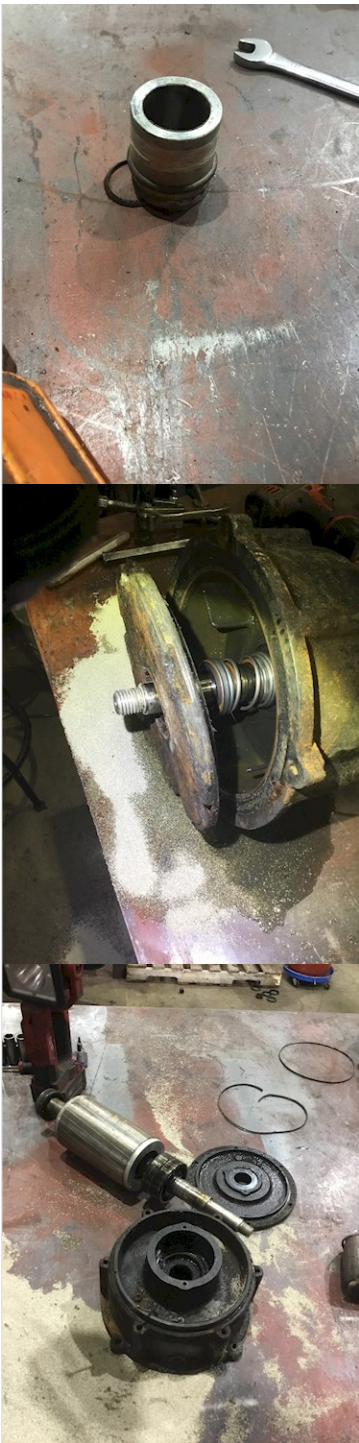
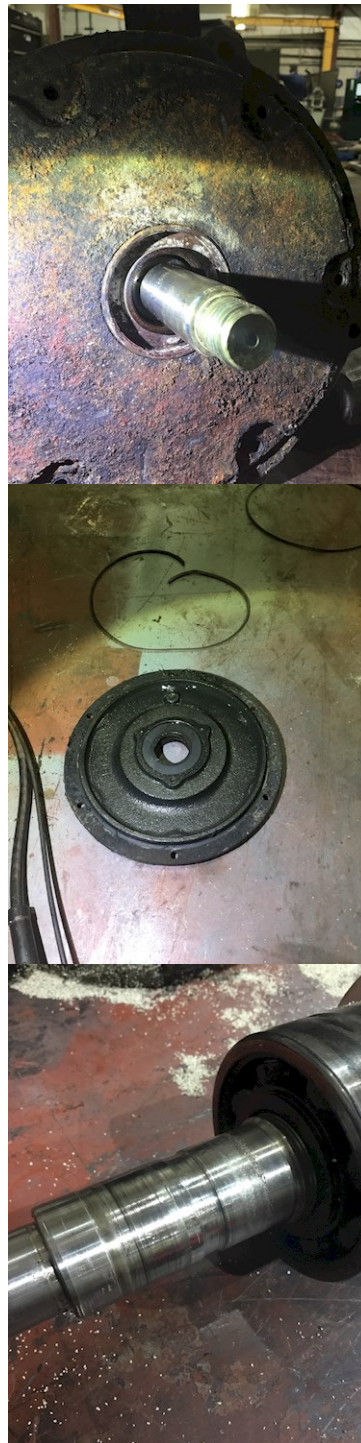
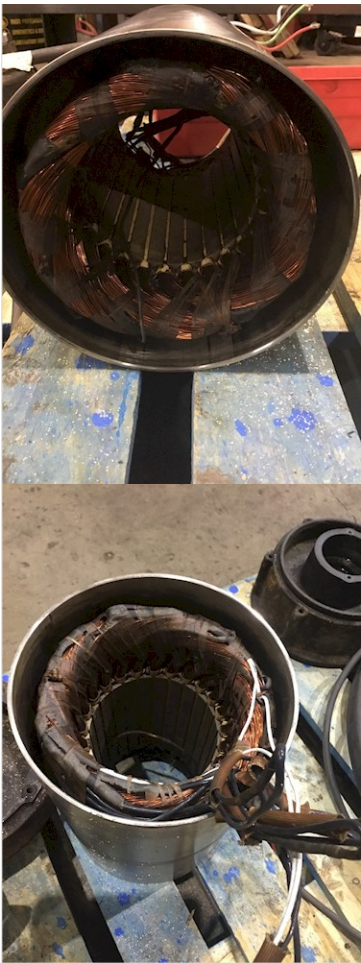
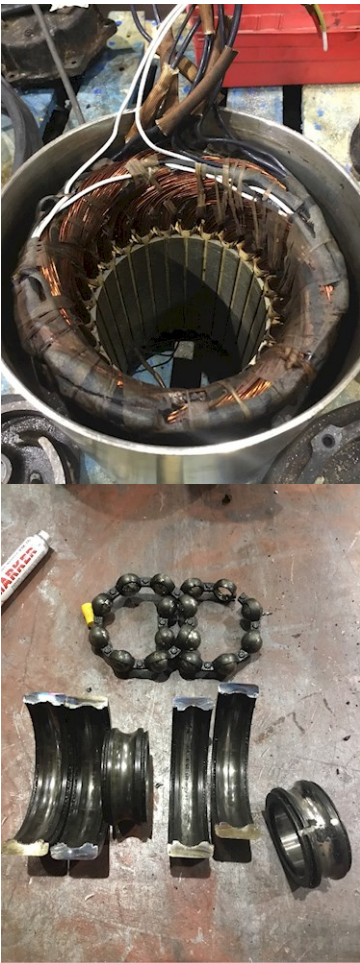
3. Photos of all six sides of the machine.

4.	Describe the Overall Condition of the Equipment as Received		
	<i>Serviceable</i>		
5.	Distance from the end of the shaft to the Coupling/Sheave	inches	
	<i>Impeller sits on shaft shoulder.</i>		
Initial Mechanical/Electrical			
6.	Does Shaft Turn Freely?	(Y) Yes	
7.	Does the shaft require T.I.R in Lathe to identify additional repairs?	(Yes) Yes	
	<i>Seal surfaces bad</i>		
8.	Does Shaft Have Visible Damage?	(Yes) Yes	P26
	<i>D.E. Seal surfaces bad.</i>		
9.	Assembled Shaft Runout

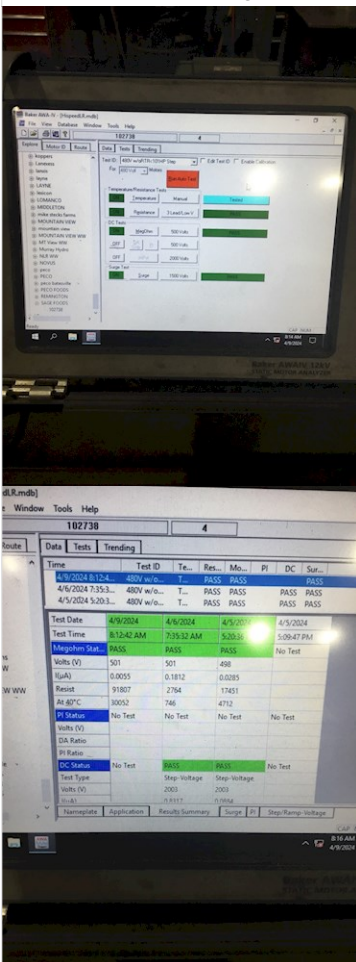
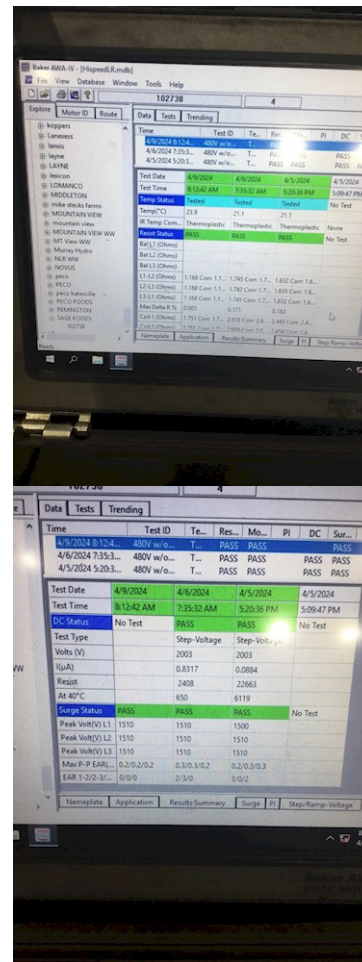
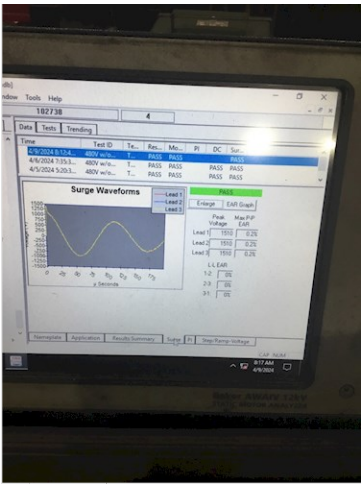
24. Perform Surge Test

(P) Pass
