AC Inspection as Found

Location: MOTOR SHOP LR

Serial Number: A2104132051

Description: 150HP BALDOR 1190RPM

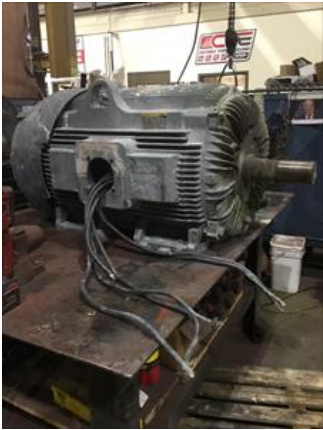
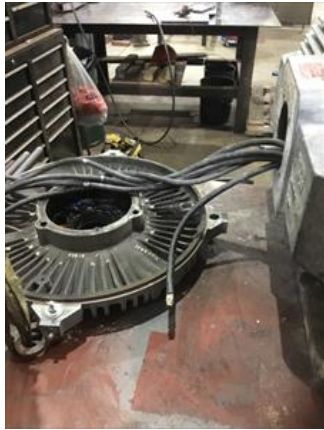
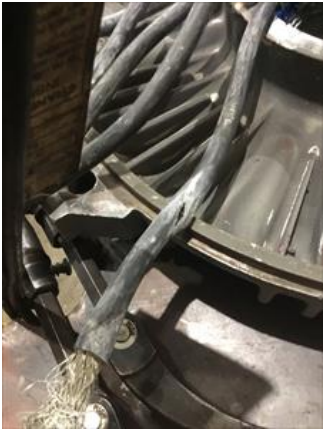
12. Lead Length	35 Inches	
13. Does it have Lugs?, If so what is the Stud Size?	(No) No	
14. Lead Numbers	1,2,3	
  2 of each.		
15. Frame Condition	pass	
16. Fan Condition	(F) Fail	P115

3 ea. blades broken.

Fan blade needs replaced.

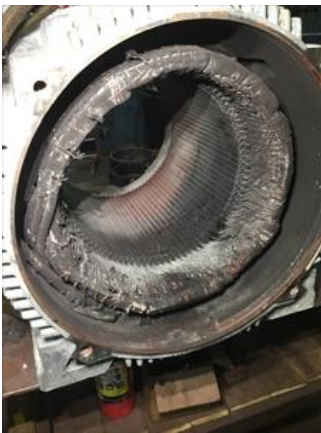
P8

20. Perform Surge Test	(F) Fail
21. Number of Stator Slots	90
22. Stator Condition	rewind
23. Stator Thermistors/Ohms	na
24. Stator Overloads/Ohms	na

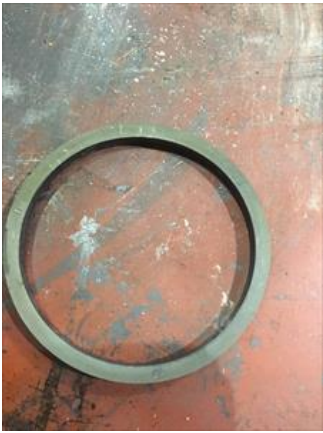
P123

40. Opposite Drive End Bearing Condition

replace

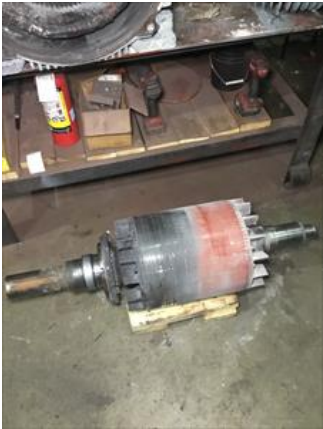
43. Rotor Type/Material	(Squirrel Aluminum) Squirrel Cage Aluminum Die Cast		P3

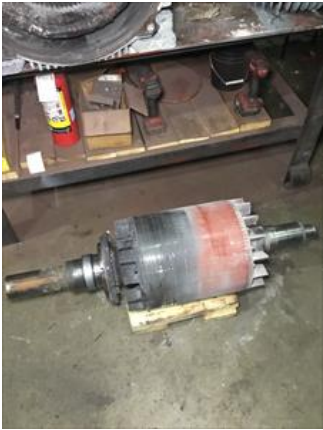
44. Growler Test	(Pass) Pass		
45. Number of Rotor Bars	71		
46. Rotor Condition	pass		P41

47. List the Parts needed for the Repair Below	<i>Replace bearings, rewind stator. Stator core requires core test due to damage from rotor drop. Fan blade has 3 broken blades. Re-sleeve both housing fits.</i>

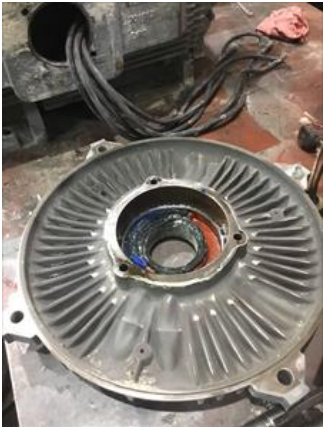
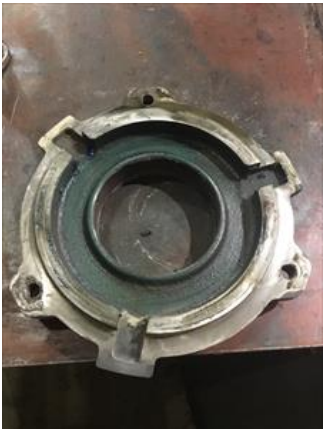
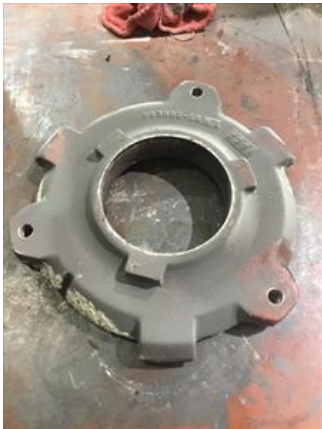
Excessive pitting and wear.

NU, D.E. bearing suffered catastrophic failure from contaminated hardened grease. This caused the rotor to drop onto the stator core and windings resulting in shorted windings and a damaged core. Both housing fits show excessive wear and requires re-sleeve.
