AC Inspection as Found

Tyson Foods (10914)

AC Inspection - Rev. 2

Description: PUMP

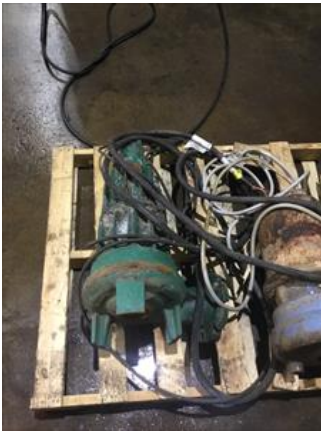
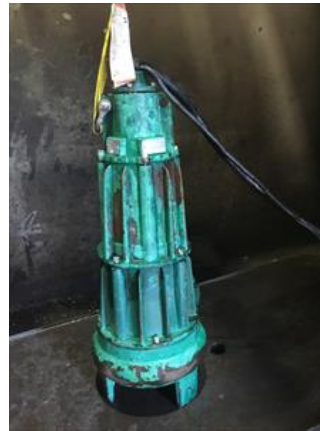
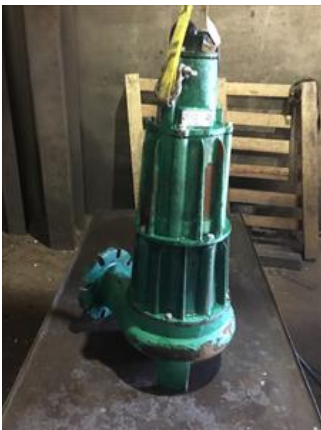
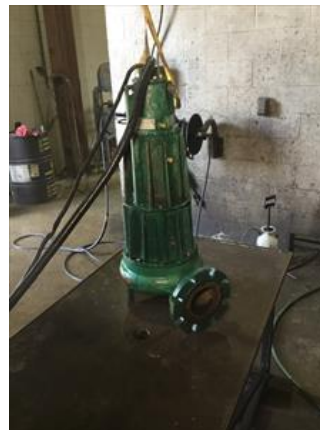
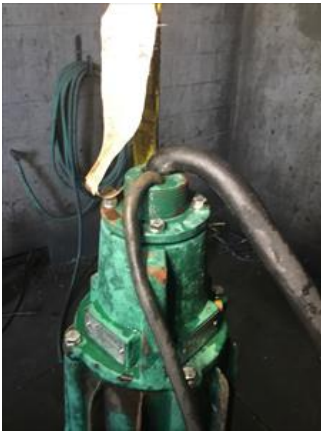
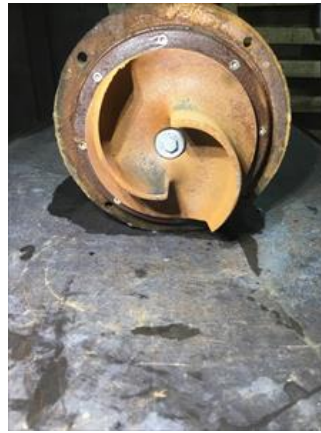
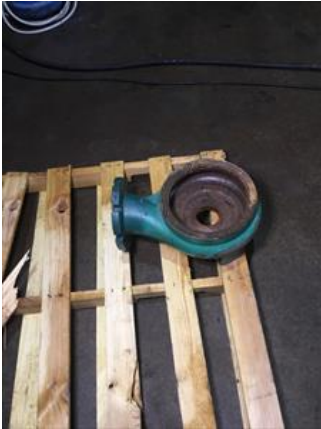
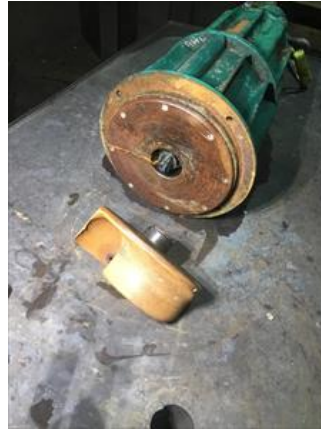
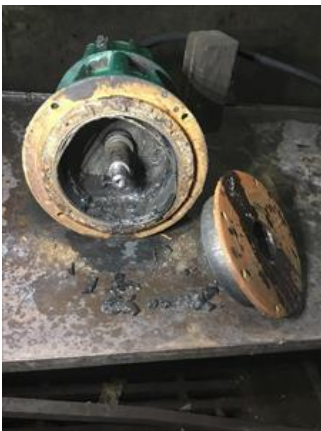
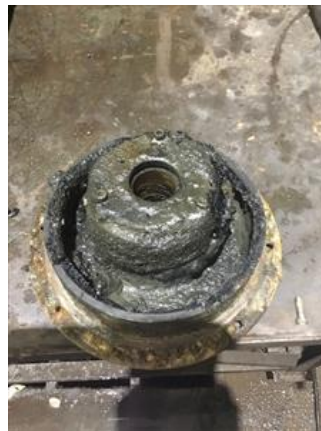
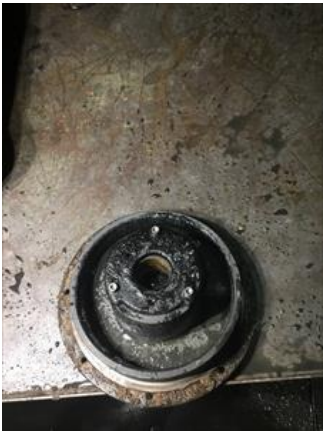
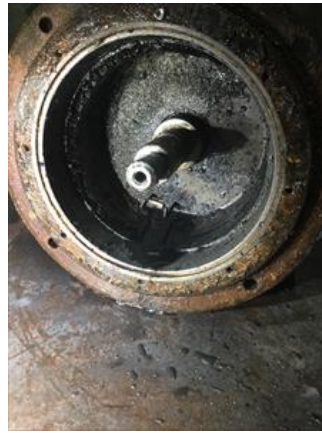
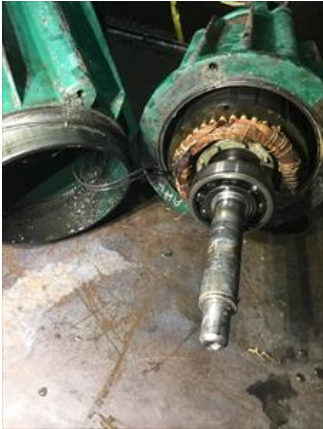
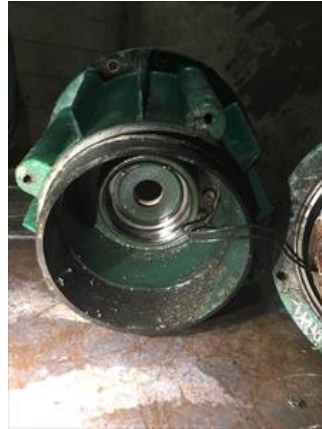
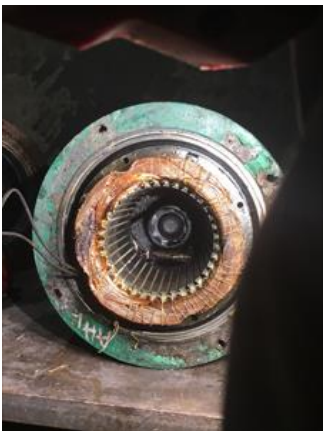
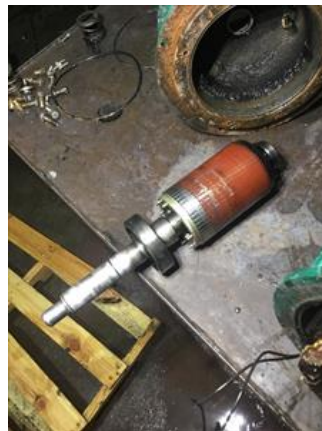
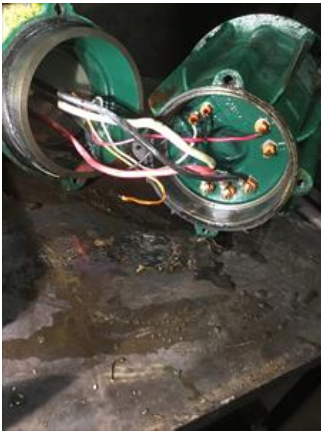
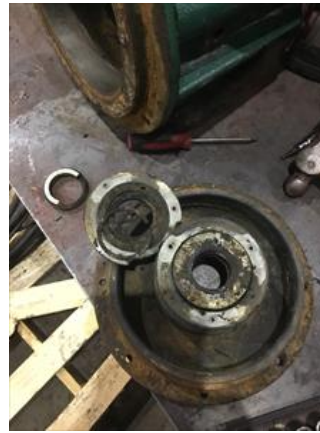
P45

3. Photos of all six sides of the machine.

Serviceable

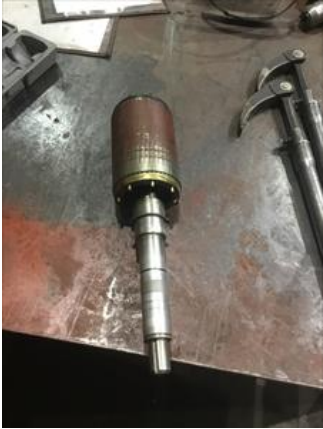
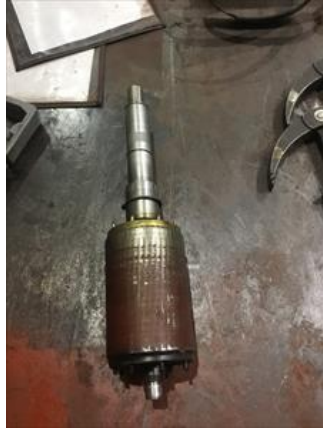
44.	Rotor Type/Material	(Squirrel Aluminum) Squirrel Cage Aluminum Die Cast
<div style="display: flex; justify-content: space-around;">

45.	Growler Test	(Pass) Pass
46.	Number of Rotor Bars	48
47.	Rotor Condition	pass
48.	List the Parts needed for the Repair Below <i>2 ea. carbon ceramic seals # D-1250-352</i> <i>8 ea. stainless steel hex head, seal mount plate bolts. 1/4*20*1/2"</i> <i>Rewind stator & repair shaft seal surface, and DE bearing fit.</i> <i>Replace power & sensor cords.</i>
