## AC Inspection as Found

Tyson Foods (10914)

### AC Inspection - Rev. 2

Description: 5HP GOULDS PUMP

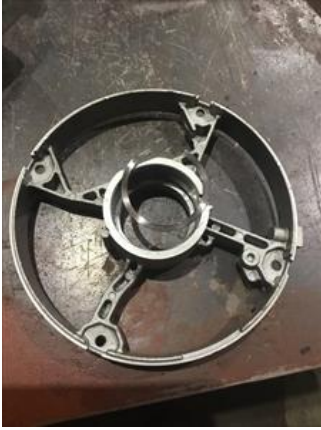
| 15. Frame Condition | |
| Serviceable | |

Stator iron core damaged from rotor contact.

<b>Root Cause of Failure</b>			
66.	Failure locations <i>Stator core laminates out of alignment from rotor drop. Rewind required. Rotor shaft bent. Replace seals and O-rings.</i>

*Outer seal seat was cracked, allowing water to penetrate into the stator. Also the ode wavy washer was broken, and missing pieces found their way into the windings. Additionally the rotor dropped onto the stator core causing the iron to become misaligned.*

47. List the Parts needed for the Repair Below  
*Bearings, seals, shaft bent. Shaft seal surface needs repair.  
 6206/6204*

63.	End Bell Air Seal Fits		
	Drive End Air Seal	Opposite Drive End Air Seal	
	Na		
64.	List Machine Work Needed Below <i>Shaft bent, and seal surface requires repair.</i>
