AC Inspection as Found
Arkansas Lime Company
600 Limedale Rd
Batesville, AR 72501

AC Inspection - Rev. 2

Location: LITTLE ROCK MOTOR SHOP
Serial Number: AF943097
Description: 150 HP BALDOR 1780 RPM

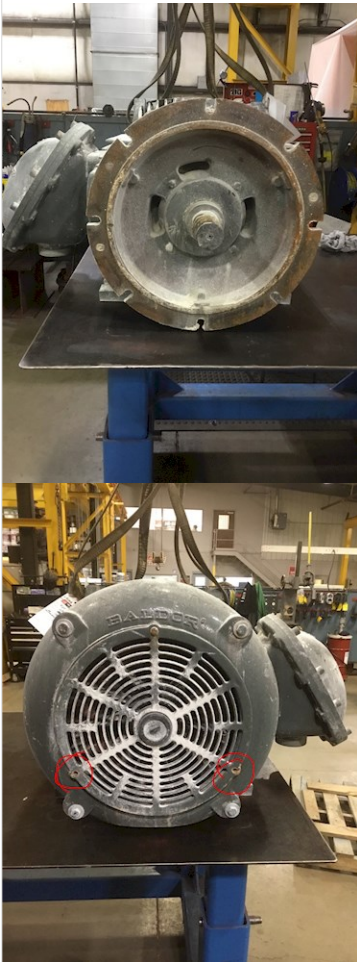
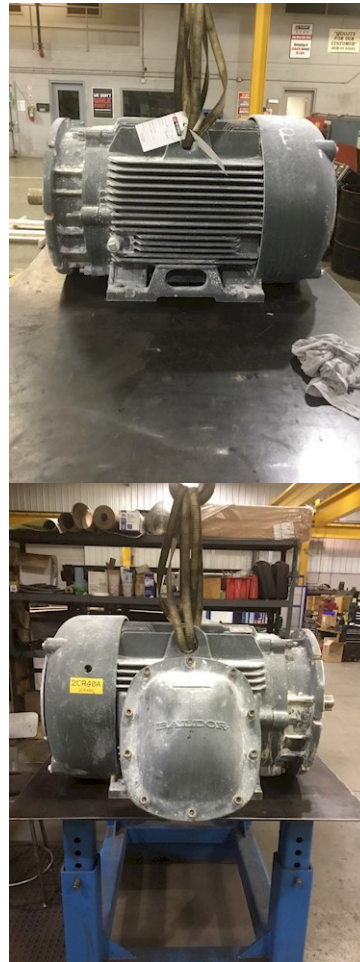
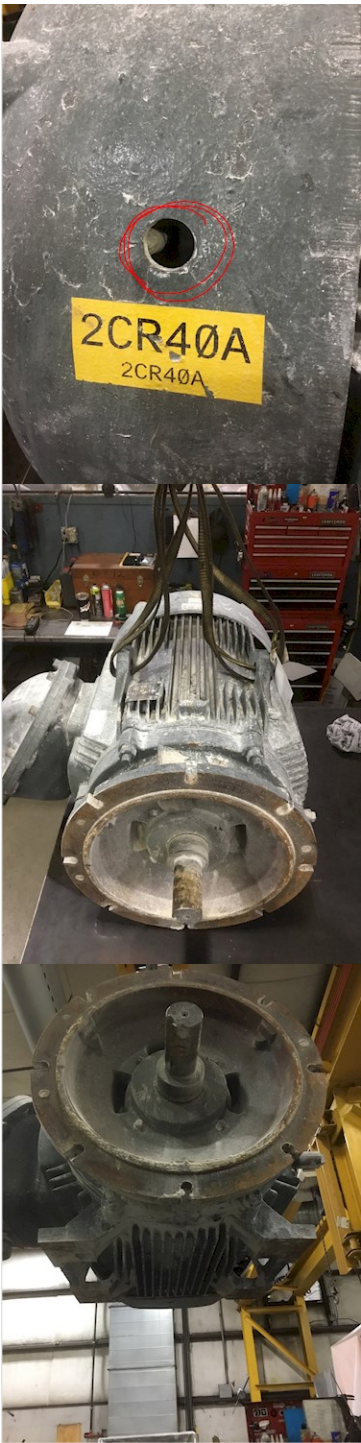
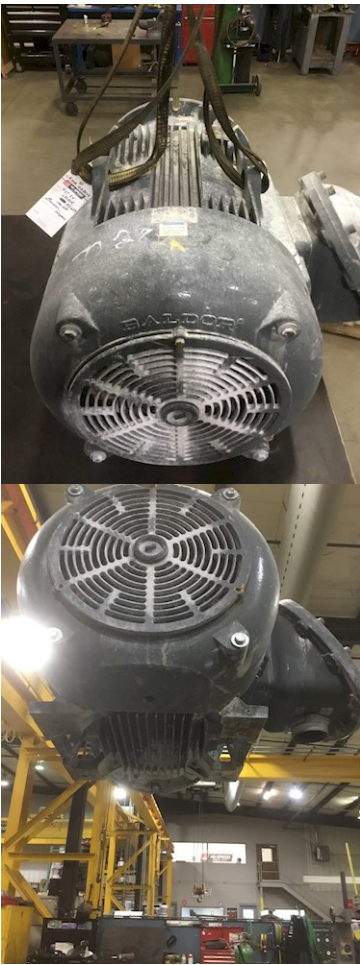
3. Photos of all six sides of the machine.

4. Describe the Overall Condition of the Equipment as Received
Stator windings are blown and requires rewind. Opposite drive end needs bushing installed.

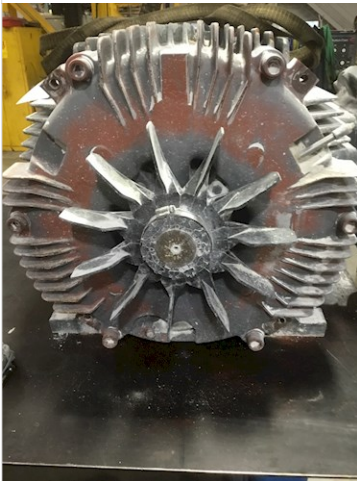
P115

16. Fan Condition **(P) Pass**

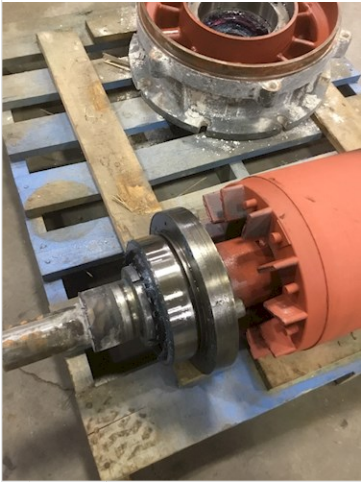
27. Drive End Bearing Qty.	1	
28. Drive End Bearing Type	(Ball) Ball Bearing	
29. Drive End Lubrication Type	(Grease) Grease Lubricated	
30. Drive End Bearing Insulation or Grounding Device?	None	
31. Drive End Wavy Washer/Snap-Ring Other Retention Device?	Lock Nut	P77

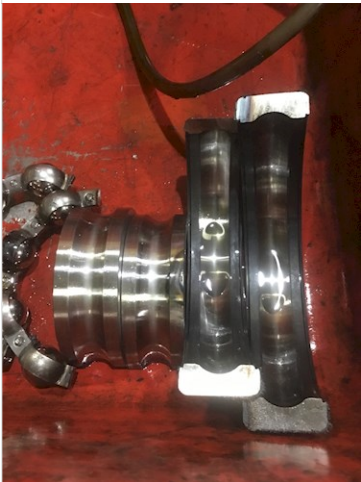
32. Drive End Bearing Condition	Normal wear	P82
