AC Inspection as Found

Peco Foods

AC Inspection - Rev. 2

Description: HOWDEN ROTARY BLOWER

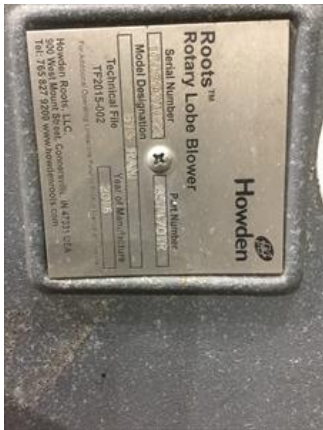
P37

2. Nameplate Picture

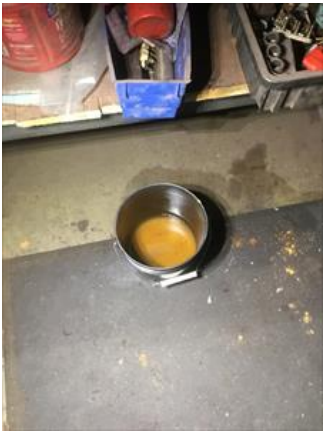
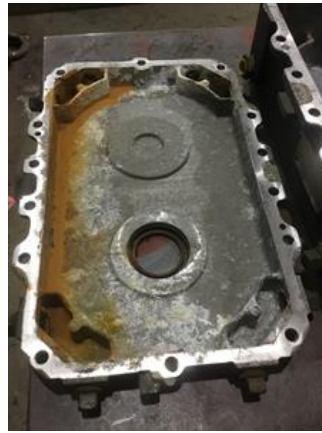
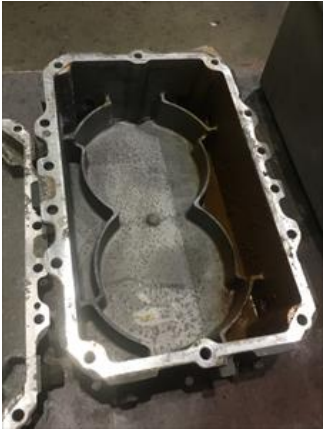
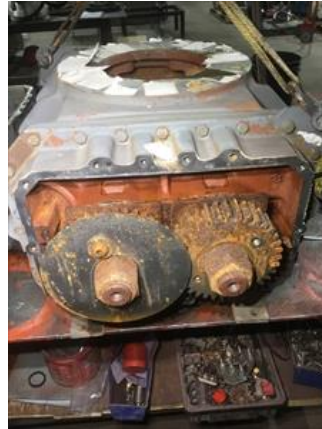
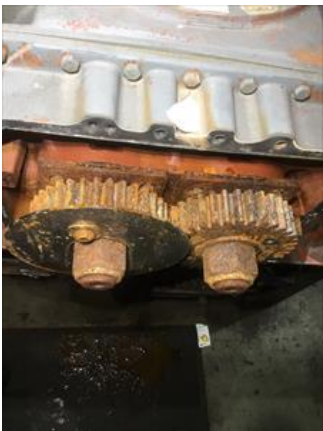
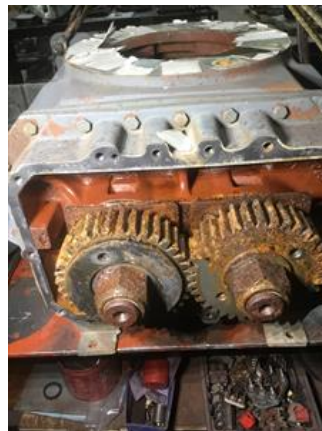
P45

3. Photos of all six sides of the machine.

4.	Describe the Overall Condition of the Equipment as Received <i>Rusted</i>		
5.	Distance from the end of the shaft to the Coupling/Sheave		inches
	<i>Na</i>		
Initial Mechanical/Electrical

13.	Lead Length		Inches
	<i>Na</i>		
14.	Does it have Lugs?, If so what is the Stud Size?		(No) No
15.	Lead Numbers		
	<i>Na</i>		
16.	Frame Condition		rusted

68. Root cause of failure
Entire oil basin on both ends contained nothing but water. Unit is completely coated internally with rust.
