AC Inspection as Found
Almatis Inc/RCP Bauxite (10014)
4701 Alcoa Road
Bauxite, AR 72011

AC Inspection - Rev. 2

Description: 1.5 HP RELIANCE VIBE MOTOR

Hi-Speed Job Number: 102901

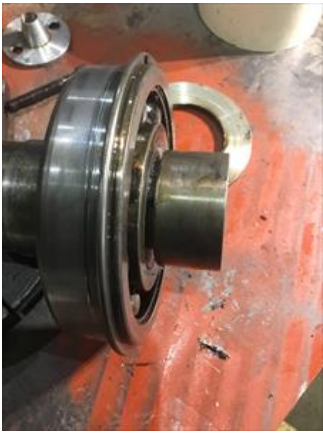
Bearing is off the shoulder.

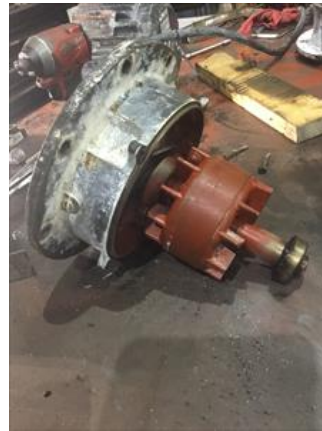
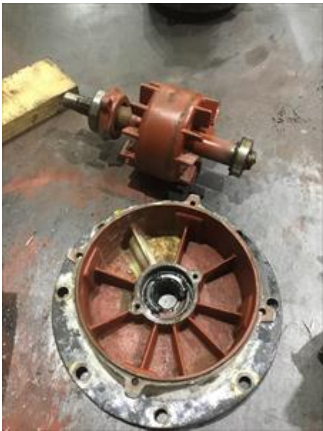
Seal surface worn.

63.	End Bell Air Seal Fits		
	Drive End Air Seal	Opposite Drive End Air Seal	
64.	List Machine Work Needed Below <i>Repair DE shaft seal surface. Repair De housing fit.</i>

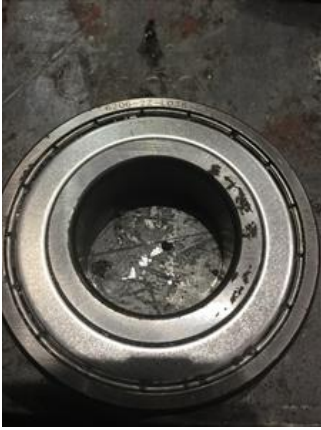
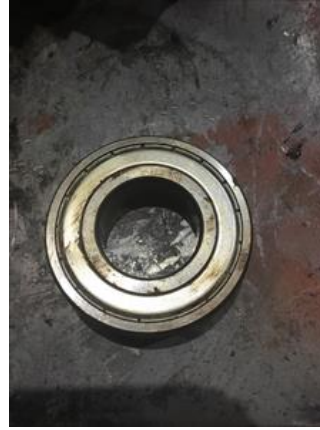
27. Drive End Bearing Qty.	1
28. Drive End Bearing Type	(Ball) Ball Bearing
29. Drive End Lubrication Type	(Grease) Grease Lubricated
30. Drive End Bearing Insulation or Grounding Device?	none
31. Drive End Wavy Washer/Snap-Ring Other Retention Device?	none
32. Drive End Bearing Condition	replace
33. Opposite Drive End Bearing Brand	FAG
34. Opposite Drive End Bearing Number-	6205-2Z-L038-C3

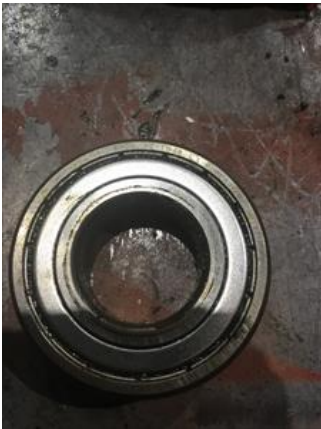
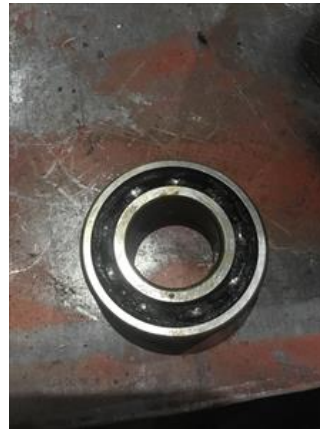
35. Opposite Drive End Bearing Qty.	1
36. Opposite Drive End Bearing Type	(Ball) Ball Bearing
37. Opposite Drive End Lubrication Type	(Grease) Grease Lubricated
38. Opposite Drive End Bearing Insulation or Grounding Device?	none
39. Opposite Drive End Wavy Washer/Snap-Ring Other Retention Device?	wavy washer

40. Opposite Drive End Bearing Condition

replace
