AC Inspection as Found

Premier Technical Plastics

Location: LR Motor Shop

Description: 100HP RELIANCE 1185RPM

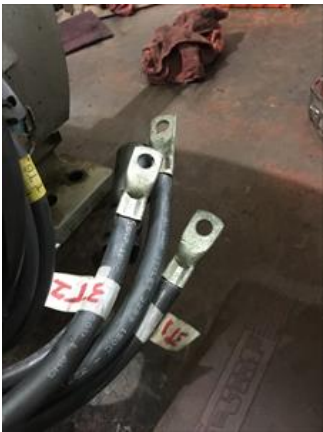
5.	Does Shaft Turn Freely?	(Y) Yes	
6.	Does the shaft require T.I.R in Lathe to identify additional repairs?	(No) No	
7.	Does Shaft Have Visible Damage?	(No) No	
8.	Assembled Shaft Runout	0.003 Inches	
9.	Assembled Shaft End Play	0 inches	
10.	Air Gap Variation <10%		
11.	Lead Condition	(P) Pass	
12.	Lead Length	17 Inches	
13.	Does it have Lugs?, If so what is the Stud Size?	(Yes) Yes	P93
