AC Inspection as Found
Phelps Fan Manufacturing Co.
10701 Interstate 30
Little Rock, AR 72209

AC Inspection - Rev. 2

Description: 125HP SIEMENS

Hi-Speed Job Number: 103310

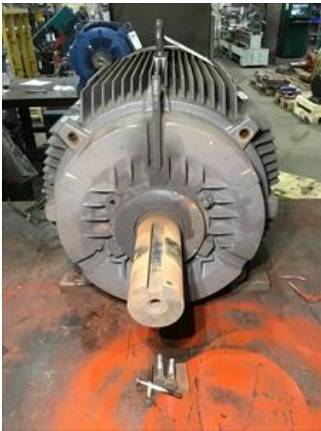
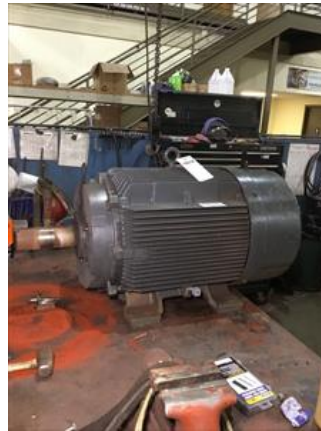
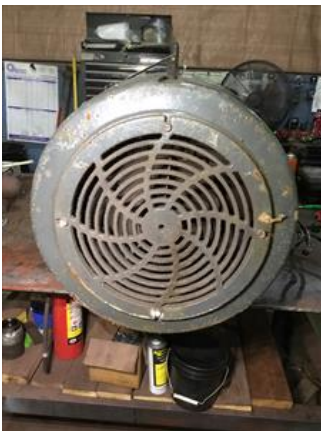
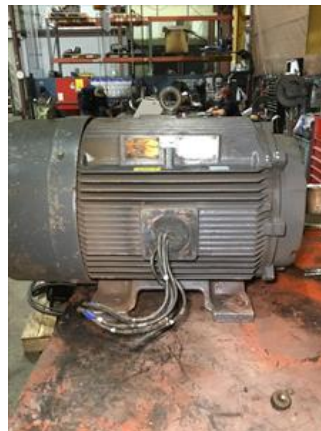
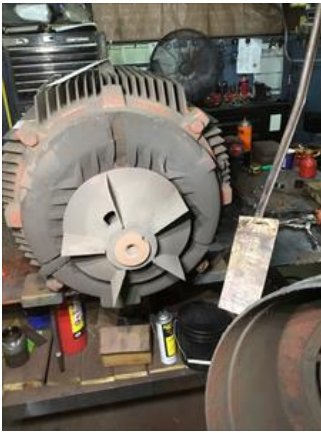
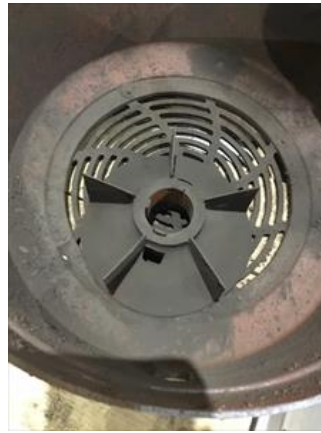
P45

3. Photos of all six sides of the machine.

4. Describe the Overall Condition of the Equipment as Received
Serviceable

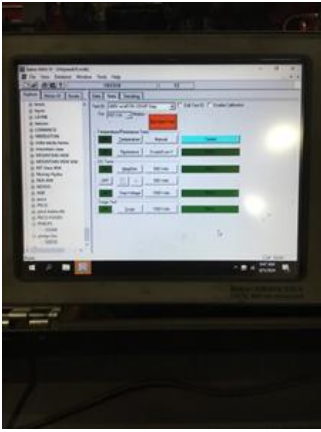
Initial Electrical Inspection
