AC Inspection as Found
Phelps Fan Manufacturing Co.
10701 Interstate 30
Little Rock, AR 72209

AC Inspection - Rev. 2

Description: 20HP/15KW TECO

Manufacturer: TECO Westinghouse

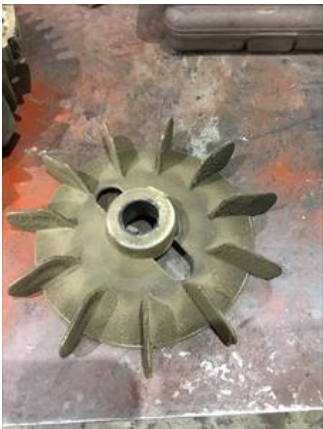
13. Lead Length	5.25 Inches	
14. Does it have Lugs?, If so what is the Stud Size?	(No) No	
15. Lead Numbers	1-9	
16. Frame Condition	pass	
17. Fan Condition	(P) Pass	P116

18. Broken or Missing Components	top connection box cover missing	
----------------------------------	----------------------------------	--

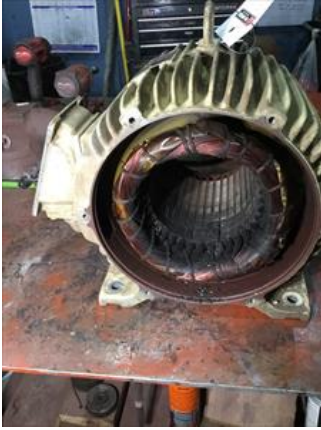
19. Insulation Resistance/Megger	Megohms	
20. Winding Resistance		
1-2	1-3	2-3

22. Number of Stator Slots	36
23. Stator Condition	rewind
24. Stator Thermistors/Ohms	
25. Stator Overloads/Ohms
