AC Inspection as Found

Union Pacific-Vine St 10945

AC Inspection - Rev. 2

Description: 1.13/6.8HP OMI HOIST MOTOR

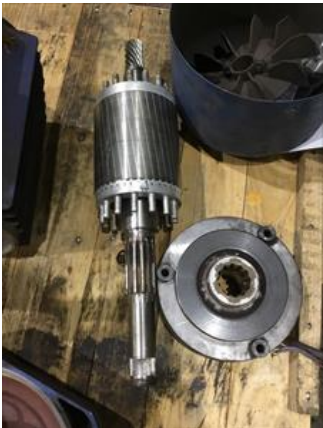
45.	Rotor Type/Material	(Squirrel Aluminum) Squirrel Cage Aluminum Die Cast	
46.	Growler Test	(Pass) Pass	
47.	Number of Rotor Bars	40	
48.	Rotor Condition	pass	P41

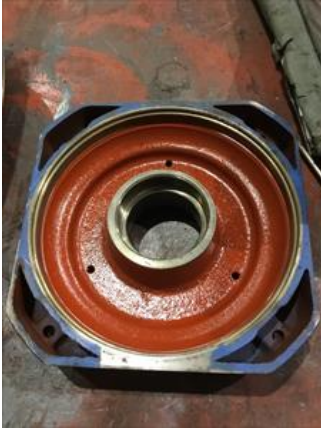
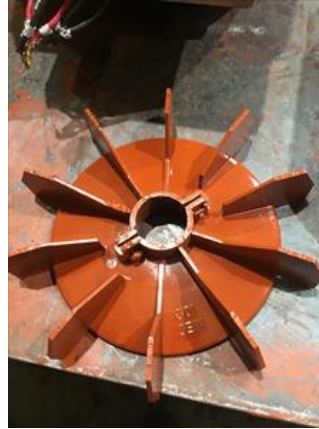
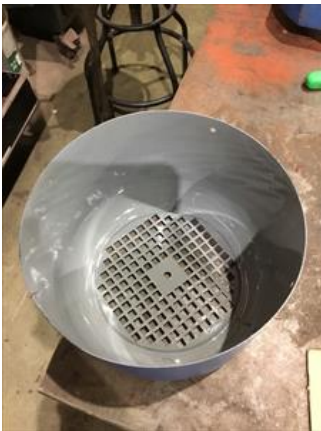
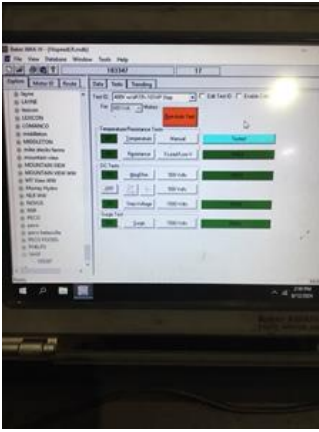
75. Photograph All Major Components prior to assembly

Brake assembly wear plates worn, and brake pad cracked on edges. ODE bearing completely locked up from worn out lubricants.

Bearing and brake assembly
