AC Inspection as Found
ARKANSAS INDUSTRIAL MACHINERY
3804 N. NONA ST
NORTH LITTLE ROCK, AR 72118

AC Inspection - Rev. 2

Description: 184/245 MARATHON

Hi-Speed Job Number: 103442

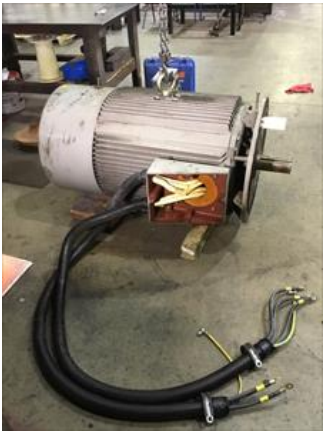
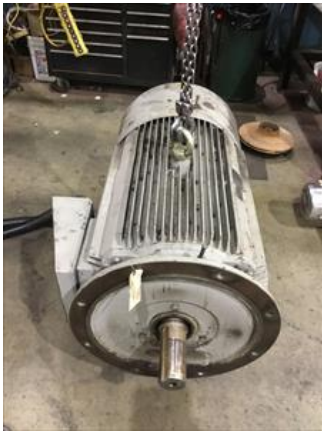
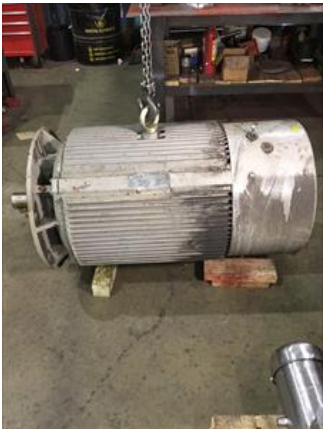
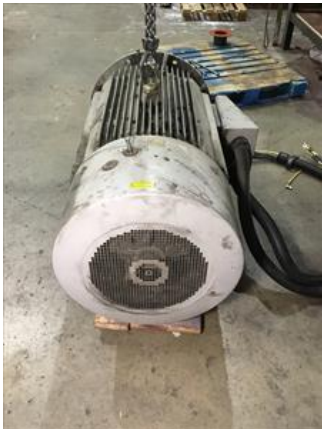
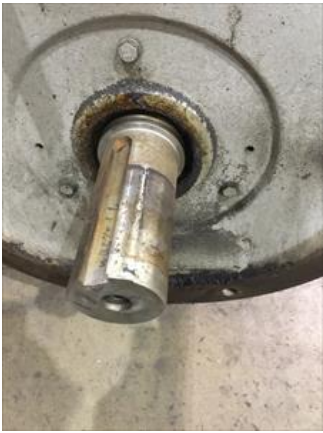
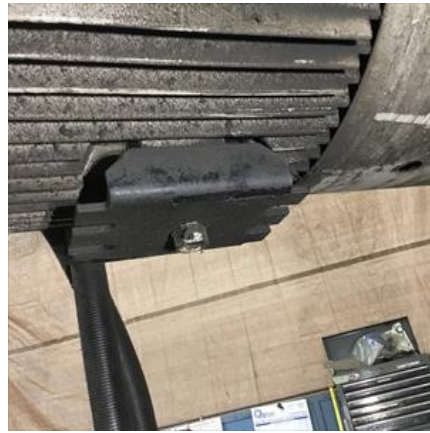
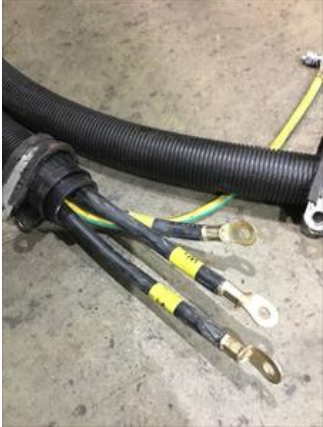
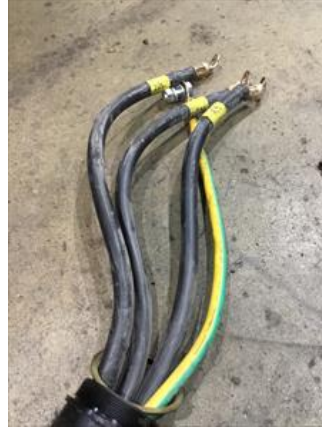
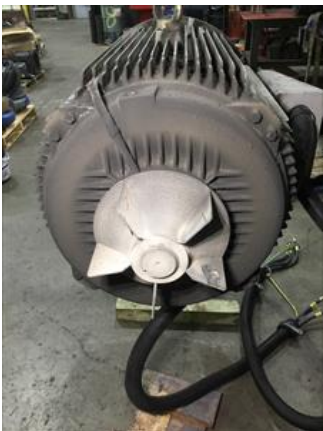
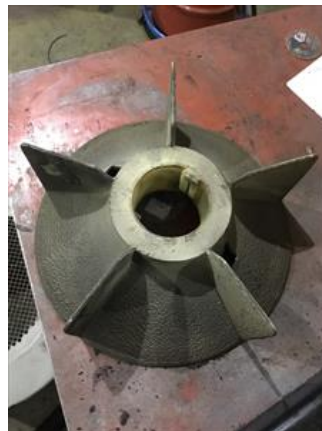
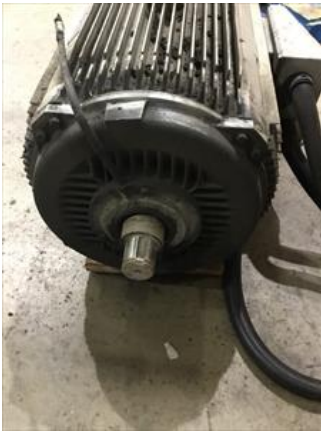
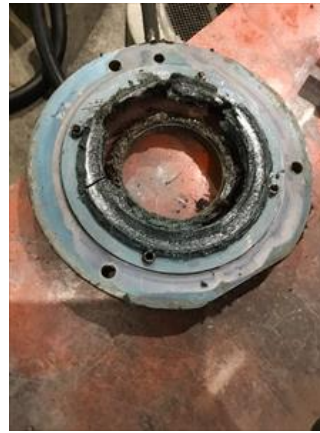
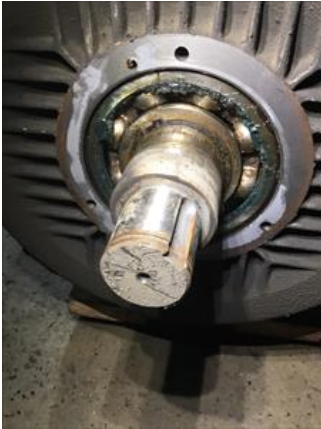
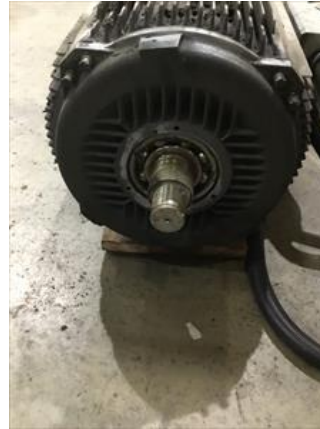
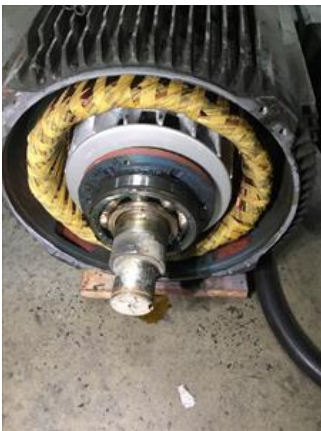
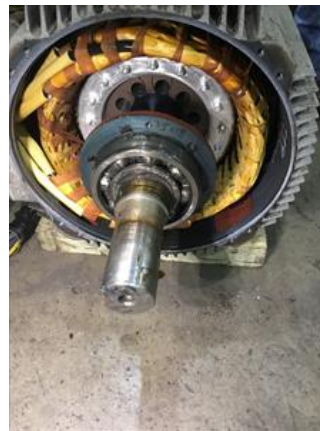
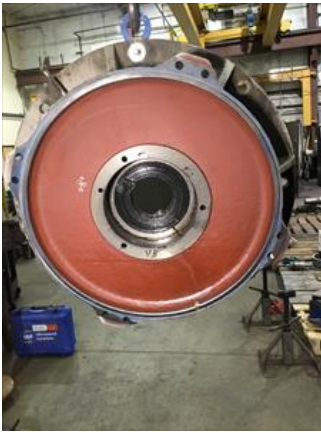
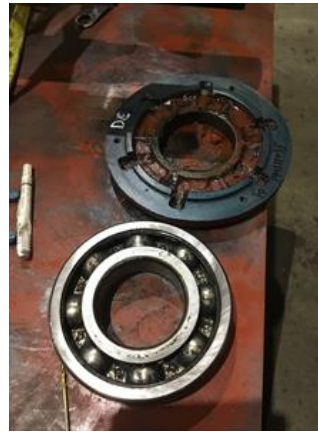
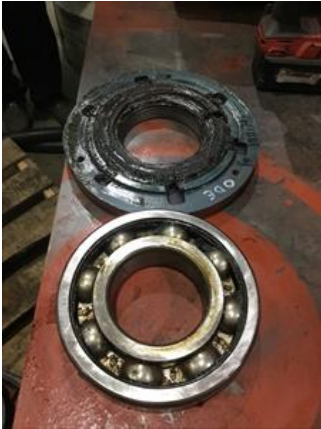
P45

3. Photos of all six sides of the machine.

4. Describe the Overall Condition of the Equipment as Received
Serviceable

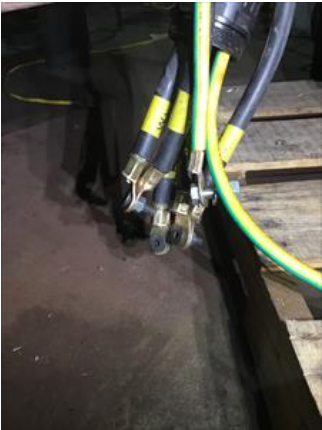
13.	Lead Length	96 Inches	
●	14. Does it have Lugs?, If so what is the Stud Size?	(Yes) Yes	P94

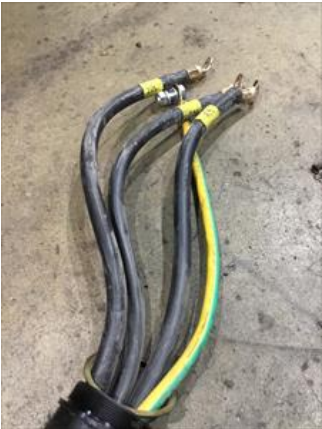
15.	Lead Numbers		P98
■	U1-V1-W1 U2-V2-W2		
<div>
