**AC Inspection as Found**  
**ARKANSAS INDUSTRIAL MACHINERY**  
3804 N. NONA ST  
NORTH LITTLE ROCK, AR 72118

**AC Inspection - Rev. 2**

Description: 184/245 MARATHON

Hi-Speed Job Number: 103442

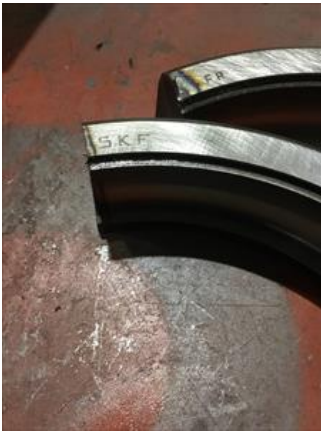
30. Drive End Lubrication Type	(Grease) Grease Lubricated	
31. Drive End Bearing Insulation or Grounding Device?	none	
32. Drive End Wavy Washer/Snap-Ring Other Retention Device?	none	
33. Drive End Bearing Condition	replace	
34. Opposite Drive End Bearing Brand		P93
