AC Inspection as Found

Arauco-Malvern MDF (10298)

AC Inspection - Rev. 2

Location: LR MOTORSHOP
Serial Number: 2MA460270-G1-KY
Description: 100HP RELIANCE 1180 RPM

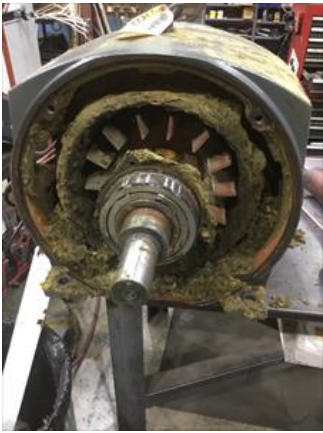
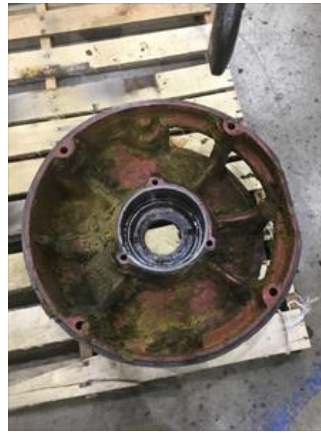
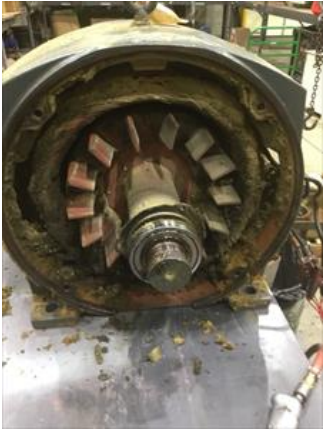
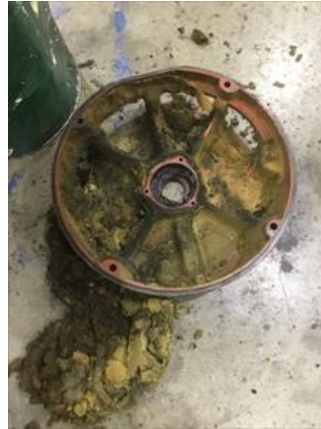
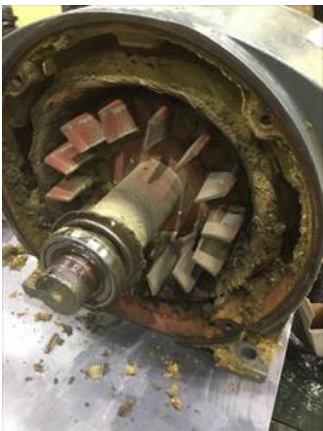
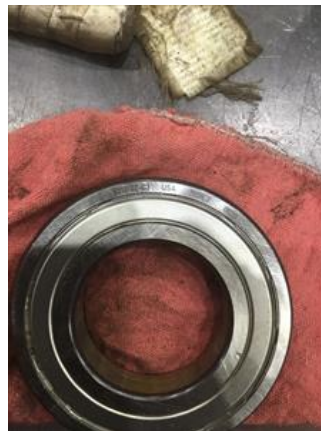
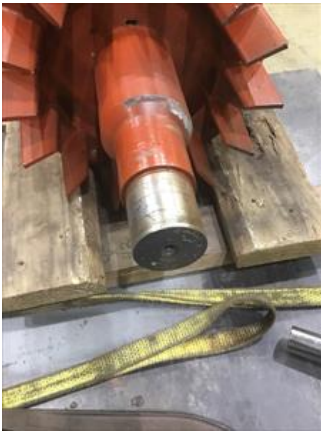
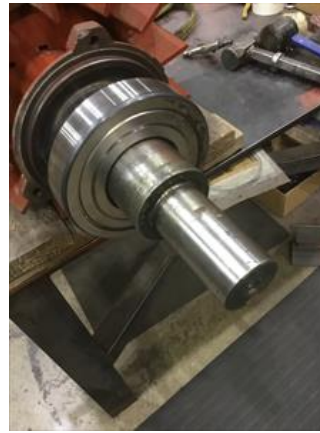
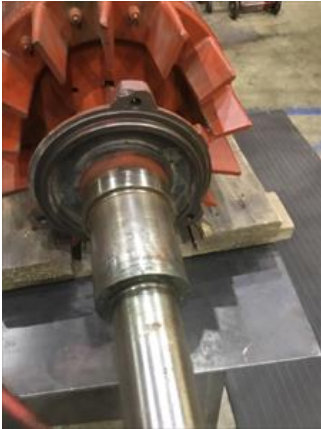
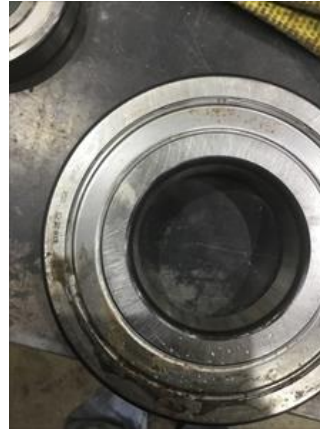
P114

6.	Does Shaft Turn Freely?	(Y) Yes
7.	Does the shaft require T.I.R in Lathe to identify additional repairs?	(No) No
8.	Does Shaft Have Visible Damage?	(No) No
9.	Assembled Shaft Runout	
10.	Assembled Shaft End Play	inches
11.	Air Gap Variation <10%	
12.	Lead Condition	(P) Pass
13.	Lead Length	16 Inches
14.	Does it have Lugs?, If so what is the Stud Size?	(Yes) Yes
15.	Lead Numbers	
16.	Frame Condition	good

Root Cause of Failure			
67.	Failure locations <i>Contamination</i>		
68.	Root cause of failure <i>Contamination deteriorated insulation on wire and needs to be rewound. Windings did check good on electrical test.</i>		
Dynamic Balance Report			
69.	Rotor Weight and Balance Grade		
	Rotor Weight	Balance Grade
