AC Inspection as Found

Peco Foods

AC Inspection - Rev. 2

Location: Shop
Serial Number: ZJE723C108U04
Description: 25HP TECO 1170RPM

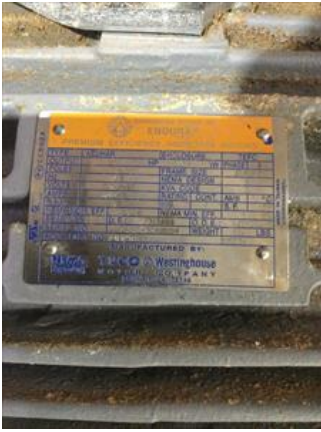
2. Nameplate Picture

Hi-Speed Job Number:	103525
Manufacturer:	TECO Westinghouse
Product Number:	TYPE: AEUH8R
Serial Number:	ZJE723C108U04
HP/kW:	25 (HP)
RPM:	1180 (RPM)
Frame:	324LPZ
Voltage:	230 / 460
Current:	60.6/30.3 (Amps)
Phase:	Three
Hz:	60 (Hz)
Service Factor:	1.15
Enclosure:	TEFC
# of Leads:	12
J-box Included:	Half
Coupling/Sheave:	None
Bearing RTDs:	No
Stator RTDs:	No
Repair Stage:	Final
Rewind:	Yes
Shaft Machined Fit Repairs Required:	No
Bearing Housing Machined Fit Repairs Required:	No
Heaters:	No
Winding Type :	Random Wound
Bearing Type:	Rolling Element

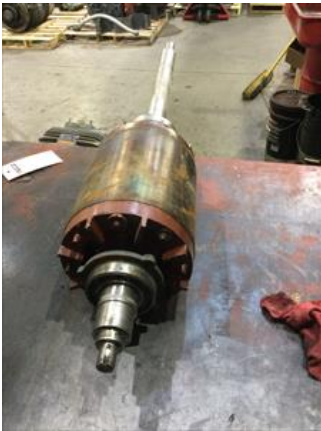
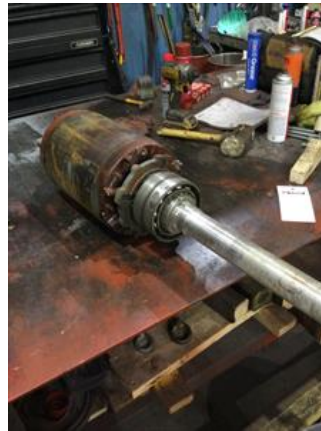
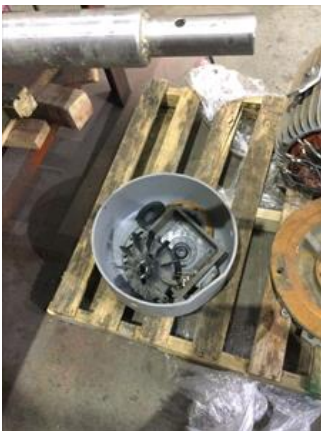
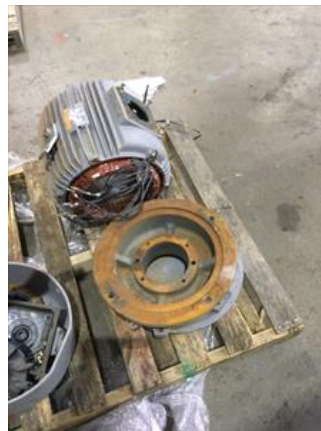
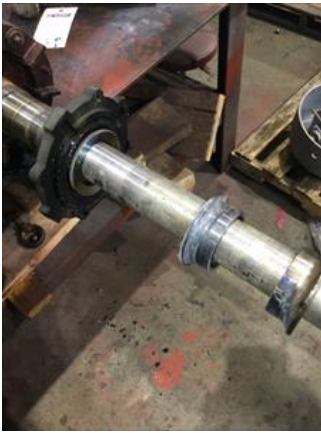
3. Photos of all six sides of the machine.

4.	Describe the Overall Condition of the Equipment as Received		
	<i>Serviceable</i>		
5.	Report Date [COPY]	10/09/2024	
Initial Mechanical/Electrical

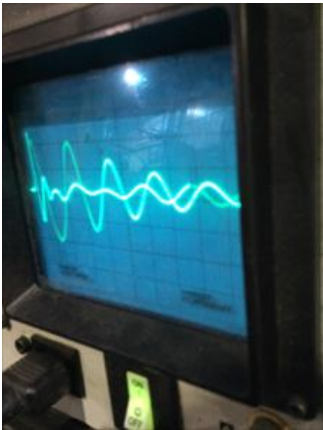
22. Number of Stator Slots	54		
23. Stator Condition	rewind

67. Failure locations
Insulation brake down shorting slot

68. Root cause of failure
Bad insulation

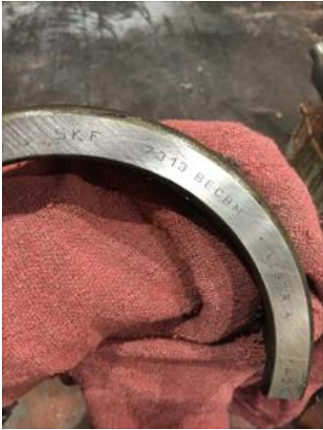
26.	Drive End Bearing Brand	SKF	
27.	Drive End Bearing Number-	7313	P32

28.	Drive End Bearing Qty.	2	
29.	Drive End Bearing Type	(Thrust) Thrust	
30.	Drive End Lubrication Type	(Grease) Grease Lubricated	
31.	Drive End Bearing Insulation or Grounding Device?	na	
32.	Drive End Wavy Washer/Snap-Ring Other Retention Device?	spanner nut	
33.	Drive End Bearing Condition	normal wear	P83

2-7313 thrust bearing 1- 6212 C3

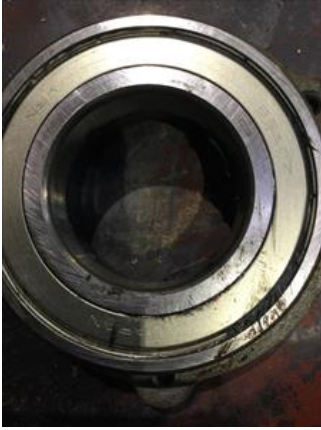
34.	Opposite Drive End Bearing Brand	NSK

6212

Debris in bearing grease

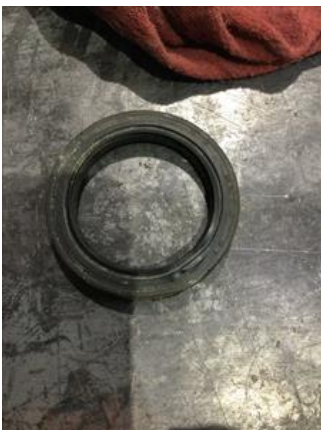
42. Drive End Seal

yes 60-82-12

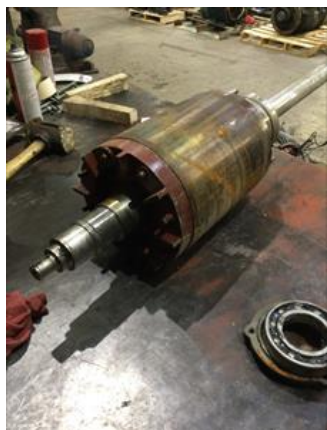
44. Rotor Type/Material

(Squirrel Aluminum) Squirrel
Cage Aluminum Die Cast

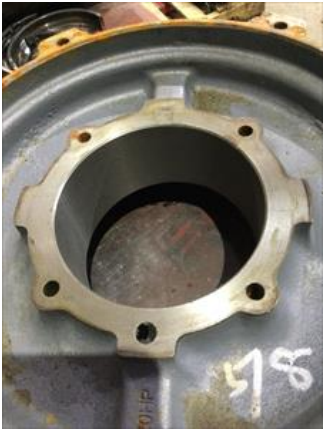
59.	Drive End - Endbell Bearing Fit			
	0 Degrees	60 Degrees	120 Degrees	
	5.5122	5.5122	5.5122

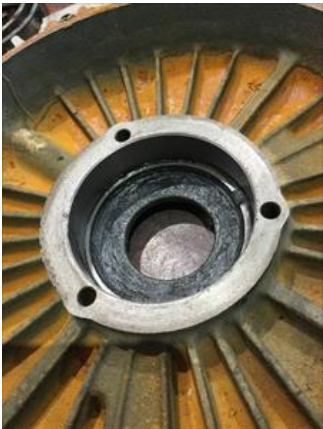
61. Opposite Drive End - Endbell Bearing Fit			
0 Degrees	60 Degrees	120 Degrees	
4.3311	4.3311	4.3311

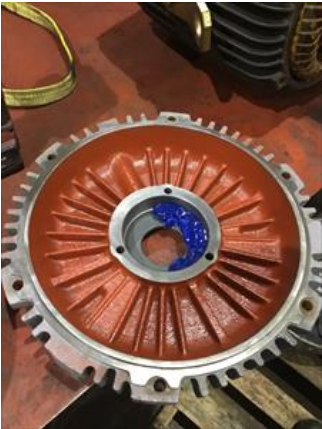
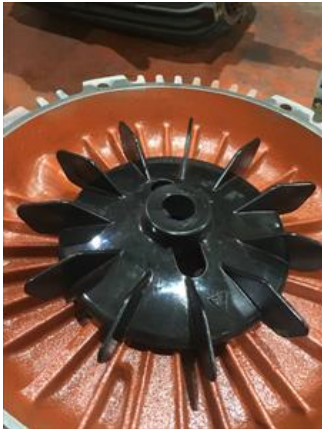
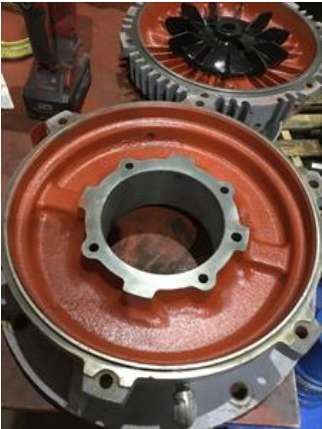
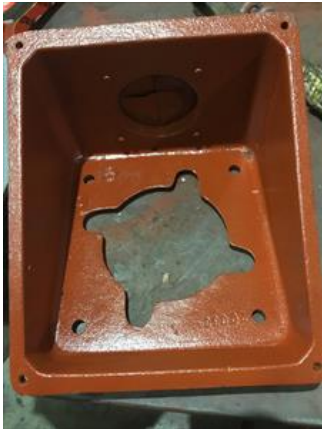
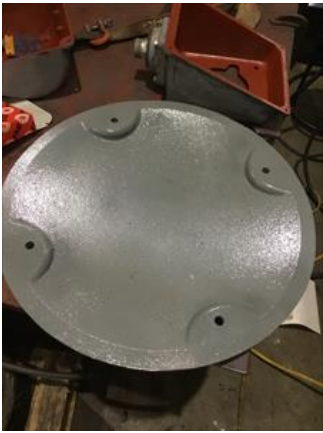
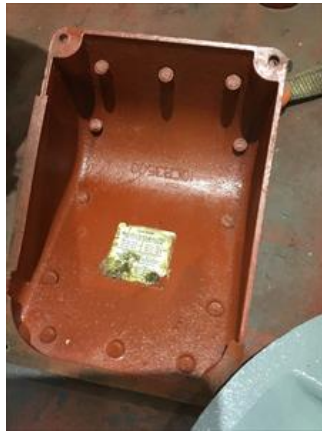
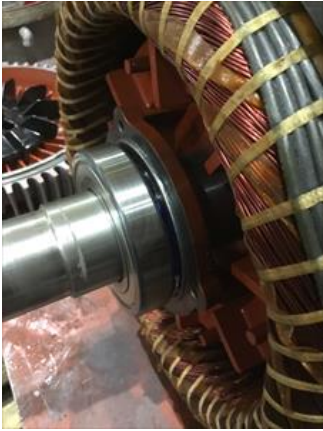
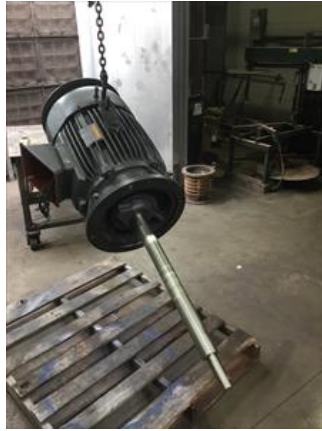
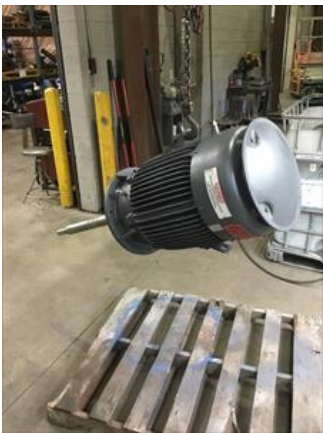
82.	Photograph All Major Components prior to assembly	(Complete) Complete	P17
<div>

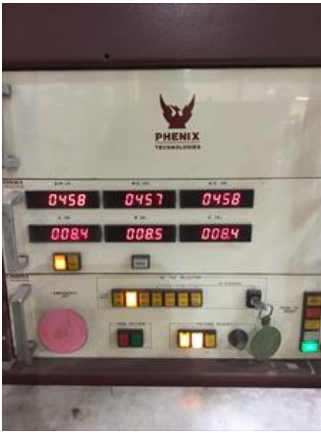
83.	Final Insulation Resistance Test	Megohms	
84.	Assembled Shaft Endplay	0 inches	
85.	Assembled Shaft Runout	0.003 inches	
86.	Test Run Voltage		
	Volts	Volts	Volts
	458	457	458
