## AC Inspection as Found

WESTERN FOODS LLC

Location: LITTLE ROCK MOTOR SHOP

Description: 40HP SIEMENS 1780RPM

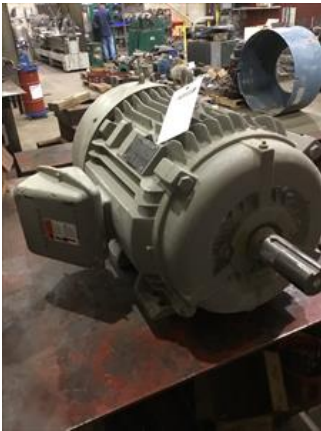
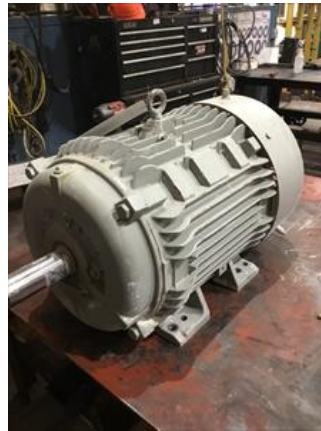
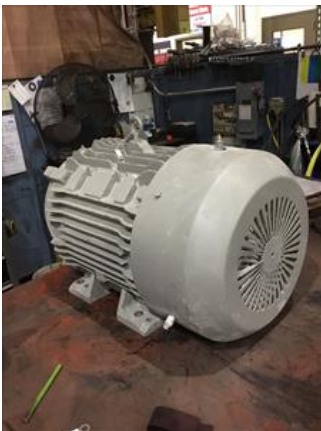
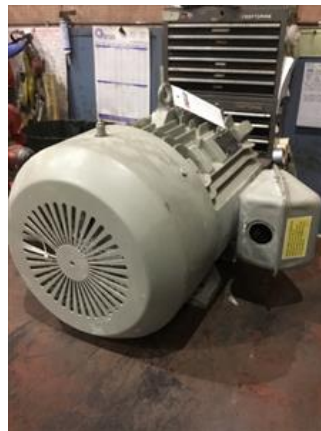
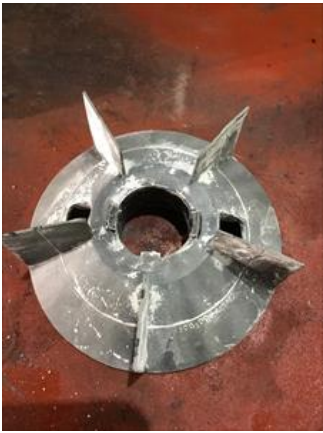
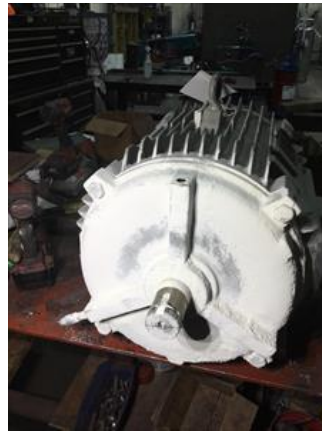
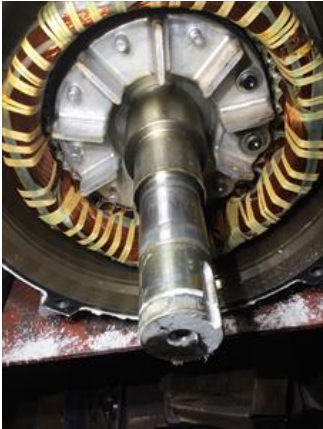
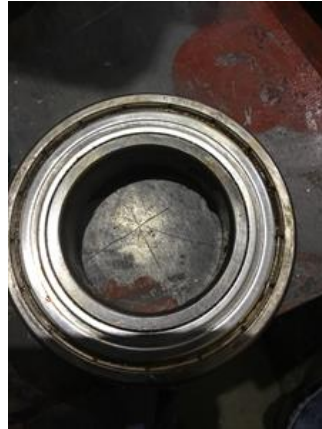
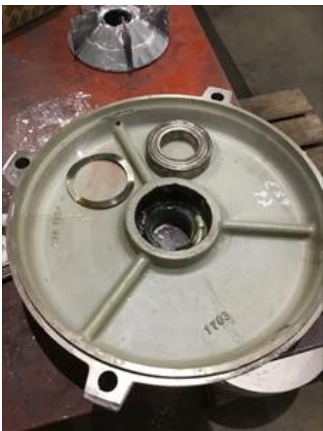
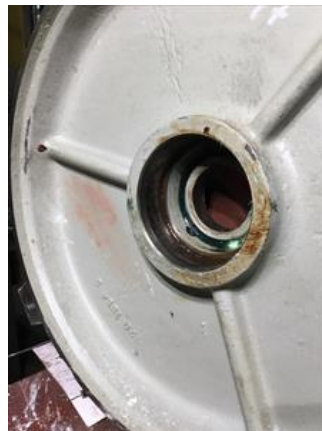
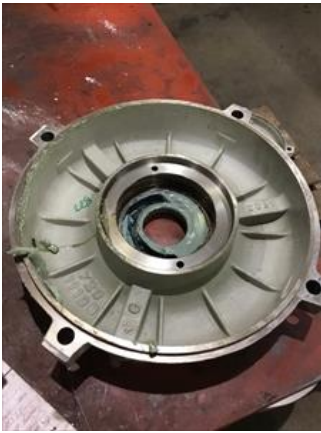
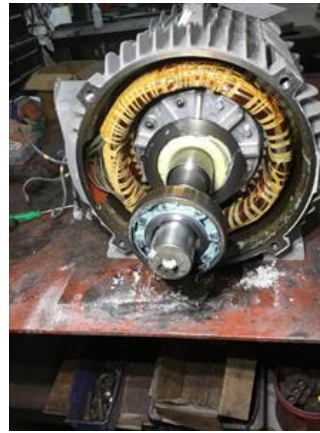
3. Photos of all six sides of the machine.

4. Describe the Overall Condition of the Equipment as Received  
*Serviceable*

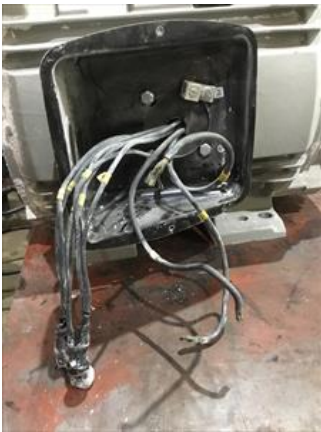
6. Does Shaft Turn Freely?	(Y) Yes	
7. Does the shaft require T.I.R in Lathe to identify additional repairs?	(No) No	
8. Does Shaft Have Visible Damage?	(No) No	
9. Assembled Shaft Runout	0 Inches	
10. Assembled Shaft End Play	0 inches	
11. Air Gap Variation <10%		
12. Lead Condition	(P) Pass	
13. Lead Length	12.5 Inches	P88

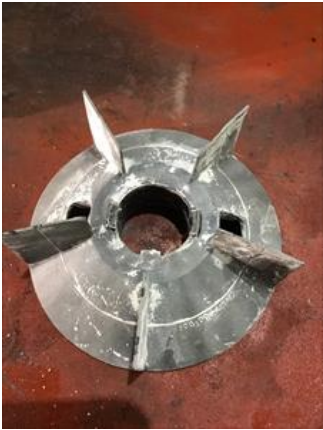
14. Does it have Lugs?, If so what is the Stud Size?	(No) No	
15. Lead Numbers	1-9	
16. Frame Condition	pass

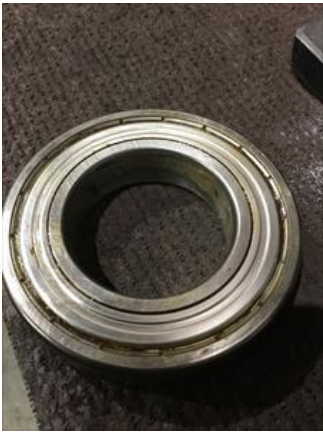
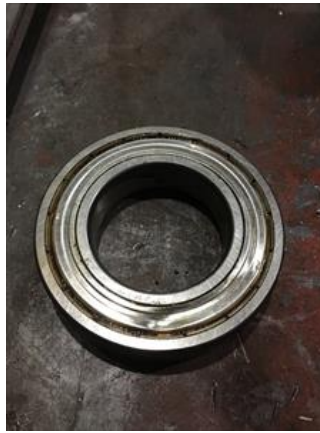
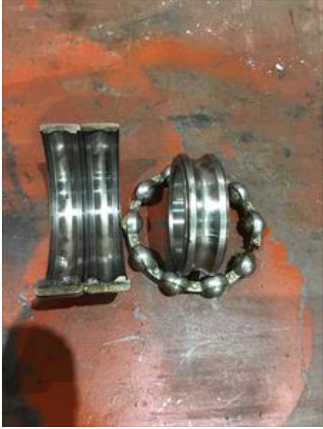
P100

36.	Opposite Drive End Bearing Qty.	1	
37.	Opposite Drive End Bearing Type	(Ball) Ball Bearing	
38.	Opposite Drive End Lubrication Type	(Grease) Grease Lubricated	
39.	Opposite Drive End Bearing Insulation or Grounding Device?	none	
40.	Opposite Drive End Wavy Washer/Snap-Ring Other Retention Device?	wavy washer	
41.	Opposite Drive End Bearing Condition	worn	P119
	Outer race fretted.

*Sleeve ODE & DE housing fits.  
Rewind stator  
6210 /C3 & 6312 / C3*

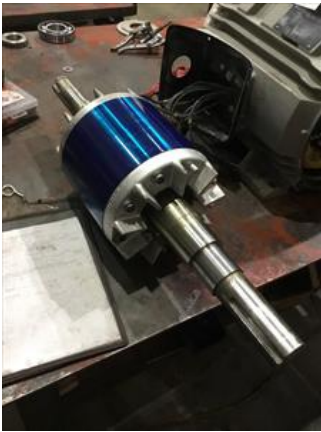
P3

(Squirrel Aluminum) Squirrel  
Cage Aluminum Die Cast

(Pass) Pass

pass

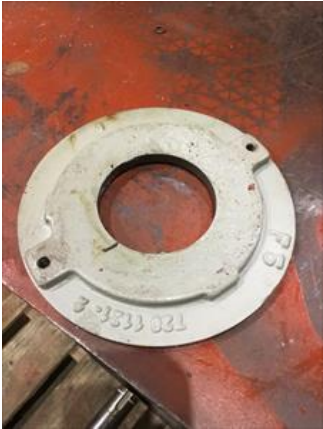
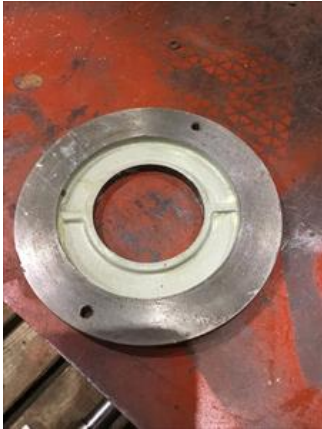
P39

5.1194	5.1191	5.1193	
60.	Drive End - Endbell Bearing Fit Condition			(F) Fail
61.	Opposite Drive End - Endbell Bearing Fit			
	0 Degrees	60 Degrees	120 Degrees

Excessive pitting

62.	Opposite Drive End - Endbell Bearing Fit Condition			(F) Fail

*Winding analyzer shows 2 of 3. phases shorted to ground. Cause is indeterminate. Also both housing fits are out of tolerance.*
