AC Inspection as Found

Welspun Tubular (11685)

AC Inspection - Rev. 2

Description: 150HP US MOTORS 1780RPM

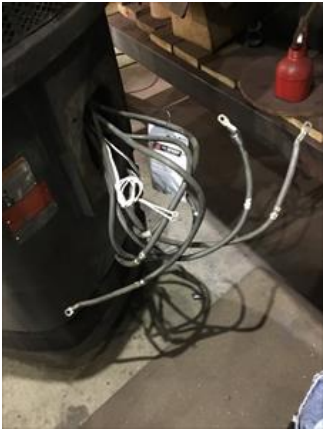
Heater ohms
