AC Inspection as Found

Welspun Tubular (11685)

AC Inspection - Rev. 2

Description: 150HP US MOTORS 1780RPM

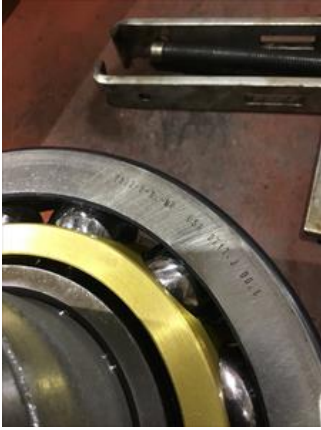
42. Opposite Drive End Bearing Condition

67.	Technician		Terrence Holland

63.	Opposite Drive End - Endbell Bearing Fit Condition		(F) Fail
64.	Bearing Cap Condition		
	Drive End Bearing Cap	Opposite Drive End Bearing Cap	
65.	End Bell Air Seal Fits		
	Drive End Air Seal	Opposite Drive End Air Seal
