AC Inspection as Found
ARKANSAS INDUSTRIAL MACHINERY
3804 N. NONA ST
NORTH LITTLE ROCK, AR 72118

AC Inspection - Rev. 2

Location: Shop
Serial Number: 1PC31042AB400DV2
Description: 55KW SIEMENS

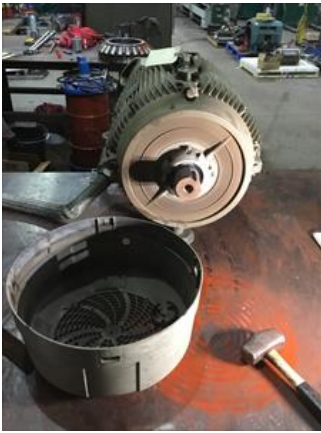
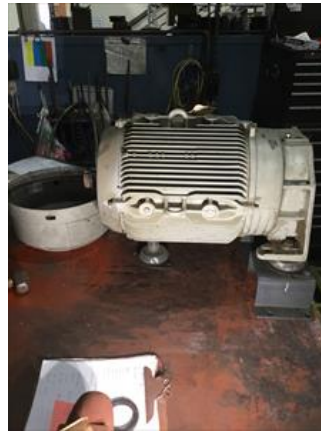
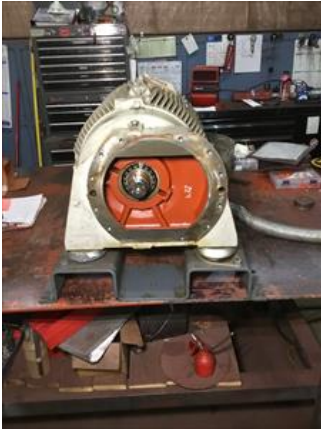
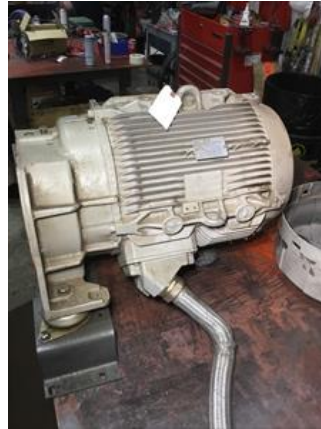
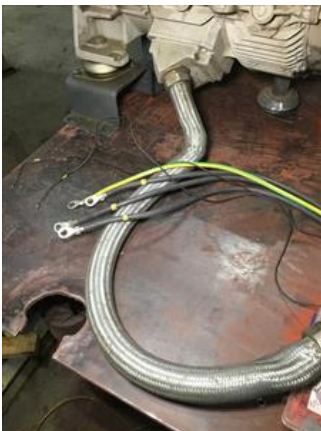
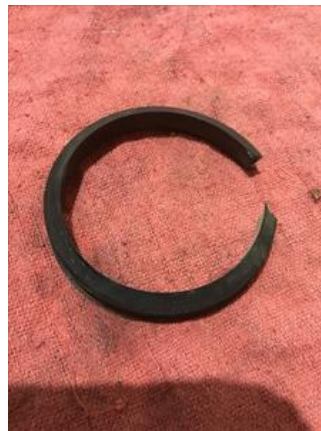
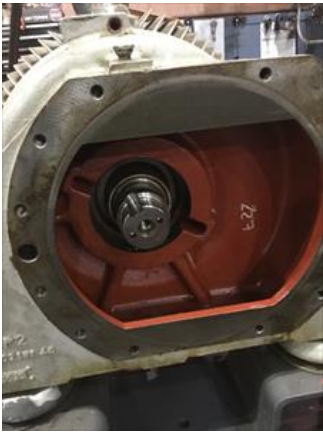
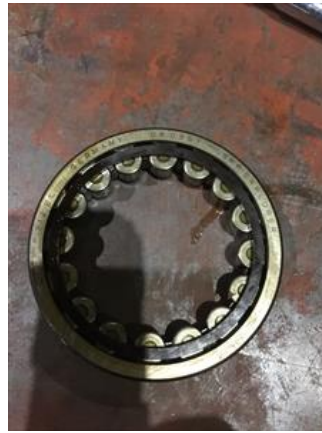
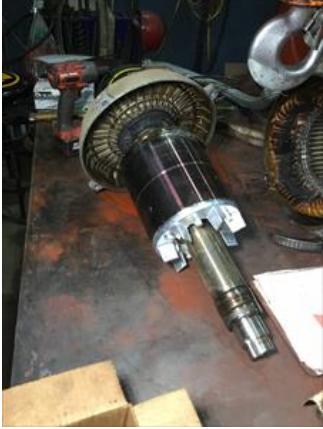
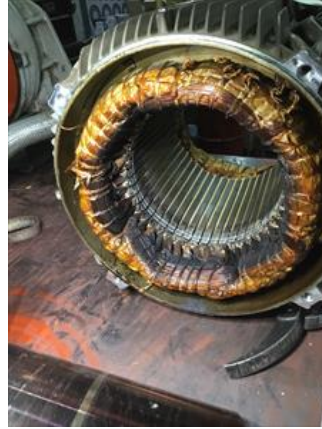
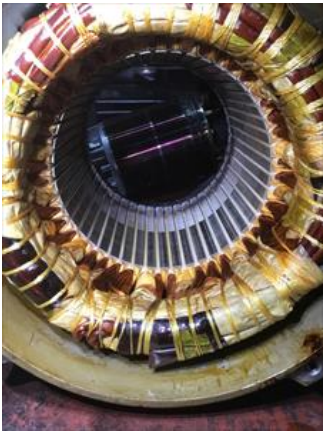
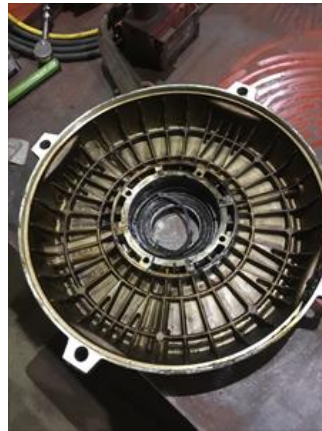
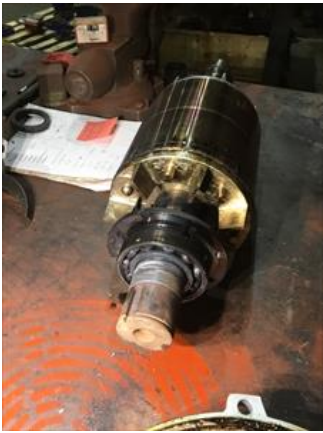
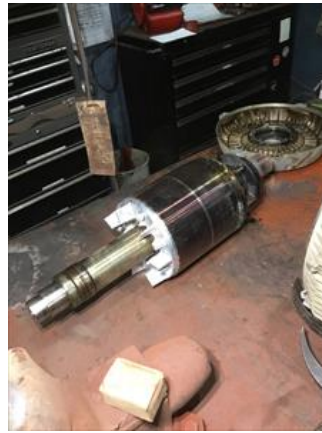
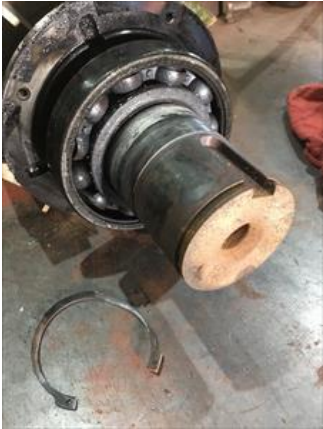
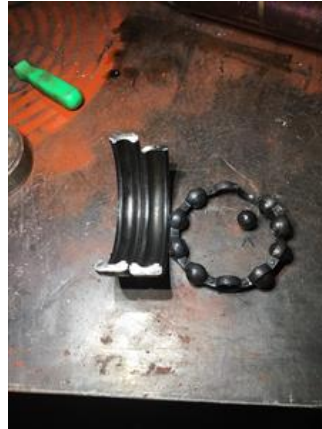
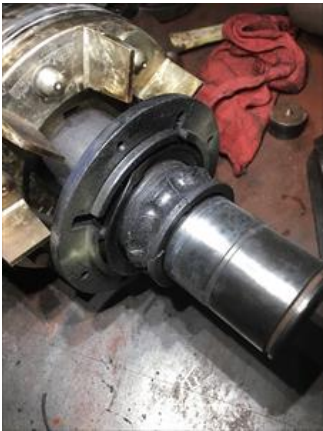
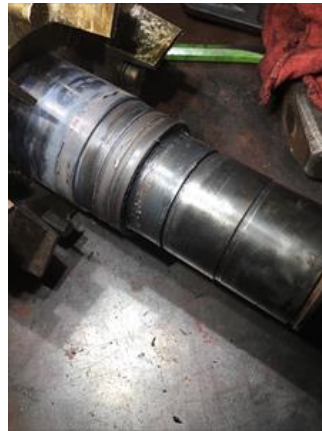
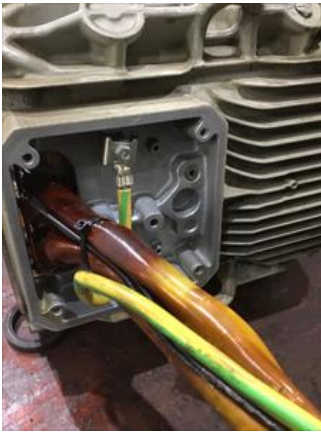
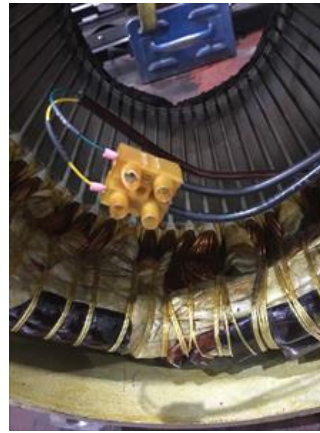
| 3. Photos of all six sides of the machine. | P45 |

4. Describe the Overall Condition of the Equipment as Received
Serviceable

6.	Does Shaft Turn Freely?	(N) No
7.	Does the shaft require T.I.R in Lathe to identify additional repairs?	(Yes) Yes
8.	Does Shaft Have Visible Damage?	(No) No
9.	Assembled Shaft Runout	Inches
10.	Assembled Shaft End Play	inches
11.	Air Gap Variation <10%	
12.	Lead Condition	(P) Pass
13.	Lead Length	
14.	Does it have Lugs?, If so what is the Stud Size?	(Yes) Yes
15.	Lead Numbers	
	<i>U1-V1-W1</i>	
16.	Frame Condition	pass
17.	Fan Condition	(F) Fail
	<i>Destroyed</i>	
18.	Broken or Missing Components	fan blade destroyed

ODE bearing cage had catastrophic failure due to lack of lubrication, causing the rotor to rub on the stator iron core shorting out the windings.

*Replace snap ring, seals and bearings. Machine ODE shaft bearing cap housing fit and shaft air seal surface.
Replace broken fan.*
