**AC Inspection as Found**  
**Bryce Corporation (10053-BRC)**  
450 S. Benton  
Searcy, AR 72143

**AC Inspection - Rev. 2**

**Description:** 55KW SIEMENS 3570RPM W/  
FANTASTIC

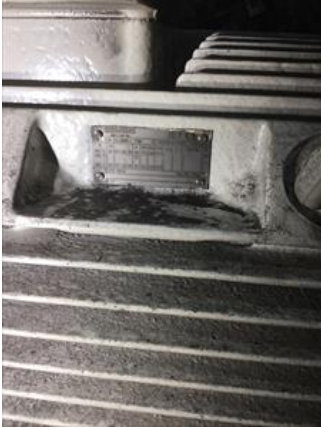
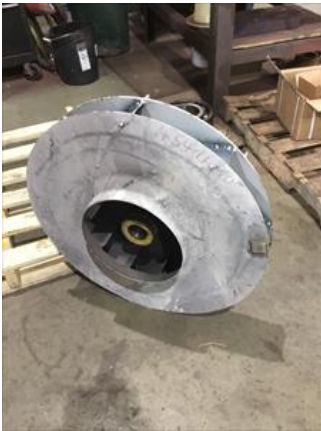
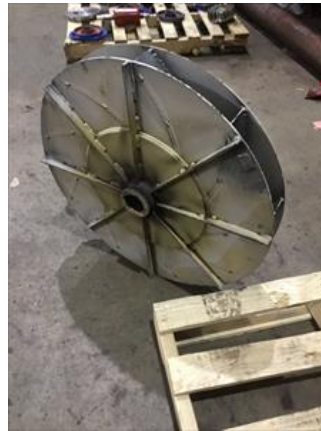
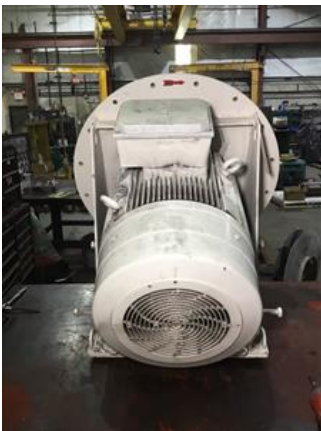
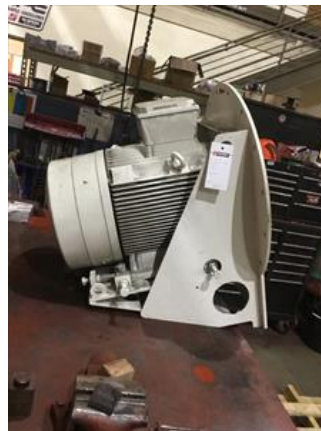
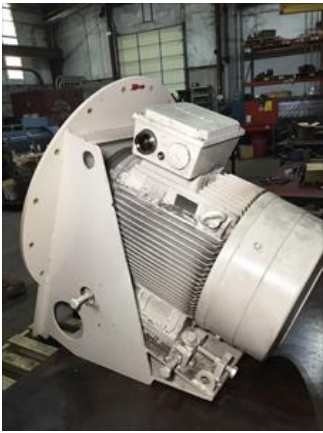
4.	Describe the Overall Condition of the Equipment as Received	
	<i>Serviceable</i>	
5.	Distance from the end of the shaft to the Coupling/Sheave	inches
	<i>Fan assembly was removed by customer.</i>	
Initial Mechanical/Electrical		<input type="checkbox"/>
6.	Does Shaft Turn Freely?	(Y) Yes
7.	Does the shaft require T.I.R in Lathe to identify additional repairs?	(No) No

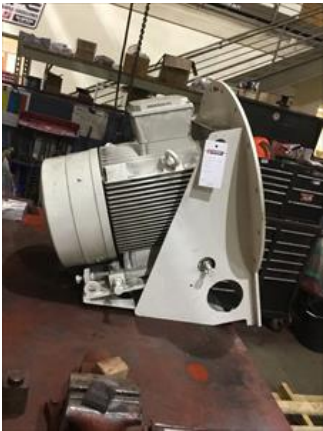
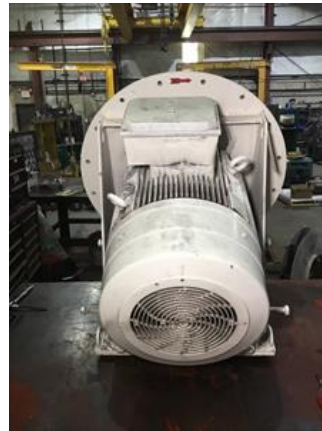
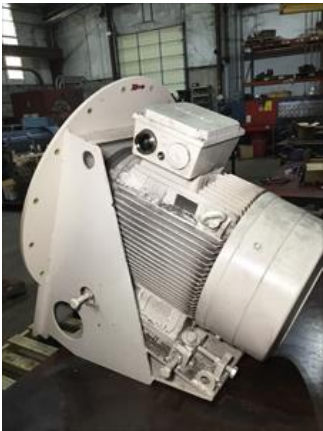
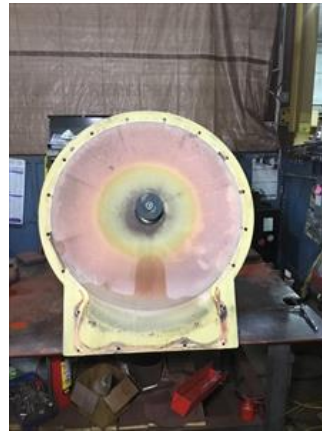
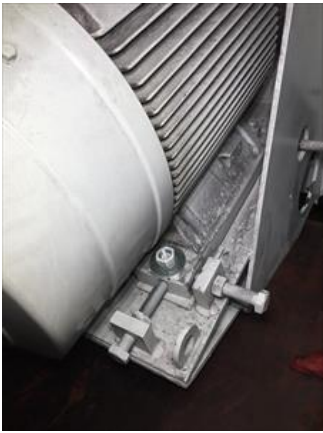
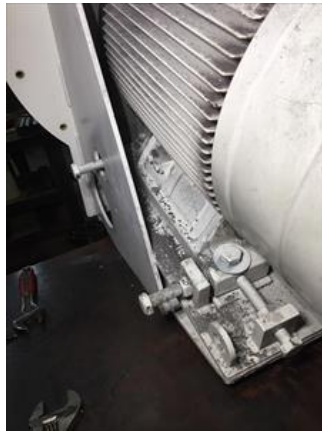
*Removed by customer*

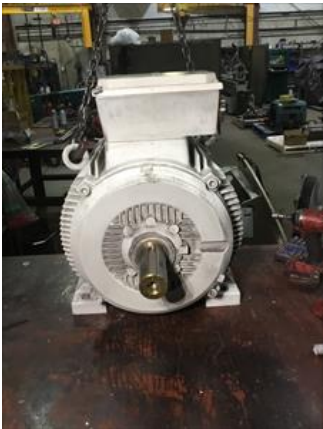
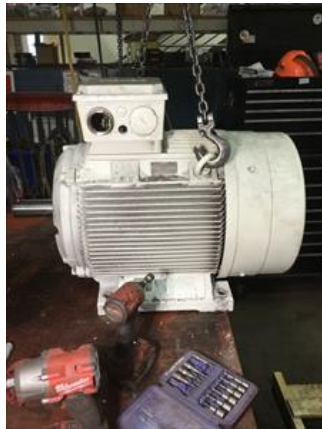
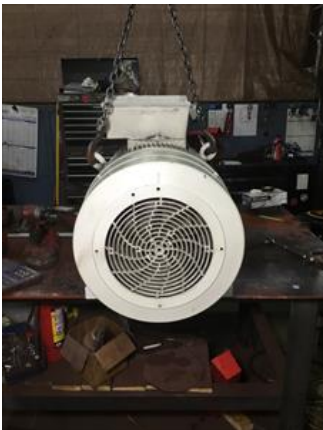
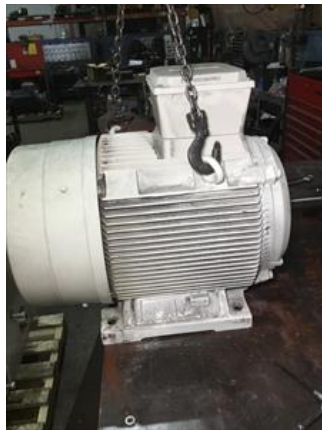
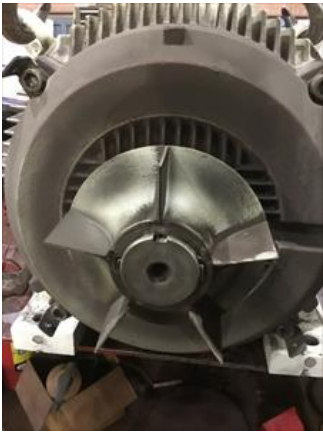
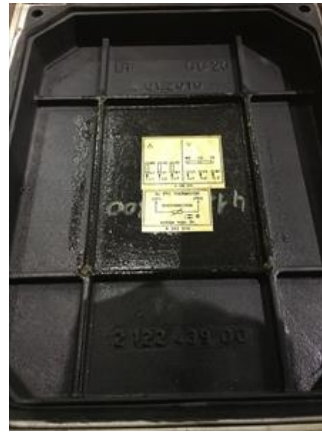
8.	Does Shaft Have Visible Damage?	(No) No	
9.	Assembled Shaft Runout	0.001 Inches	
10.	Assembled Shaft End Play	0 inches	
11.	Air Gap Variation <10%	yes	P60

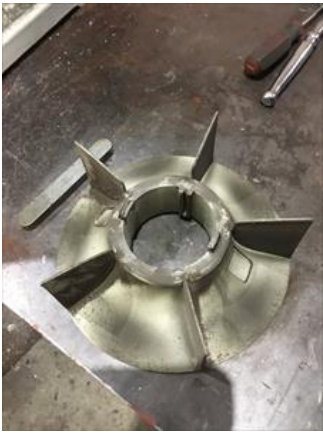
12.	Lead Condition	(P) Pass	
13.	Lead Length	Inches	
	On a connection block.		
14.	Does it have Lugs?, If so what is the Stud Size?	(Yes) Yes	
15.	Lead Numbers	U1-V1-W1. U2-V2-W2	
16.	Frame Condition	pass	
17.	Fan Condition	(P) Pass	P115

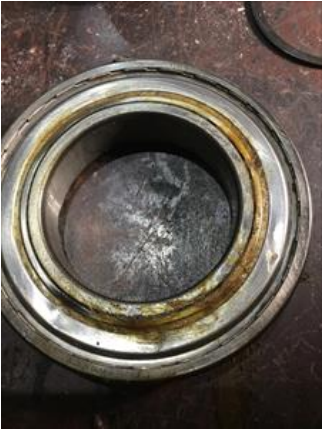
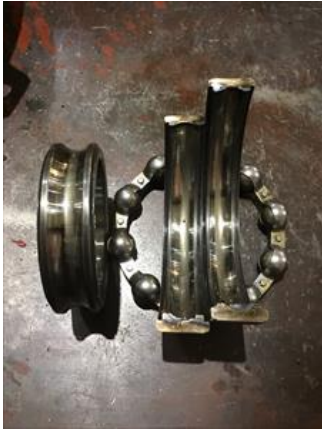
34.	Drive End Bearing Condition	replace	
35.	Opposite Drive End Bearing Brand	ORS Turkey	P92

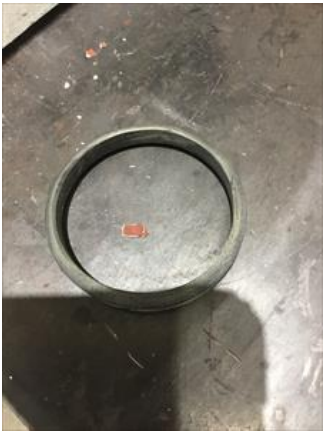
40.	Opposite Drive End Bearing Insulation or Grounding Device?	none	
41.	Opposite Drive End Wavy Washer/Snap-Ring Other Retention Device?		
	2) snap rings.		
42.	Opposite Drive End Bearing Condition	replace	
43.	Drive End Seal	dust seal	P120

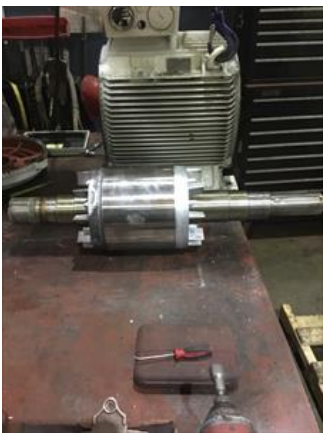
45.	Rotor Type/Material	(Squirrel Aluminum) Squirrel Cage Aluminum Die Cast	P3
-----	---------------------	--	----

46.	Growler Test	(Pass) Pass	
47.	Number of Rotor Bars	28
