AC Inspection as Found
DELTA PLASTICS OF THE SOUTH
3104 SOUTH MAIN STREET
STUTT GART, AR 72160

AC Inspection - Rev. 2

Location: Shop
Serial Number: TGR9216632001
Description: 300HP TECO 1188RPM

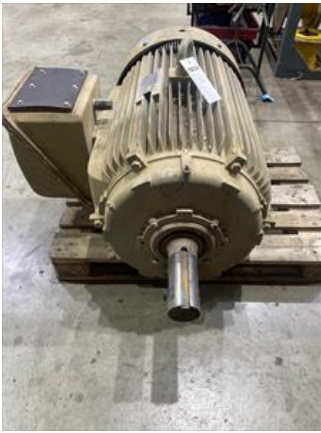
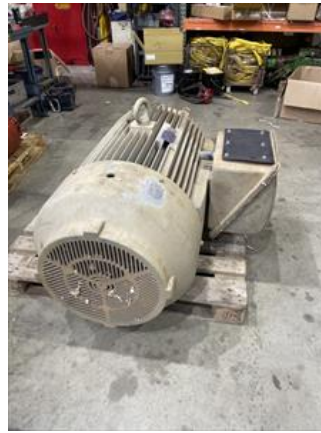
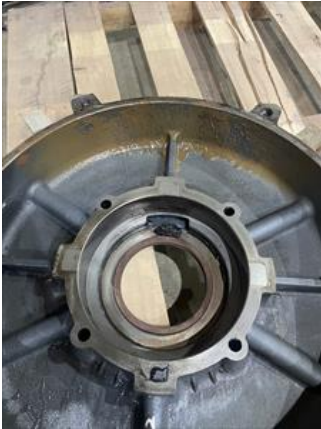
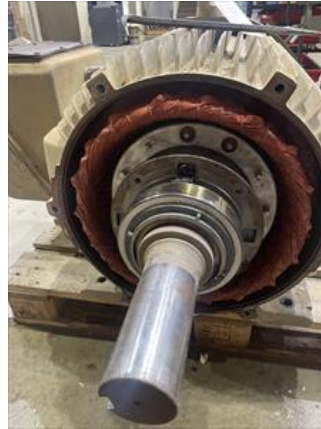
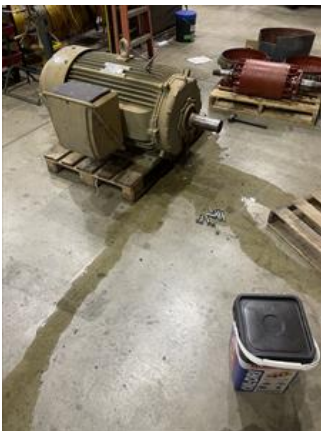
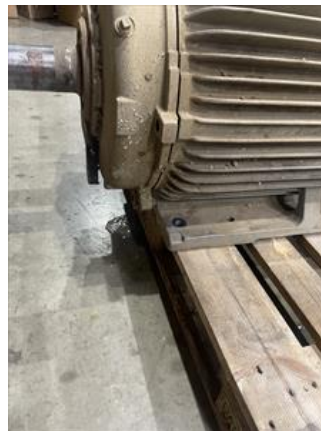
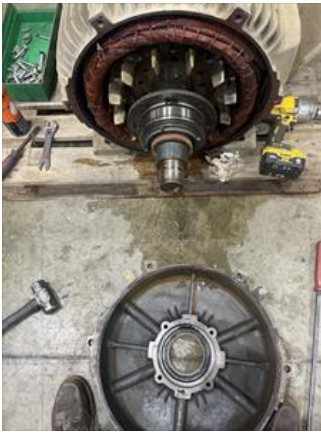
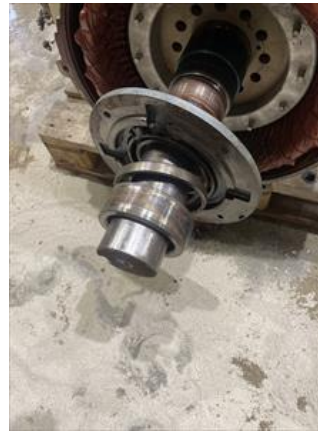
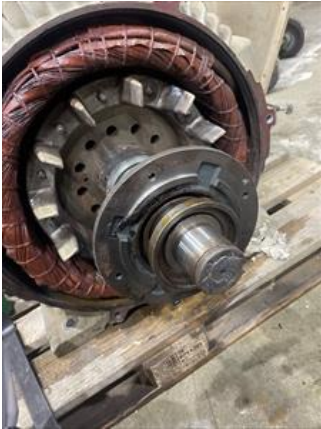
| 3. Photos of all six sides of the machine. | P45 |

4.	Describe the Overall Condition of the Equipment as Received	
	<i>Serviceable</i>	
5.	Distance from the end of the shaft to the Coupling/Sheave	inches
	<i>N/a</i>	
Initial Mechanical/Electrical		
6.	Does Shaft Turn Freely?	(Y) Yes
7.	Does the shaft require T.I.R in Lathe to identify additional repairs?	(No) No
8.	Does Shaft Have Visible Damage?	(No) No
9.	Assembled Shaft Runout	Inches
	<i>Unable to capture</i>	
10.	Assembled Shaft End Play	inches
	<i>None</i>	
11.	Air Gap Variation <10%	
12.	Lead Condition	(P) Pass
13.	Lead Length	13 Inches
	<i>Inches</i>	
14.	Does it have Lugs?, If so what is the Stud Size?	(No) No
15.	Lead Numbers	1-6
16.	Bearing Temperature Detector Rating and Function	
	Quantity	Rating
		Quantity Passed
	<i>N/a</i>	
17.	Frame Condition	good
