AC Inspection as Found

Post Foods LLC
5800 C.W. Post Rd
Jonesboro, AR 72401

AC Inspection - Rev. 2

Hi-Speed Job Number:	153874
Manufacturer:	Other
Product Number:	8P75P3C
Spec/ID #:	BJ65
Serial Number:	P 10 7382794-0010 M 0001
HP/kW:	75 (HP)
RPM:	1190 (RPM)
Frame:	405T
Voltage:	460
Current:	87 (Amps)
Phase:	Three
Hz:	60 (Hz)
Service Factor:	1.15
Enclosure:	TEFC
# of Leads:	3
J-box Included:	Complete
Coupling/Sheave:	None
Date Received:	10/09/2024
Bearing RTDs:	No
Stator RTDs:	No
Repair Stage:	Teardown Inspection
Heaters:	No
Winding Type :	Random Wound
Bearing Type:	Rolling Element

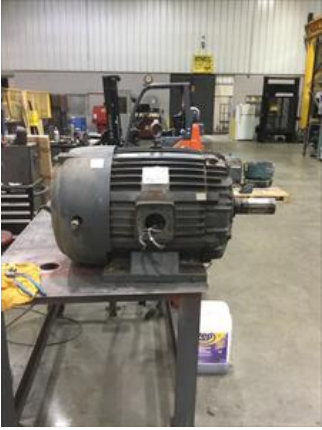
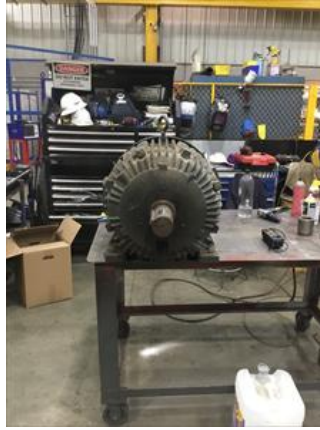
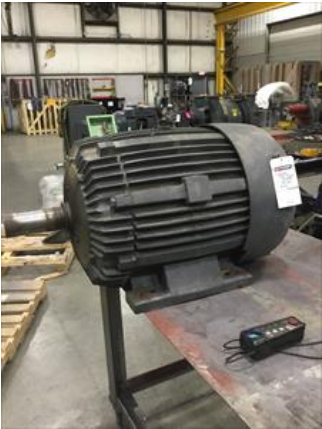
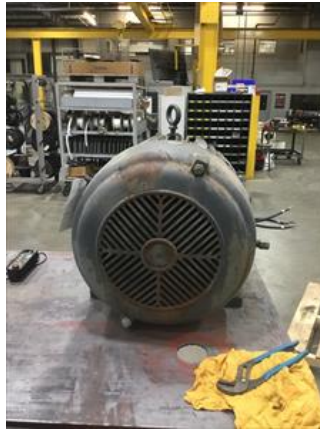
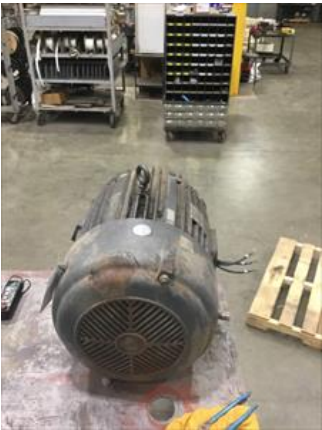
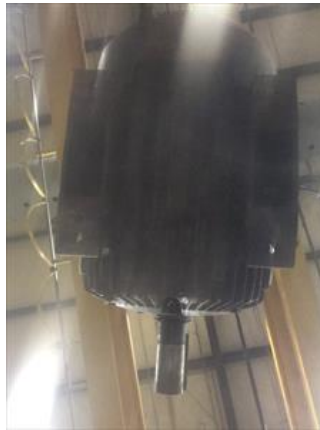
*Has machine work on the drive end
Needs new fan
Windings good*

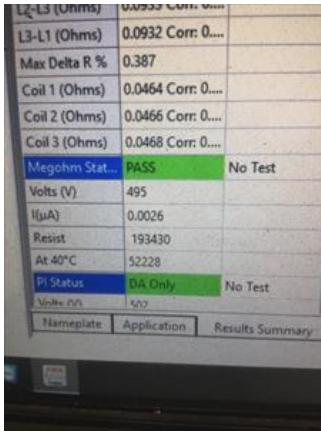
P24

20. Winding Resistance

.0464

.0466

.0468

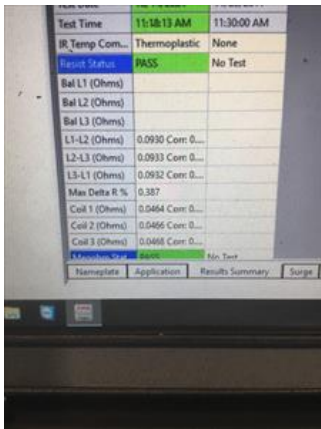
P25

21. Perform Surge Test

(P) Pass

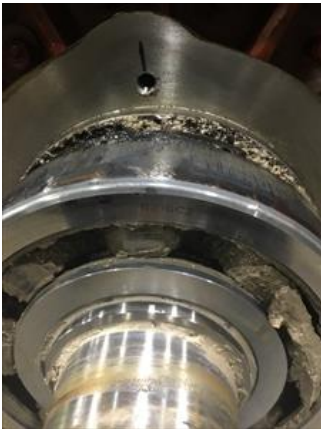
34.	Opposite Drive End Bearing Brand	no name	
35.	Opposite Drive End Bearing Number-	6316 zz c3	P39

27.	Drive End Bearing Number-	6316 zz c3	
28.	Drive End Bearing Qty.	1	
29.	Drive End Bearing Type	(Ball) Ball Bearing	
30.	Drive End Lubrication Type	(Grease) Grease Lubricated	
31.	Drive End Bearing Insulation or Grounding Device?	none present	
32.	Drive End Wavy Washer/Snap-Ring Other Retention Device?	none present	
33.	Drive End Bearing Condition	failed	P37

**Bearing failed**

55. Drive End Bearing Shaft Fit Condition

(F) Fail

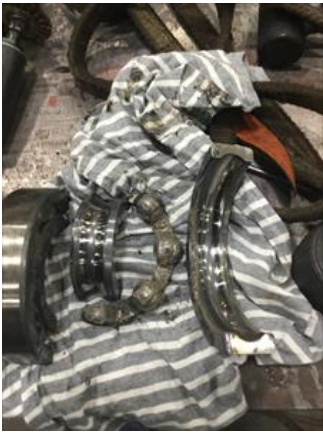
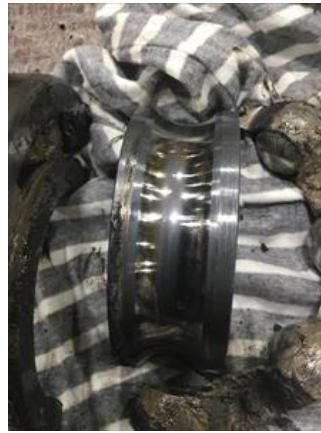
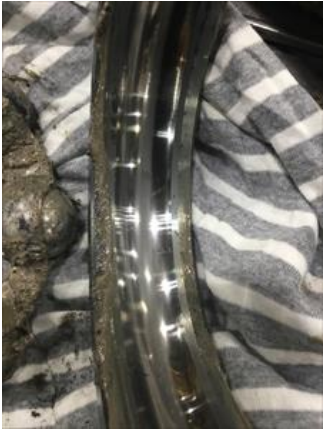
36.	Opposite Drive End Bearing Qty.	1	
37.	Opposite Drive End Bearing Type	(Ball) Ball Bearing	
38.	Opposite Drive End Lubrication Type	(Grease) Grease Lubricated	
39.	Opposite Drive End Bearing Insulation or Grounding Device?	none present	
40.	Opposite Drive End Wavy Washer/Snap-Ring Other Retention Device?	wavy washer	
41.	Opposite Drive End Bearing Condition	normal wear	P45

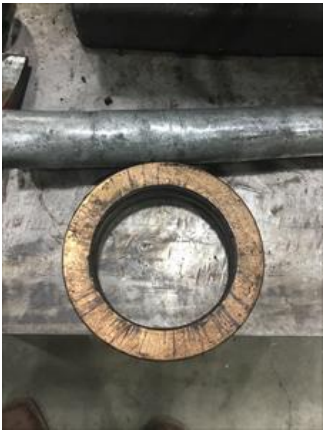
P46

42. Drive End Seal

impro seal

44. Rotor Type/Material	(Squirrel Aluminum) Squirrel Cage Aluminum Die Cast
45. Growler Test	(Pass) Pass
46. Number of Rotor Bars	84
47. Rotor Condition	good
48. List the Parts needed for the Repair Below 1- impro seals od 3.630 shaft 3.227 1- impro seal od 3.897. Shaft 2.940 2- 6316 zz c3 1- fan	
49. Signature of Technician that Disassembled Motor	Nigel Hill
