## AC Inspection as Found

**MARS FOOD (0001269)**

### AC Inspection - Rev. 2

Location: 5 Floor

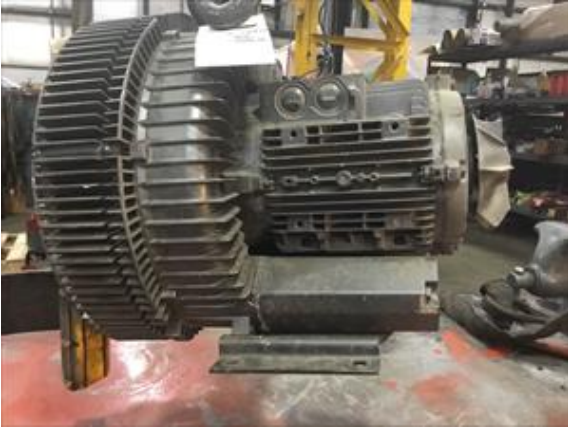
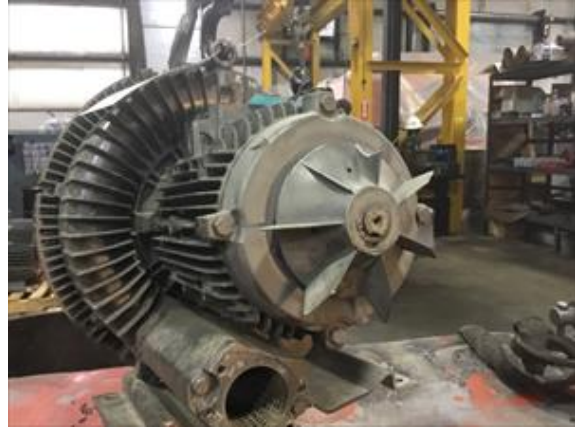
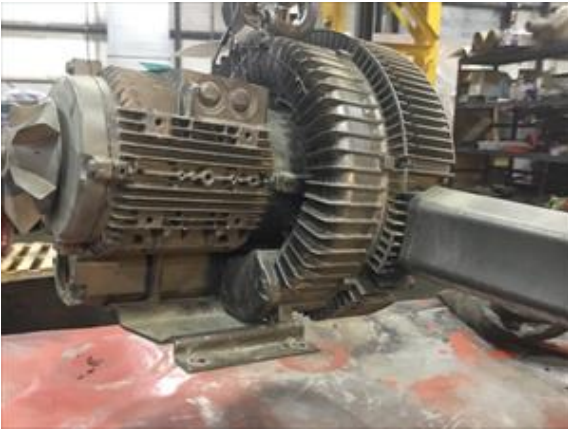
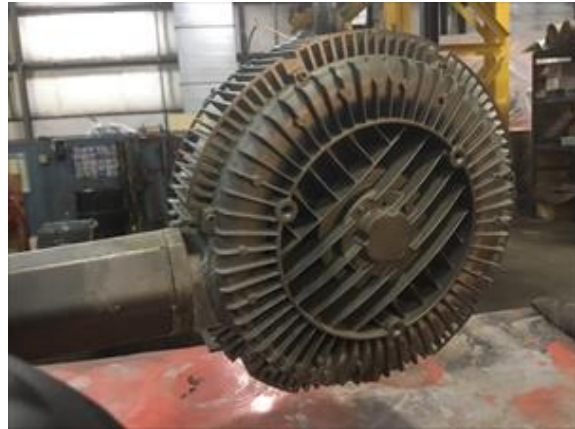
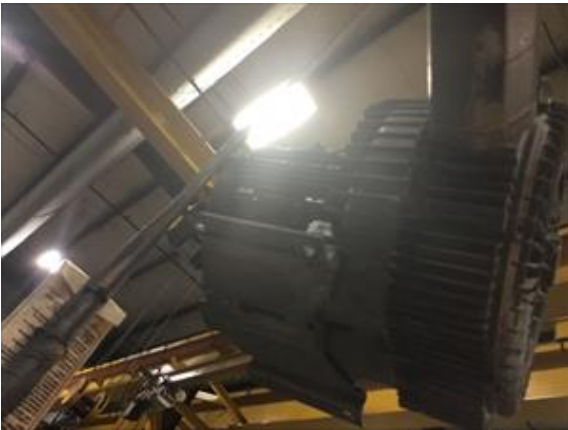
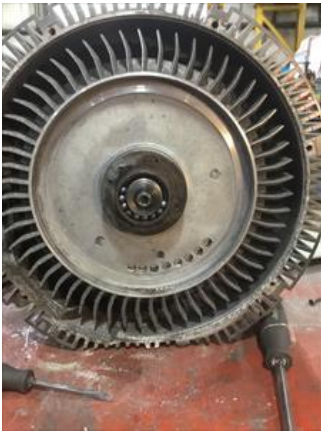
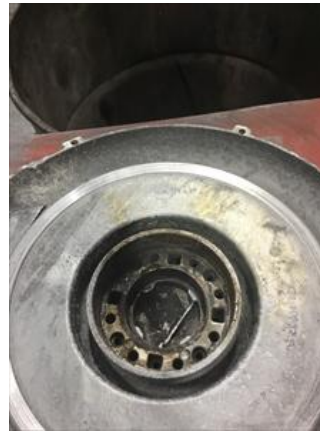
5.	Does Shaft Turn Freely?	(N) No
6.	Does the shaft require T.I.R in Lathe to identify additional repairs?	(Yes) Yes
7.	Does Shaft Have Visible Damage?	(No) No
8.	Assembled Shaft Runout	Inches
9.	Assembled Shaft End Play	
10.	Air Gap Variation <10%	
11.	Lead Condition	(P) Pass
12.	Lead Length	8 Inches
13.	Does it have Lugs?, If so what is the Stud Size?	
14.	Lead Numbers	1-3
15.	Frame Condition	good
16.	Fan Condition	(P) Pass
17.	Heater Quantity, Ratings	
	Quantity	Volts/Watts
		Pass/Fail
18.	Broken or Missing Components	3 broken bolts and 2 still in housing.

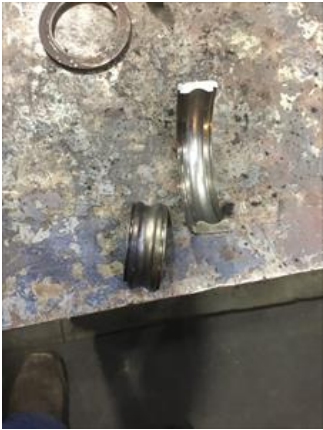
34.	Opposite Drive End Bearing Brand	Skf	
35.	Opposite Drive End Bearing Number-	6205	
36.	Opposite Drive End Bearing Qty.	1	
37.	Opposite Drive End Bearing Type	(Ball) Ball Bearing	
38.	Opposite Drive End Lubrication Type	(Grease) Grease Lubricated	
39.	Opposite Drive End Bearing Insulation or Grounding Device?	no	
40.	Opposite Drive End Wavy Washer/Snap-Ring Other Retention Device?	wavy washer	P43

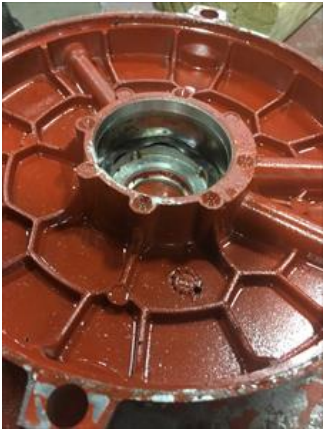
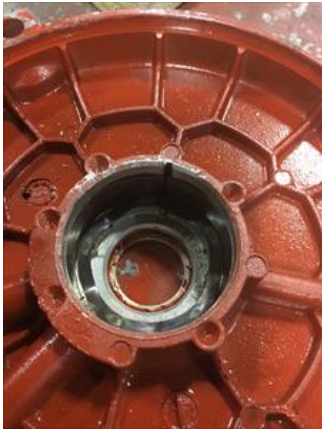
63. Bearing Cap Condition

Drive End Bearing Cap	Opposite Drive End Bearing Cap
<b>good</b>	<b>good</b>
