AC Inspection as Found

Big River Steel (004767)

AC Inspection - Rev. 2

Manufacturer: Rossi

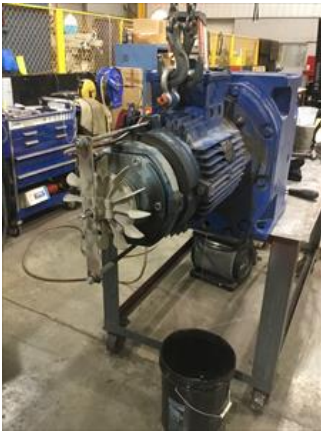
4. Describe the Overall Condition of the Equipment as Received
- Gear box was about 3 gallons over full
Seal on input side of gearbox was blown out into the space between the motor and gear box causing oil to fill the motor
Fill cap replaced with bolt on gear box
Motor had about 1 gallon of oil inside*
- Motor is a rewind
No machine work
New seals and bearings*
