AC Inspection as Found

ARKEMA, INC.
2571 Fite Road
Memphis, TN 38127

Description: 125 Hp Ac Motor

Hi-Speed Job Number:	152680
Manufacturer:	TECO Westinghouse
Product Number:	773B975G27
Serial Number:	8207
HP/kW:	125 (HP)
RPM:	1780 (RPM)
Frame:	444T
Voltage:	460
Current:	136 (Amps)
Phase:	Three
Hz:	60 (Hz)
Service Factor:	1.16
Enclosure:	TEFC
# of Leads:	3
J-box Included:	Half
Coupling/Sheave:	None
Date Received:	04/29/2024
Bearing RTDs:	No
Stator RTDs:	No
Repair Stage:	Teardown Inspection
Shaft Machined Fit Repairs Required:	No
Bearing Housing Machined Fit Repairs Required:	Yes
Heaters:	No
Winding Type :	Random Wound
Bearing Type:	Rolling Element

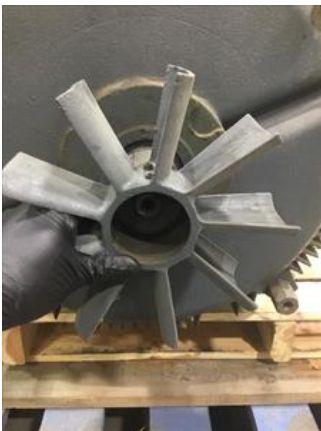
5.	Does Shaft Turn Freely?	(Y) Yes	
6.	Does the shaft require T.I.R in Lathe to identify additional repairs?	(No) No	
7.	Does Shaft Have Visible Damage?	(No) No	
8.	Assembled Shaft Runout	0.0005 Inches	
9.	Assembled Shaft End Play	0.0005 inches	
10.	Air Gap Variation <10%	no provision for measurement	
11.	Lead Condition	(P) Pass	
12.	Lead Length	16 Inches	
13.	Does it have Lugs?, If so what is the Stud Size?	(Yes) Yes	
	3/8 hole		
14.	Lead Numbers	1-3	
15.	Frame Condition		
16.	Fan Condition	(P) Pass	P16

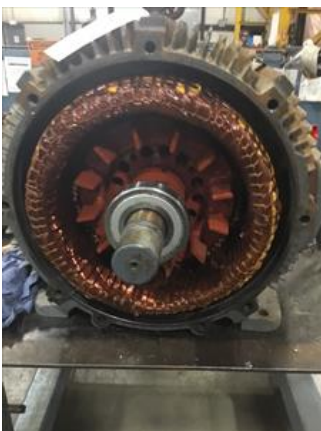
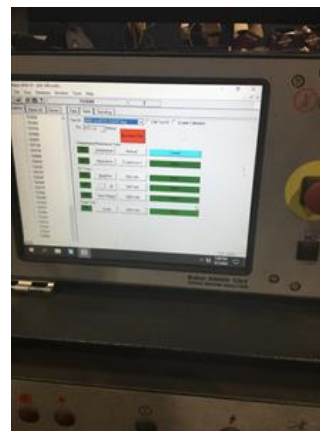
P22

22. Stator Condition

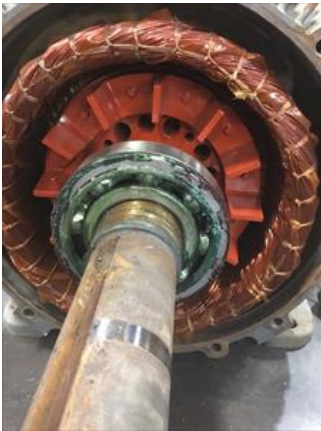
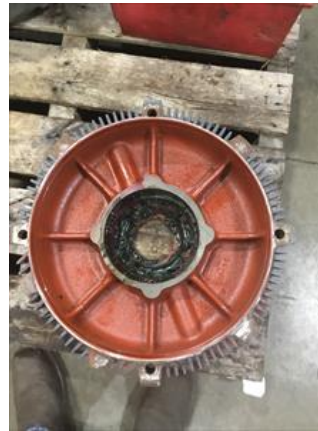
P32

27. Drive End Bearing Qty.	1
28. Drive End Bearing Type	(Ball) Ball Bearing
29. Drive End Lubrication Type	(Grease) Grease Lubricated
30. Drive End Bearing Insulation or Grounding Device?	none present
31. Drive End Wavy Washer/Snap-Ring Other Retention Device?	none
32. Drive End Bearing Condition

44.	Growler Test		(Pass) Pass
45.	Number of Rotor Bars		
46.	Rotor Condition		acceptable
47.	List the Parts needed for the Repair Below 6319ZZC3 bearing 6313ZZC3 bearing		
48.	Signature of Technician that Disassembled Motor		
Mechanical Fits- Rotor			
49.	Shaft Runout		0.001 inches
50.	Rotor Runout		
	Drive End Bearing Fit	Rotor Body	Opposite Drive End Bearing
	0.002	2	2
51.	Coupling Fit Closest to Bearing Housing		
	0 Degrees	90 Degrees	120 Degrees
	3.375	3.375	3.375
52.	Coupling Fit Closest to the end of the Shaft		
	0 Degrees	60 Degrees	120 Degrees
	3.375	3.375	3.375
53.	Drive End Bearing Shaft Fit		
	0 Degrees	60 Degrees	120 Degrees
	3.7404	3.7404	3.7404
	Tolerance is 3.7403-3.7409		
54.	Drive End Bearing Shaft Fit Condition		(P) Pass

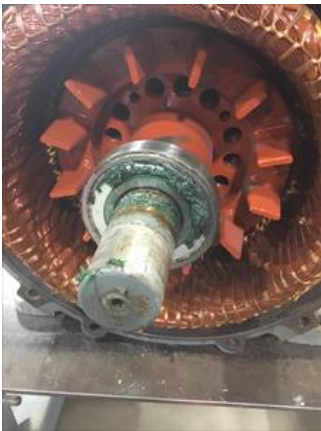
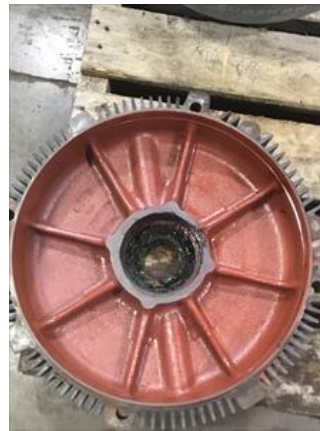
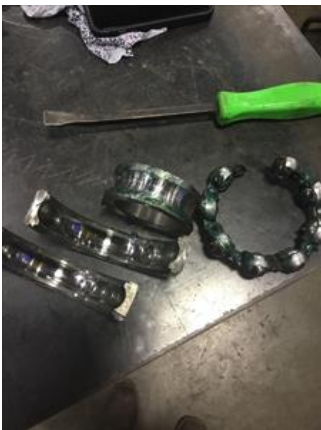
P40

35. Opposite Drive End Bearing Qty.	1
36. Opposite Drive End Bearing Type	(Ball) Ball Bearing
37. Opposite Drive End Lubrication Type	(Grease) Grease Lubricated
38. Opposite Drive End Bearing Insulation or Grounding Device?	none present
39. Opposite Drive End Wavy Washer/Snap-Ring Other Retention Device?	none present
40. Opposite Drive End Bearing Condition

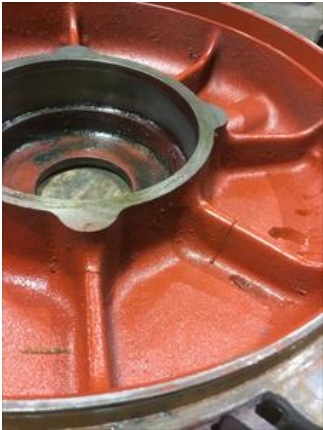
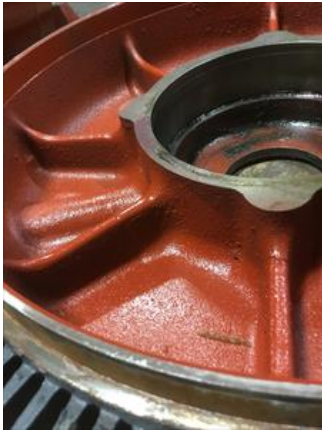
0 Degrees	60 Degrees	120 Degrees
7.8771	7.8771	7.8774

Tolerance is 7.8740-7.8751

59. Drive End - Endbell Bearing Fit Condition (F) Fail

63. End Bell Air Seal Fits	
Drive End Air Seal	Opposite Drive End Air Seal
Pass	Pass
64. List Machine Work Needed Below	
<i>Bore and bush drive end.</i> <i>Drive end end bell is cracked and needs repaired</i>
