**AC Inspection as Found**  
**Arkansas Lime Company**  
600 Limedale Rd  
Batesville, AR 72501

**AC Inspection - Rev. 2**

**Location:** LITTLE ROCK MOTOR SHOP  
**Serial Number:** AF943097  
**Description:** 150 HP BALDOR 1780 RPM

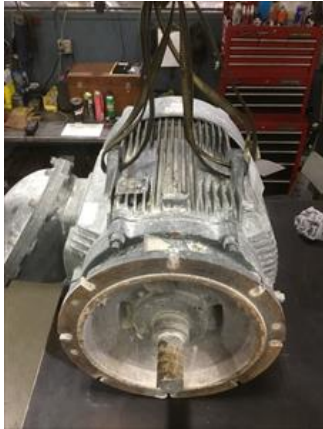
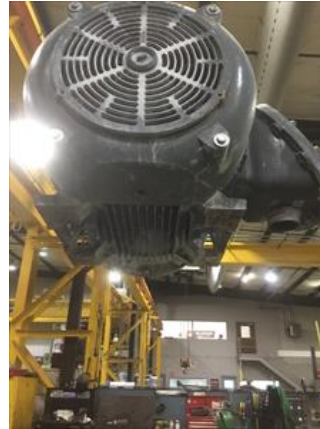
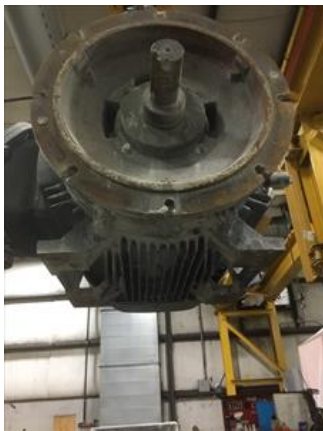
P45

4. Describe the Overall Condition of the Equipment as Received  
*Stator windings are blown and requires rewind. Opposite drive end needs bushing installed.*

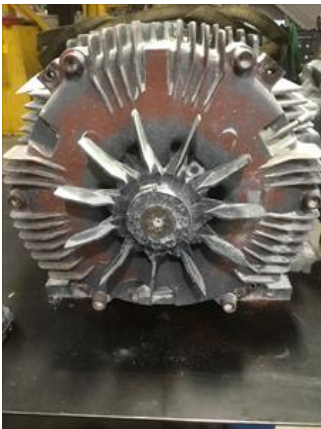
P115

16. Fan Condition **(P) Pass**

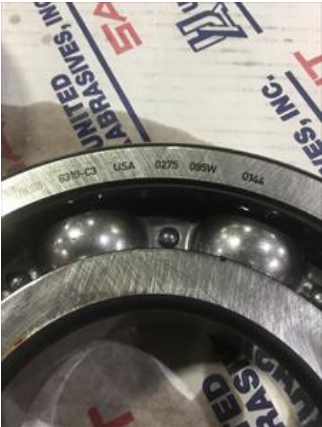
25.	Drive End Bearing Brand	FAG	P12
	<div>

</div>		
26.	Drive End Bearing Number-	6319 C3

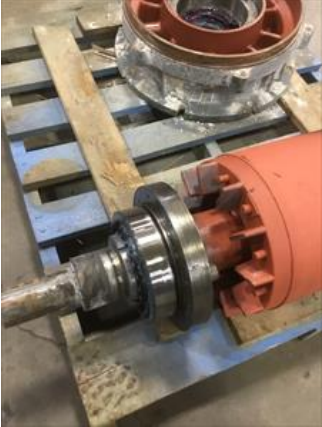
27. Drive End Bearing Qty.	1	
28. Drive End Bearing Type	(Ball) Ball Bearing	
29. Drive End Lubrication Type	(Grease) Grease Lubricated	
30. Drive End Bearing Insulation or Grounding Device?	None	
31. Drive End Wavy Washer/Snap-Ring Other Retention Device?	Lock Nut	P77

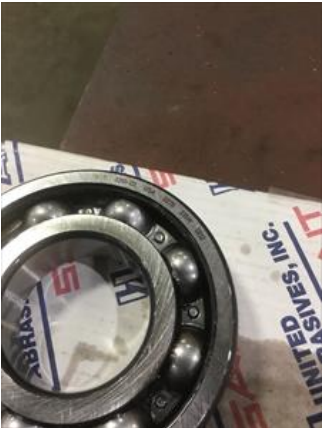
33. Opposite Drive End Bearing Brand	FAG	P92

34. Opposite Drive End Bearing Number-	6324 C3	
35. Opposite Drive End Bearing Qty.	1	
36. Opposite Drive End Bearing Type	(Ball) Ball Bearing	
37. Opposite Drive End Lubrication Type	(Grease) Grease Lubricated

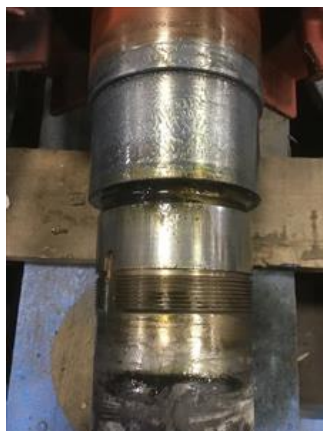
50.	Rotor Runout		
	Drive End Bearing Fit	Rotor Body	Opposite Drive End Bearing
	0.002	0.002	0.002
51.	Coupling Fit Closest to Bearing Housing		
	0 Degrees	90 Degrees	120 Degrees
	2.375	2.375	2.375
52.	Coupling Fit Closest to the end of the Shaft		
	0 Degrees	60 Degrees	120 Degrees
	2.375	2.375	2.375
53.	Drive End Bearing Shaft Fit		
	0 Degrees	60 Degrees	120 Degrees
	3.7408	3.7408	3.7408
	<div><div></div>Tolerance is 3.7403-3.7409</div>		
<div><div></div>

</div>			
54.	Drive End Bearing Shaft Fit Condition		(P) Pass
55.	Opposite Drive End Bearing Shaft Fit		
	0 Degrees	60 Degrees	120 Degrees
	2.7562	2.7562	2.7562
	<div><div></div>Tolerance is 2.7560-2.7565</div>		
<div><div></div> </div>			
56.	Opposite Drive End Bearing Shaft Fit Condition		(P) Pass
57.	Shaft Air Seal Fits		
	Drive End Air Seal	Opposite Drive End Air Seal	
	Pass	Pass
