AC Inspection as Found
Almatis Inc/RCP Bauxite (10014)
4701 Alcoa Road
Bauxite, AR 72011

AC Inspection - Rev. 2

Location: LR Motor Shop
Serial Number: P1022397037 KD
Description: 75HP LOUIS ALLIS

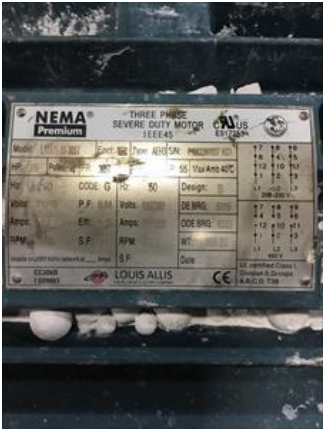
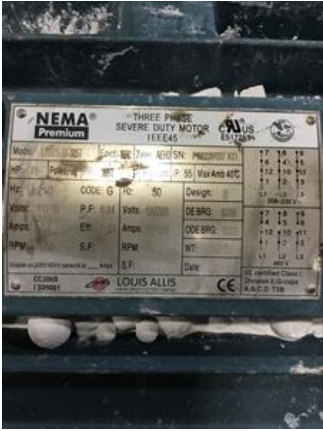
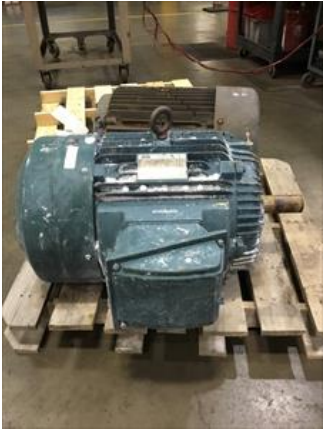
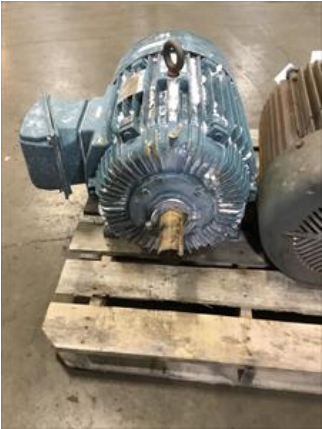
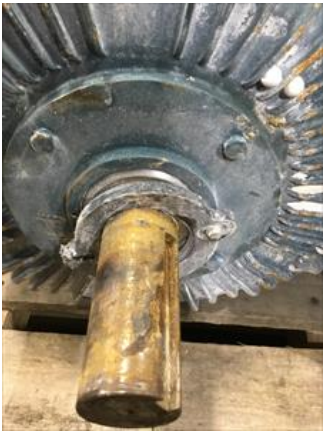
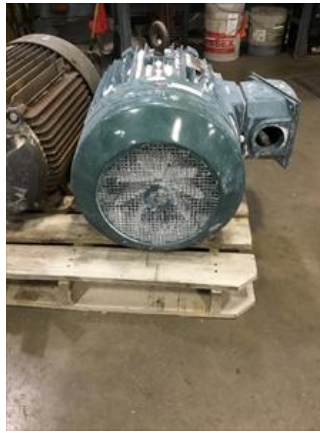
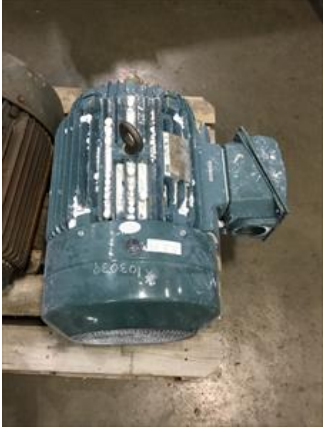
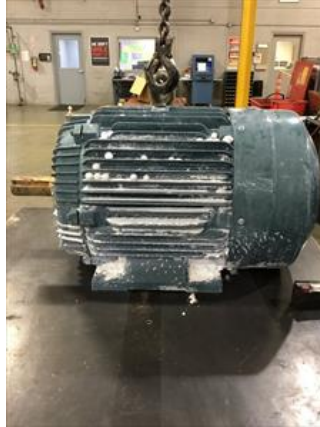
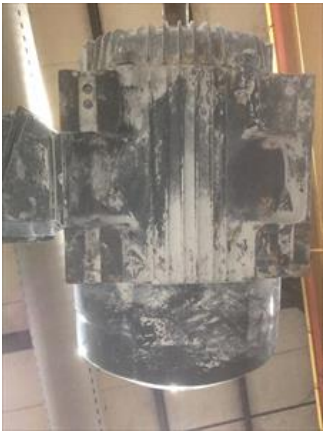
4. Describe the Overall Condition of the Equipment as Received
Good condition, passed all electrical tests. Requires machine work to shaft and end bells.

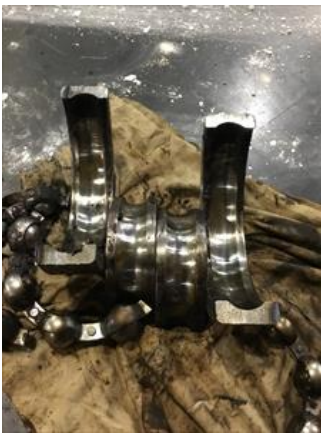
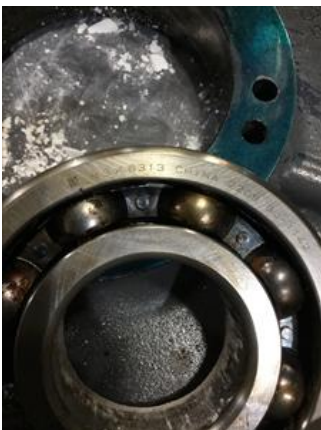
26. Drive End Bearing Number-	6316
27. Drive End Bearing Qty.	1
28. Drive End Bearing Type	(Ball) Ball Bearing
29. Drive End Lubrication Type	(Grease) Grease Lubricated
30. Drive End Bearing Insulation or Grounding Device?	None
31. Drive End Wavy Washer/Snap-Ring Other Retention Device?	None
32. Drive End Bearing Condition	Normal wear
