## AC Inspection as Found

Cerf Shelby LLC  
7103 OLD MILLINGTON ROAD  
MILLINGTON, TN 38053

### AC Inspection - Rev. 2

Description: 125 HP AC

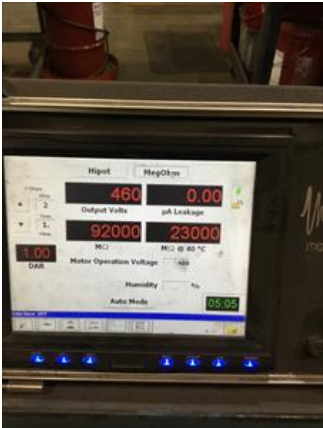
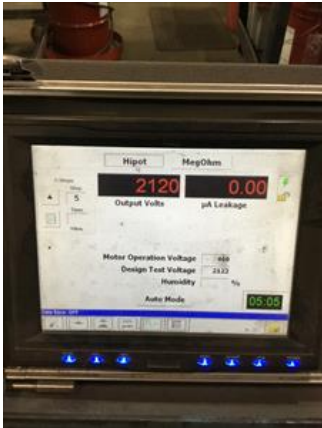
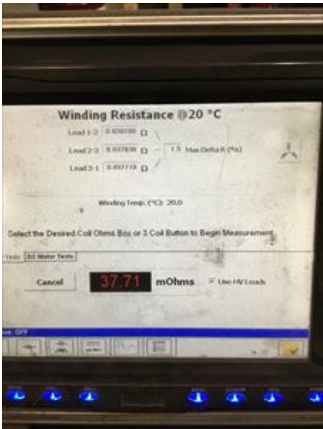
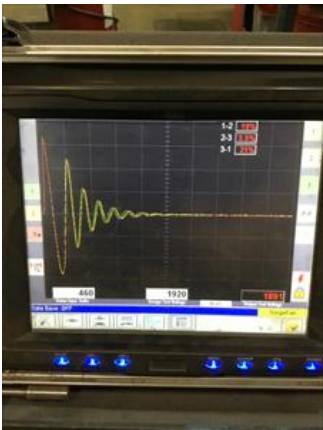
1-2

1-3

2-3

*Stator will run but surge test failed. Recommend rewind.*

Recommend Rewind
