AC Inspection as Found

Process And Power

AC Inspection - Rev. 2

Hi-Speed Job Number:	15362
Manufacturer:	TECO Westinghouse
Serial Number:	RBE7164510003
HP/kW:	60 (HP)
RPM:	1775 (RPM)
Frame:	364TP
Voltage:	460
Current:	68 (Amps)
Phase:	Three
Hz:	60 (Hz)
Service Factor:	1.15
Enclosure:	TEFC
# of Leads:	12
J-box Included:	Complete
Coupling/Sheave:	None
Date Received:	09/05/2024
Bearing RTDs:	No
Stator RTDs:	No
Repair Stage:	Teardown Inspection
Rewind:	No
Shaft Machined Fit Repairs Required:	No
Bearing Housing Machined Fit Repairs Required:	No
Heaters:	No
Winding Type :	Random Wound
Bearing Type:	Rolling Element

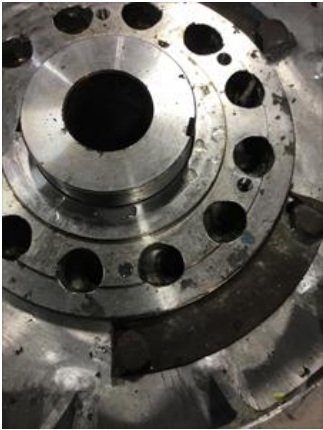
6.	Does Shaft Turn Freely?	(Y) Yes
7.	Does the shaft require T.I.R in Lathe to identify additional repairs?	(No) No
8.	Does Shaft Have Visible Damage?	(No) No
9.	Assembled Shaft Runout	0.001 Inches
10.	Assembled Shaft End Play	0.0045 inches
11.	Air Gap Variation <10%	
12.	Lead Condition	(P) Pass
13.	Lead Length	14 Inches
14.	Does it have Lugs?, If so what is the Stud Size?	
15.	Lead Numbers	1-12
16.	Frame Condition	good
17.	Fan Condition	(P) Pass

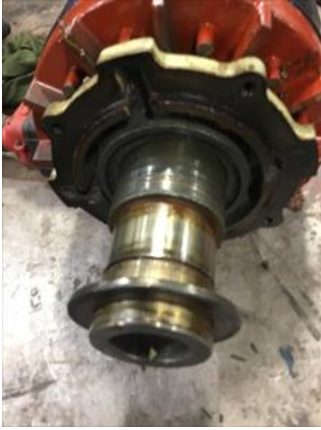
Mechanical Fits- Rotor

44.	Rotor Type/Material	(Squirrel Aluminum) Squirrel Cage Aluminum Die Cast	
45.	Growler Test	(Pass) Pass	
46.	Number of Rotor Bars	40	
47.	Rotor Condition	good
