AC Inspection as Found

ARKEMA, INC.
2571 Fite Road
Memphis, TN 38127

Serial Number: P36G0401B

Description: 60 HP Baldor Motor

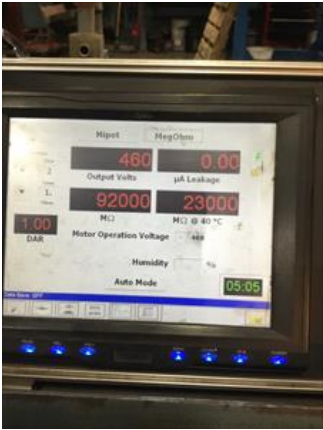
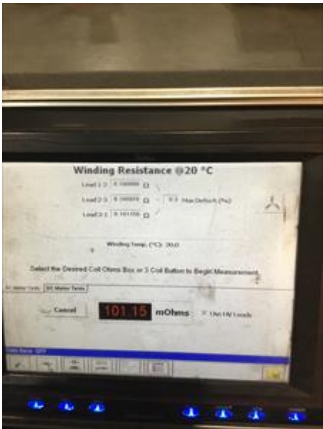
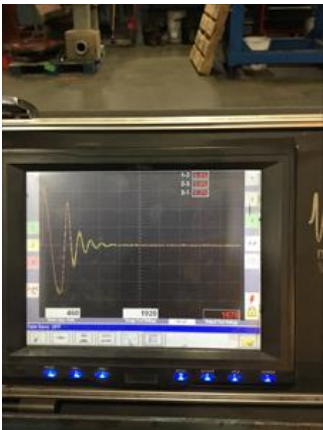
1-2	1-3	2-3
.100880	.101150	.100920

22. Number of Stator Slots	48
23. Stator Condition	good
24. Stator Thermistors/Ohms	N/A
25. Stator Overloads/Ohms	N/A
