## AC Inspection as Found

Big River Steel (004767)

### AC Inspection - Rev. 2

Manufacturer: Rossi

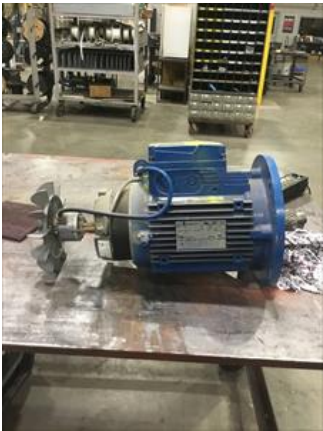
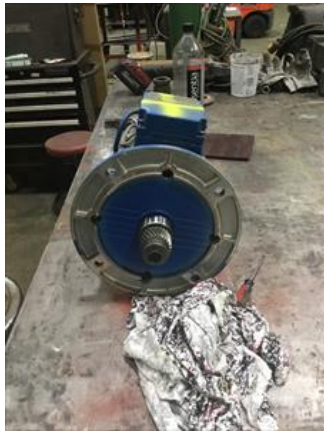
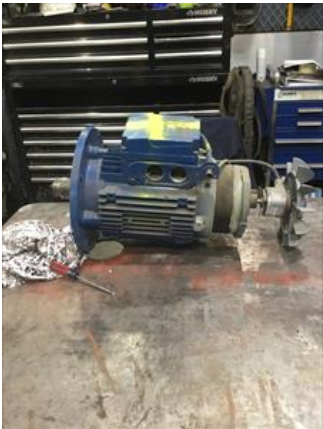
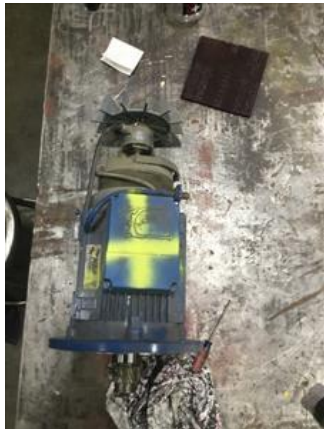
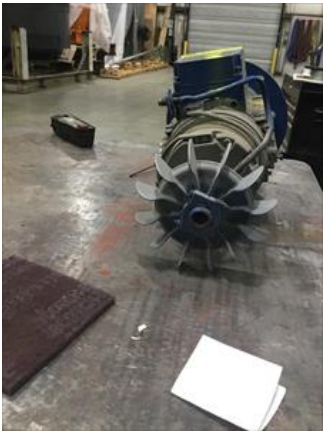
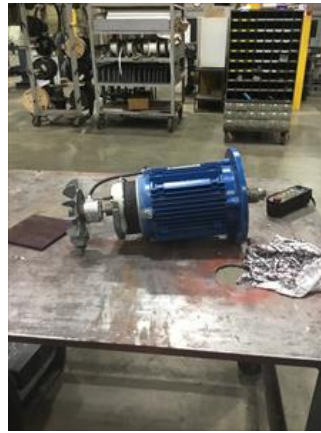
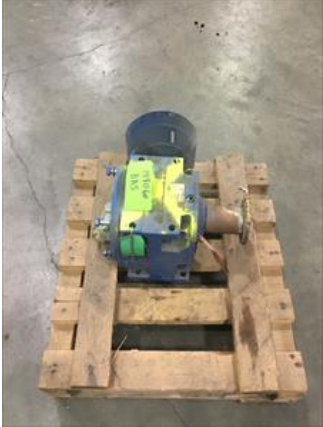
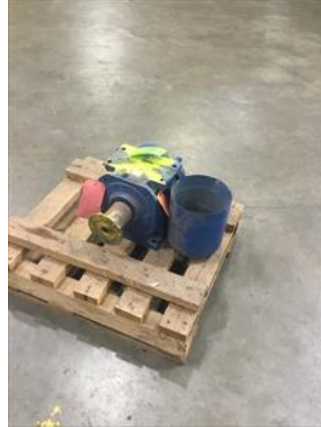
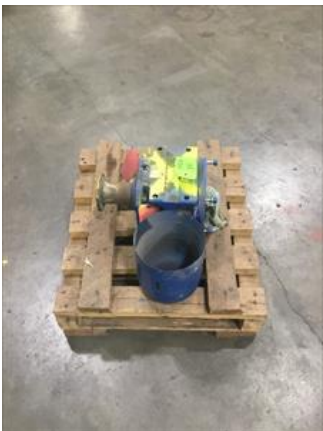
P3

3. Photos of all six sides of the machine.

4.	Describe the Overall Condition of the Equipment as Received <i>Rewind stator and replace gear box seals</i>	
5.	Distance from the end of the shaft to the Coupling/Sheave <i>Shouldered with shaft bolt</i>	0 inches
6.	Report Date [COPY]	09/13/2024
Initial Mechanical/Electrical
