AC Inspection as Found

Peco Foods (004801)

Serial Number: 12W793Y49761

Description: 20 Hp Motor

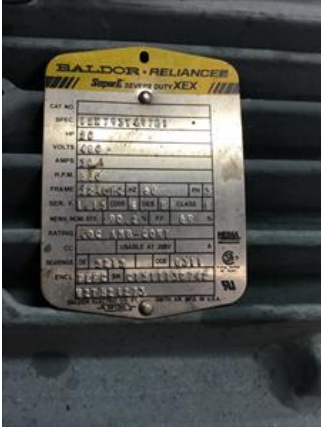
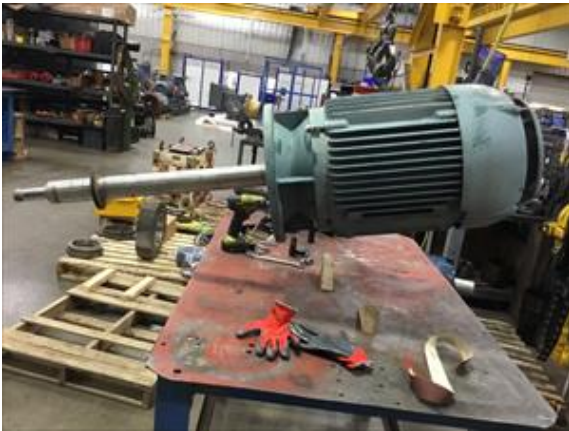
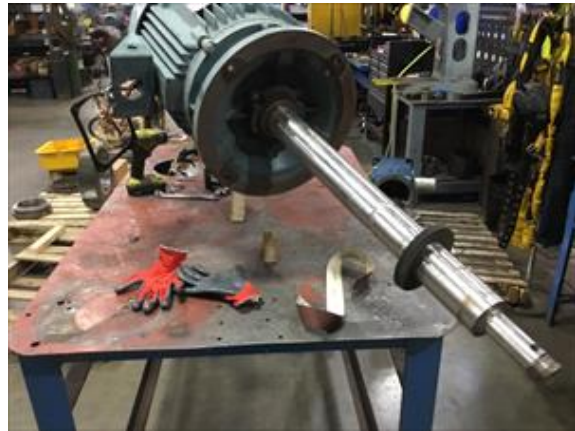
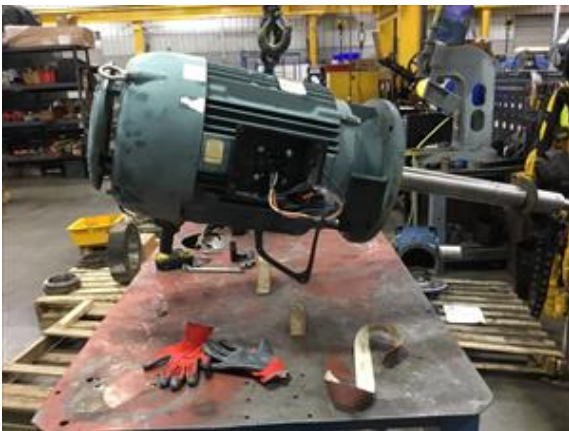
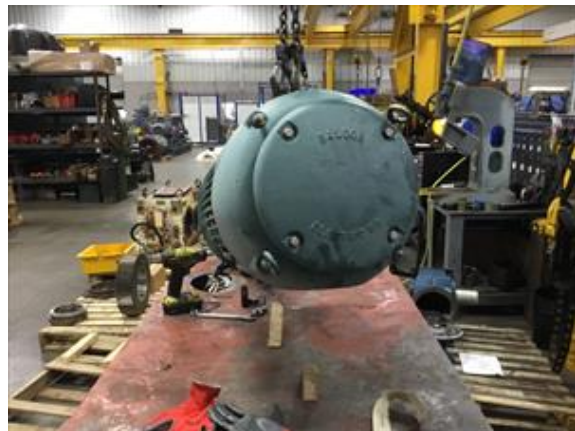
4. Describe the Overall Condition of the Equipment as Received

Shaft damage

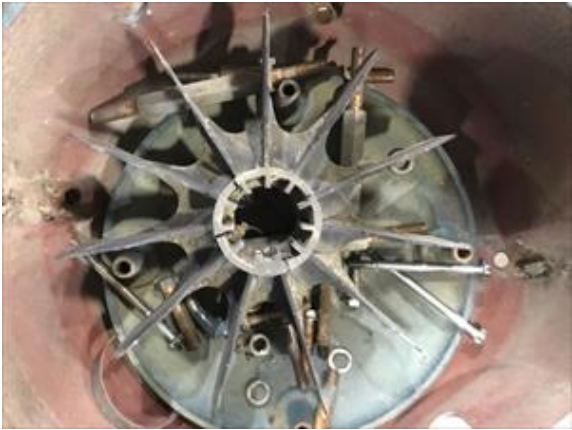
6.	Does Shaft Turn Freely?	(Y) Yes
7.	Does the shaft require T.I.R in Lathe to identify additional repairs?	(No) No
8.	Does Shaft Have Visible Damage?	(Yes) Yes
	Seal surface damaged	
9.	Assembled Shaft Runout	0.003 Inches
10.	Assembled Shaft End Play	inches
	N/a	
11.	Air Gap Variation <10%	
12.	Lead Condition	(P) Pass
13.	Lead Length	10 Inches
14.	Does it have Lugs?, If so what is the Stud Size?	
15.	Lead Numbers	1-3
16.	Frame Condition	good

49. List the Parts needed for the Repair Below
1-3215 a c3 bearing
1-6311 c3 bearing
1- shaft replacement see measurements in rotor condition section
