AC Inspection as Found

MARS FOOD (0001269)

AC Inspection - Rev. 2

Hi-Speed Job Number:	153906
Manufacturer:	Other
Product Number:	NRD132M2
Serial Number:	EN60034-1
HP/kW:	20 (HP)
RPM:	6250 (RPM)
Frame:	IP54
Voltage:	460
Current:	32 (Amps)
Phase:	Three
Hz:	105 (Hz)
Service Factor:	1.15
Enclosure:	TEFC
# of Leads:	3
J-box Included:	Complete
Coupling/Sheave:	None
Date Received:	10/16/2024
Bearing RTDs:	No
Stator RTDs:	No
Repair Stage:	Teardown Inspection
Rewind:	No
Shaft Machined Fit Repairs Required:	No
Bearing Housing Machined Fit Repairs Required:	No
Heaters:	No
Winding Type :	Random Wound
Bearing Type:	Rolling Element

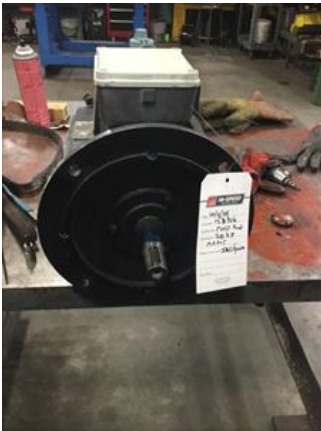
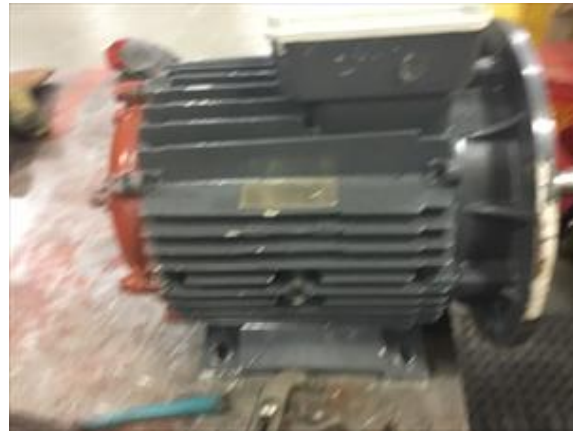
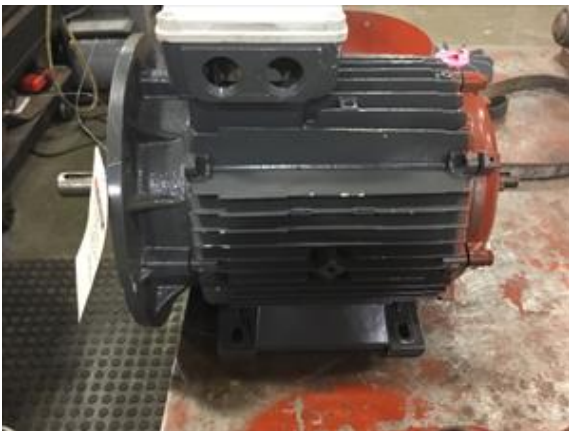
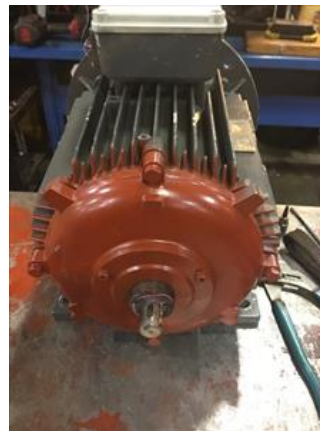
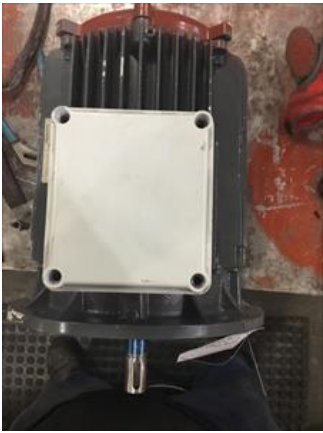
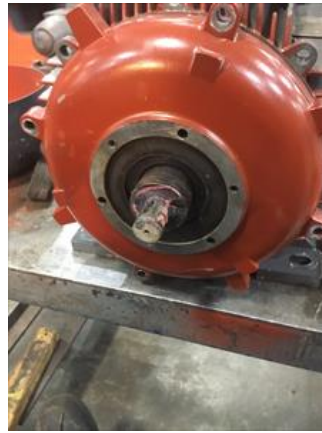
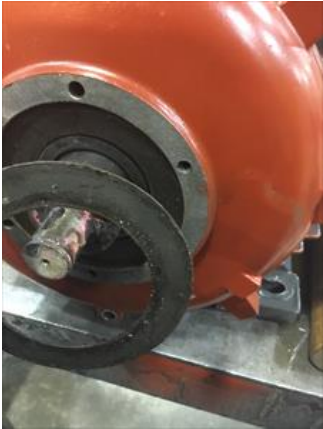
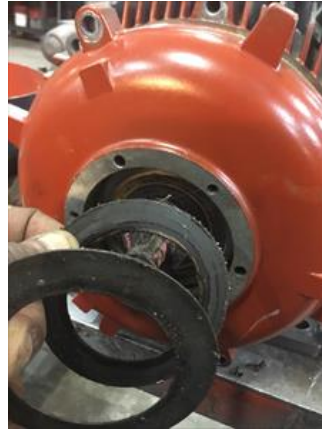
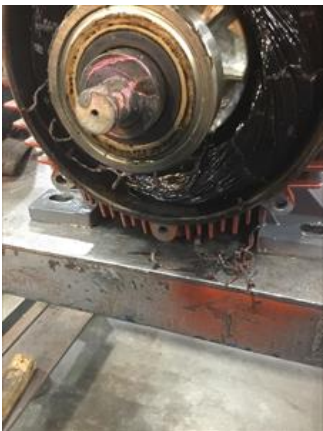
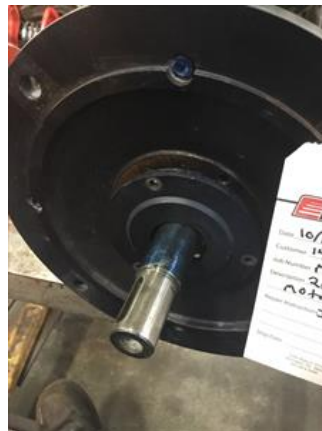
P3

3. Photos of all six sides of the machine.

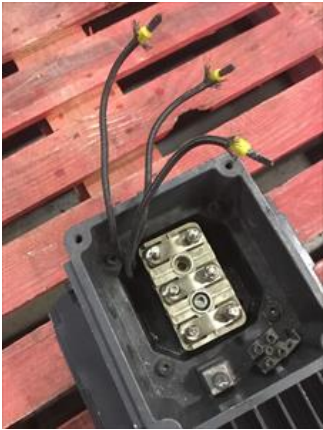
<div><div></div></div>	13. Lead Length	10 Inches	
	14. Does it have Lugs?, If so what is the Stud Size?		
<div><div></div></div>	15. Lead Numbers	1-3	
<div><div></div></div>	16. Frame Condition	good	
<div><div></div></div>	17. Fan Condition	(F) Fail	P17
