Hi-Speed Industrial Service
7030 Ryburn Dr
Millington, Tn 38053
901-873-5300

AC Inspection as Found

KTG USA MOTOR
400 Mahannah
Memphis, TN 38107

Location: Ktg
Serial Number: 4624124
Description: 757 KW ABB

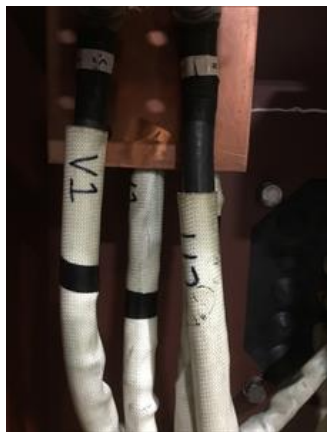
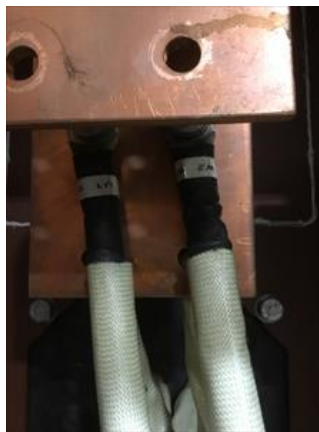
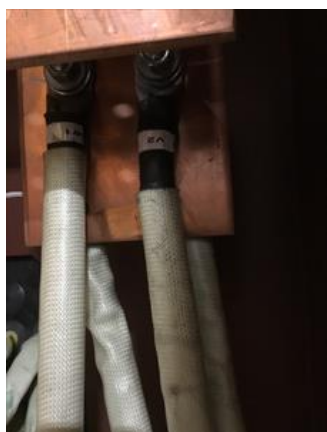
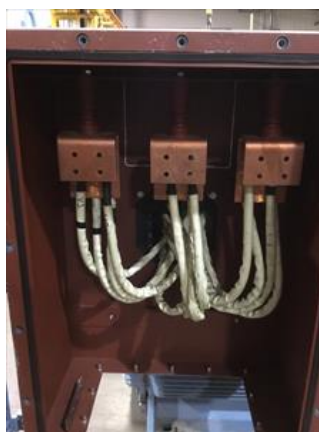
Inside J BOX

LANDED ON BUSS.

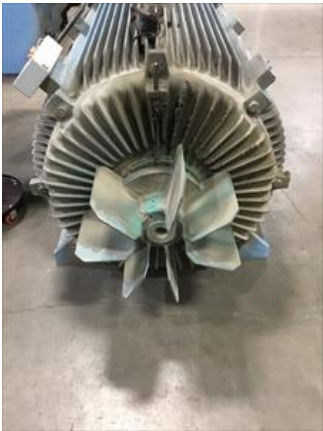
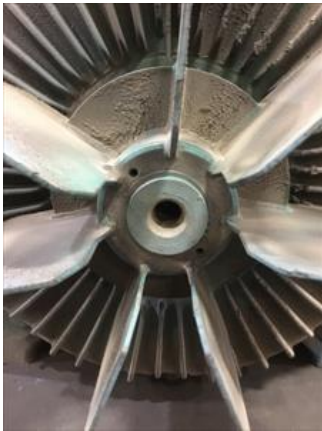
18. Fan Condition

(P) Pass

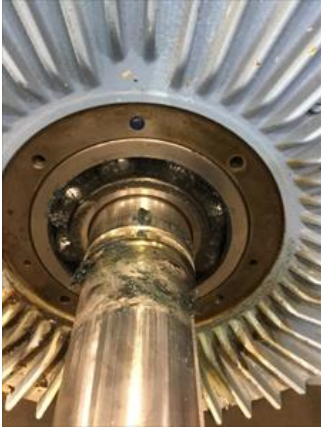
Great condition! Passed all electrical tests and no machine work required. Drive end bearing had significant electrical fluting. Recommend adding Aegis ring internal to drive end. Opposite drive endbell is insulated so no insulated bearing required.

29. Drive End Bearing Number-	6324 C3
30. Drive End Bearing Qty.	1
31. Drive End Bearing Type	(Ball) Ball Bearing
32. Drive End Lubrication Type	(Grease) Grease Lubricated
33. Drive End Bearing Insulation or Grounding Device?	None
34. Drive End Wavy Washer/Snap-Ring Other Retention Device?	None
35. Drive End Bearing Condition	Significant electrical fluting.

70. Root cause of failure
Electrical fluting

50. List the Parts needed for the Repair Below
 6324 C3
 6322 C3
 Aegis ring SGR-133.9-3FH [Mfr# SGR-133.9-154.9-3FH]

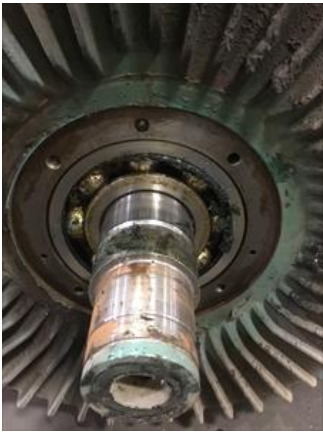
37. Opposite Drive End Bearing Number-	6322 C3	
38. Opposite Drive End Bearing Qty.	1	
39. Opposite Drive End Bearing Type	(Ball) Ball Bearing	
40. Opposite Drive End Lubrication Type	(Grease) Grease Lubricated	
41. Opposite Drive End Bearing Insulation or Grounding Device?	Insulated end bell	P41
<div>

1000 meg, 0 ohms </div>

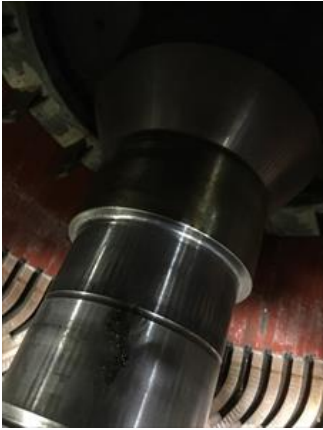
58. Opposite Drive End Bearing Shaft Fit

0 Degrees	60 Degrees	120 Degrees
4.3318	4.3318	4.3318

Tolerance is 4.3312-4.3318
