Location: MOTOR SHOP LR Serial Number: A03187050800001M0001

Description:25 HP AERATOR

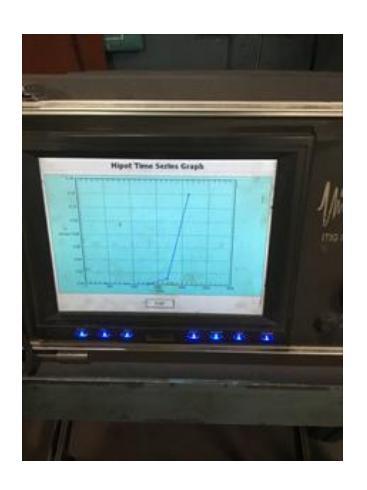
92000 Megohms

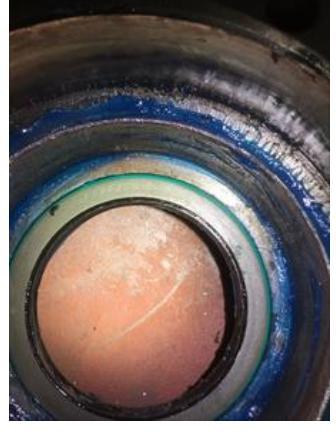
34. Opposite Drive End Bearing Number-	6211 2RS C3	
35. Opposite Drive End Bearing Qty.	1	
36. Opposite Drive End Bearing Type	(Ball) Ball Bearing	
37. Opposite Drive End Lubrication Type	(Grease) Grease Lubricated	
38. Opposite Drive End Bearing Insulation or Grounding Device?	None	
39. Opposite Drive End Wavy Washer/Snap-Ring Other Retention Device?	None	
40. Opposite Drive End Bearing Condition	Normal wear	
41. Drive End Seal	29224	P127

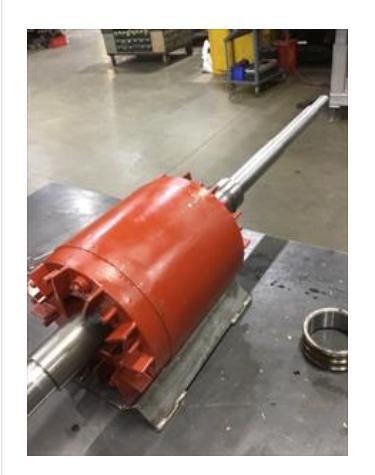
42.	Opposite Drive End Seal	None
Rotor I	nspection	
43.	Rotor Type/Material	(Squirrel Aluminum) Squirrel Cage Aluminum Die Cast
44.	Growler Test	(Pass) Pass
45.	Number of Rotor Bars

47. List the Parts needed for the Repair Below 5316 C3 6211 C3 29224 seal
