## AC Inspection as Found

ARKEMA, INC.  
2571 Fite Road  
Memphis, TN 38127

### AC Inspection - Rev. 2

Description: 125 HP

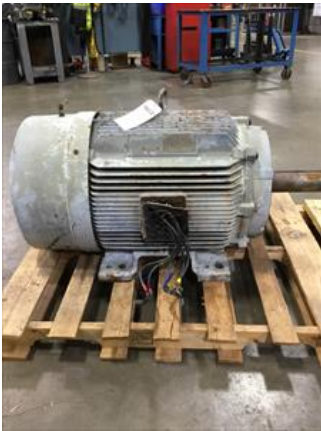
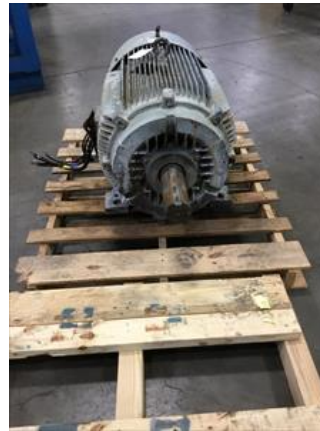
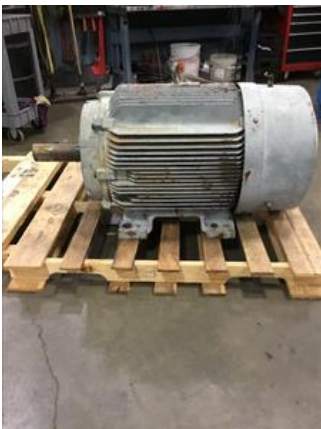
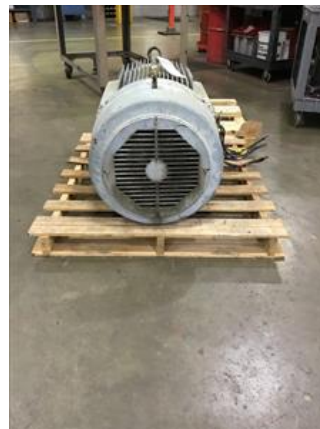
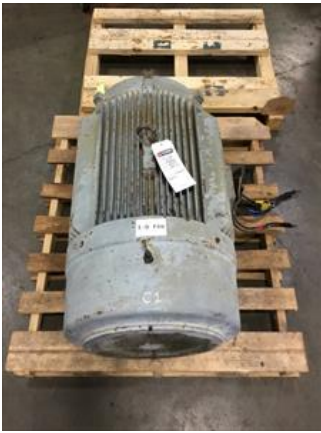
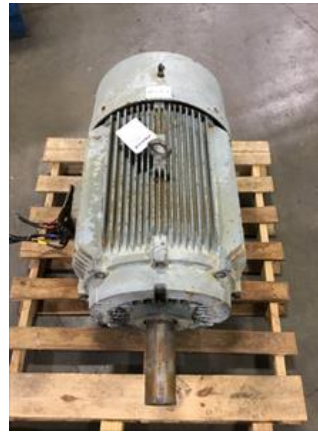
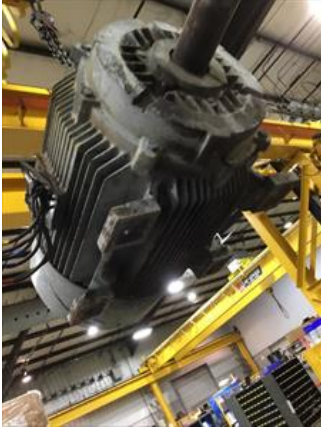
P3

3. Photos of all six sides of the machine.

*Failed electrical tests and requires rewind. Additional requires machine work to bearing fits*

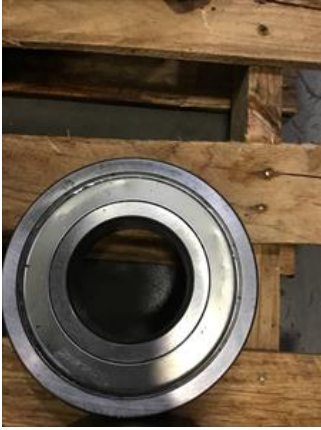
P40

34. Opposite Drive End Bearing Number-	6316 ZC3
35. Opposite Drive End Bearing Qty.	1
36. Opposite Drive End Bearing Type	(Ball) Ball Bearing
37. Opposite Drive End Lubrication Type	(Grease) Grease Lubricated
38. Opposite Drive End Bearing Insulation or Grounding Device?	None
39. Opposite Drive End Wavy Washer/Snap-Ring Other Retention Device?	Wavy Washer
40. Opposite Drive End Bearing Condition	Normal wear
